BUILDING INFORMATION	
FACILITY	Overfelt APO
DATE	July 16, 2014
BUILDING	P1, P2, P3, T1
ROOF SQ FT	4,000

BUILDING INFORMATION	
FACILITY	Overfelt APO
DATE	July 16, 2014
BUILDING	P4, P5, P6, P7, T2
ROOF SQ FT	5,500

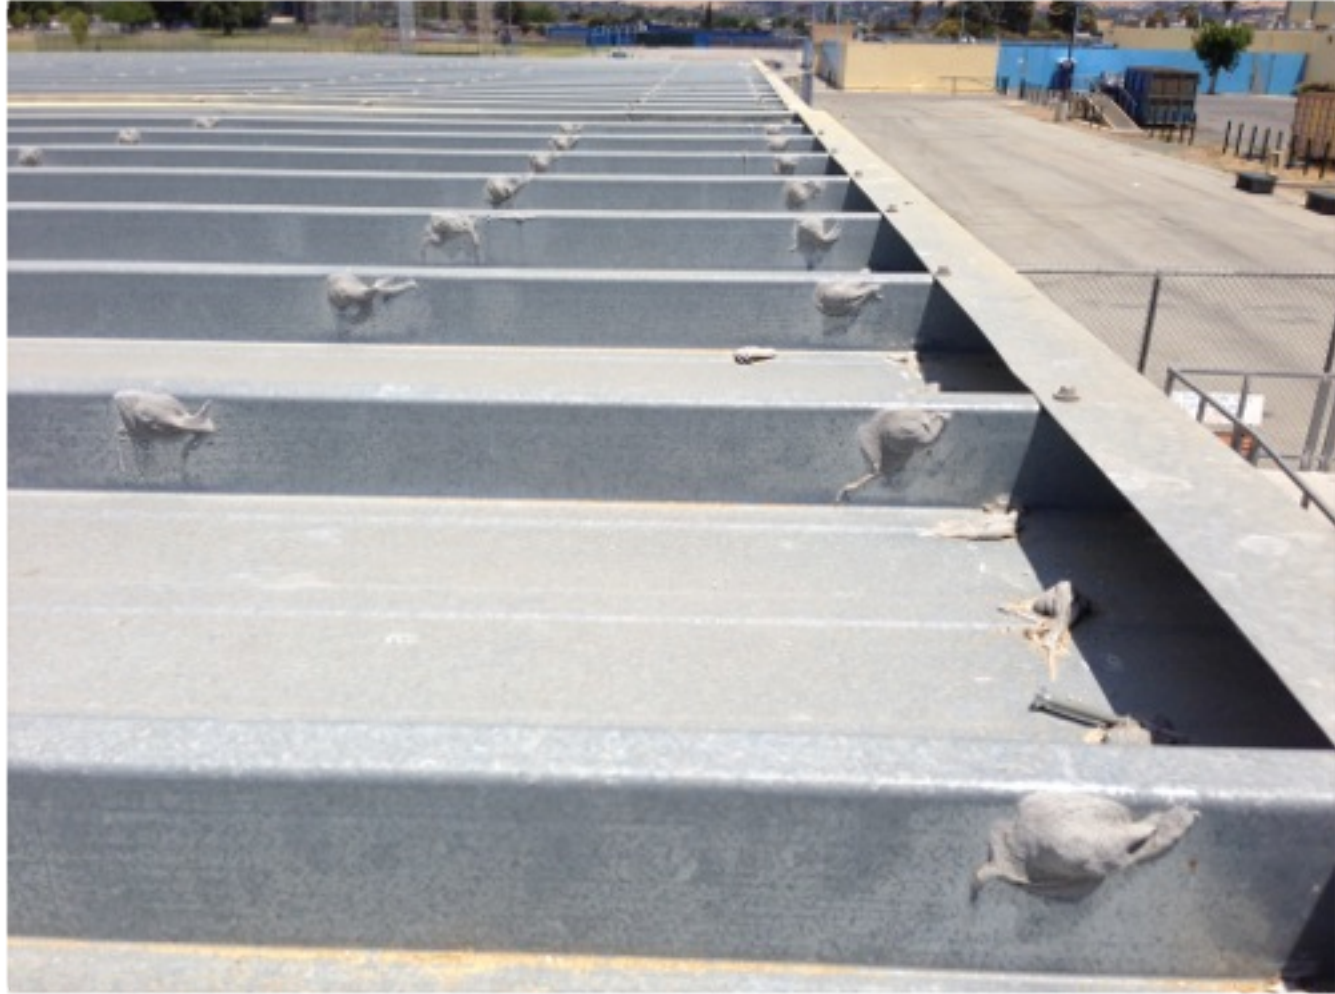
The photo below shows the metal roofs have no signs of fastener/sealant failure.

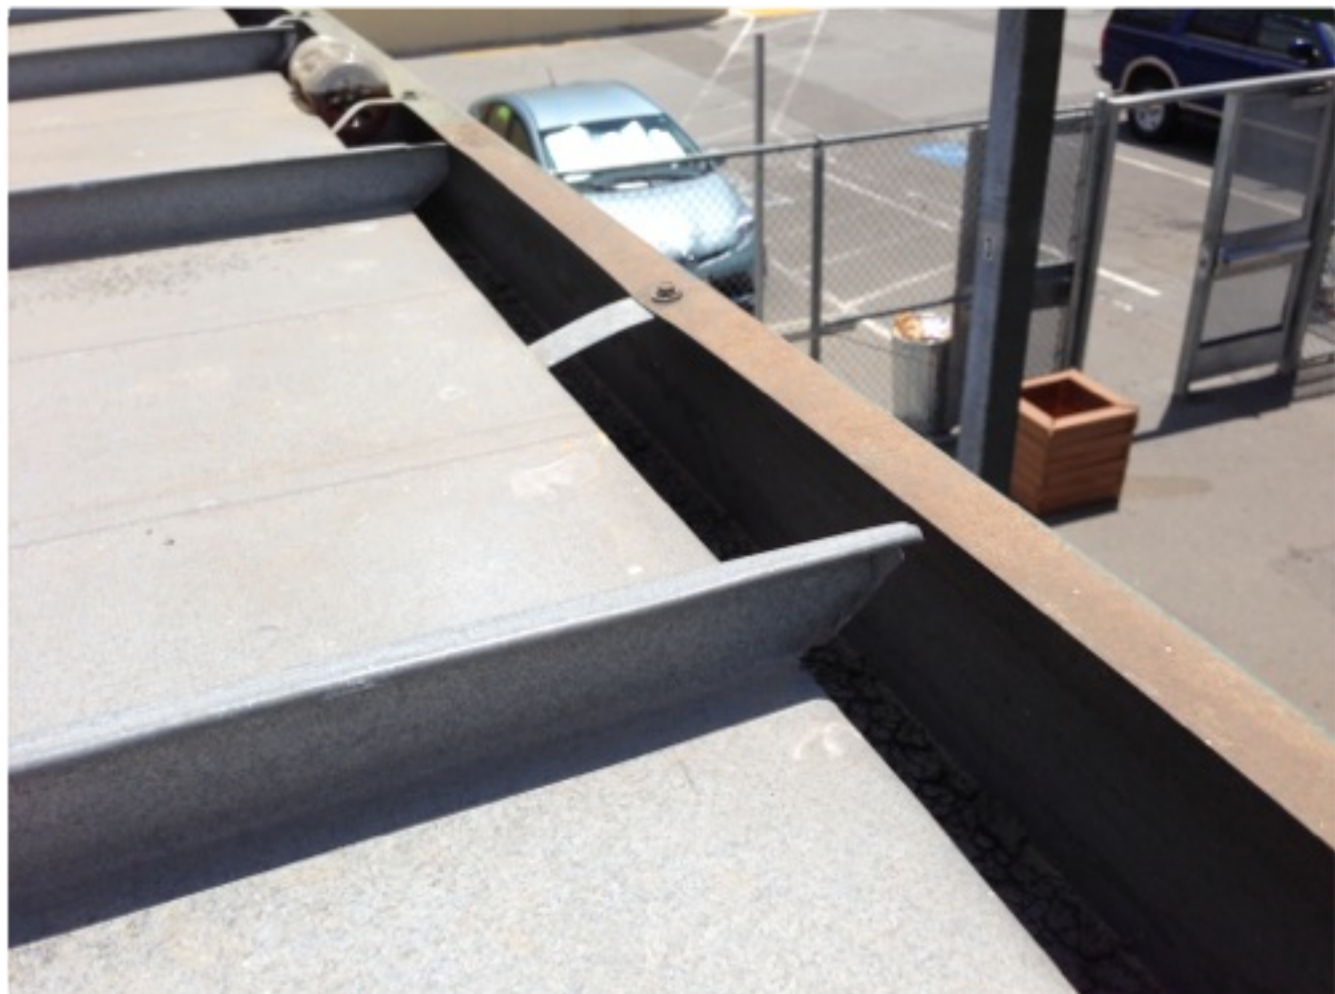
The photo below shows some rust around the roof perimeter edge/fascia.

DRAINAGE	REPAIRS NEEDED	<input type="checkbox"/>		RATING 7
	ADD/ENHANCE CRICKETS	<input type="checkbox"/>	ADD/ENHANCE OVERFLOW	<input type="checkbox"/>
	CLEAR DRAINS	<input type="checkbox"/>	ADD GUTTER	<input type="checkbox"/>
	GUTTER REPAIR NEEDED	<input type="checkbox"/>	GUTTER COATING NEEDED	<input type="checkbox"/>
PENETRATION	REPAIRS NEEDED	<input type="checkbox"/>		RATING 7
	RESEAL/REPAIR ALL	<input type="checkbox"/>	RESEAL/REPAIR SELECT	<input type="checkbox"/>
		<input type="checkbox"/>		<input type="checkbox"/>
		<input type="checkbox"/>		<input type="checkbox"/>
MAINTENANCE	KEEP DRAINS CLEAN	<input type="checkbox"/>	KEEP GUTTERS CLEAN	<input checked="" type="checkbox"/>
	SPOT REPAIR UNTIL REROOF	<input type="checkbox"/>	TRIM TREES	<input type="checkbox"/>
	CLEAR ROOF OF DEBRIS	<input type="checkbox"/>	HVAC REPAIR NEEDED	<input type="checkbox"/>
	HAZMAT SUSPECTED	<input type="checkbox"/>	CONSIDER PAINTING ROOF EDGE	<input checked="" type="checkbox"/>

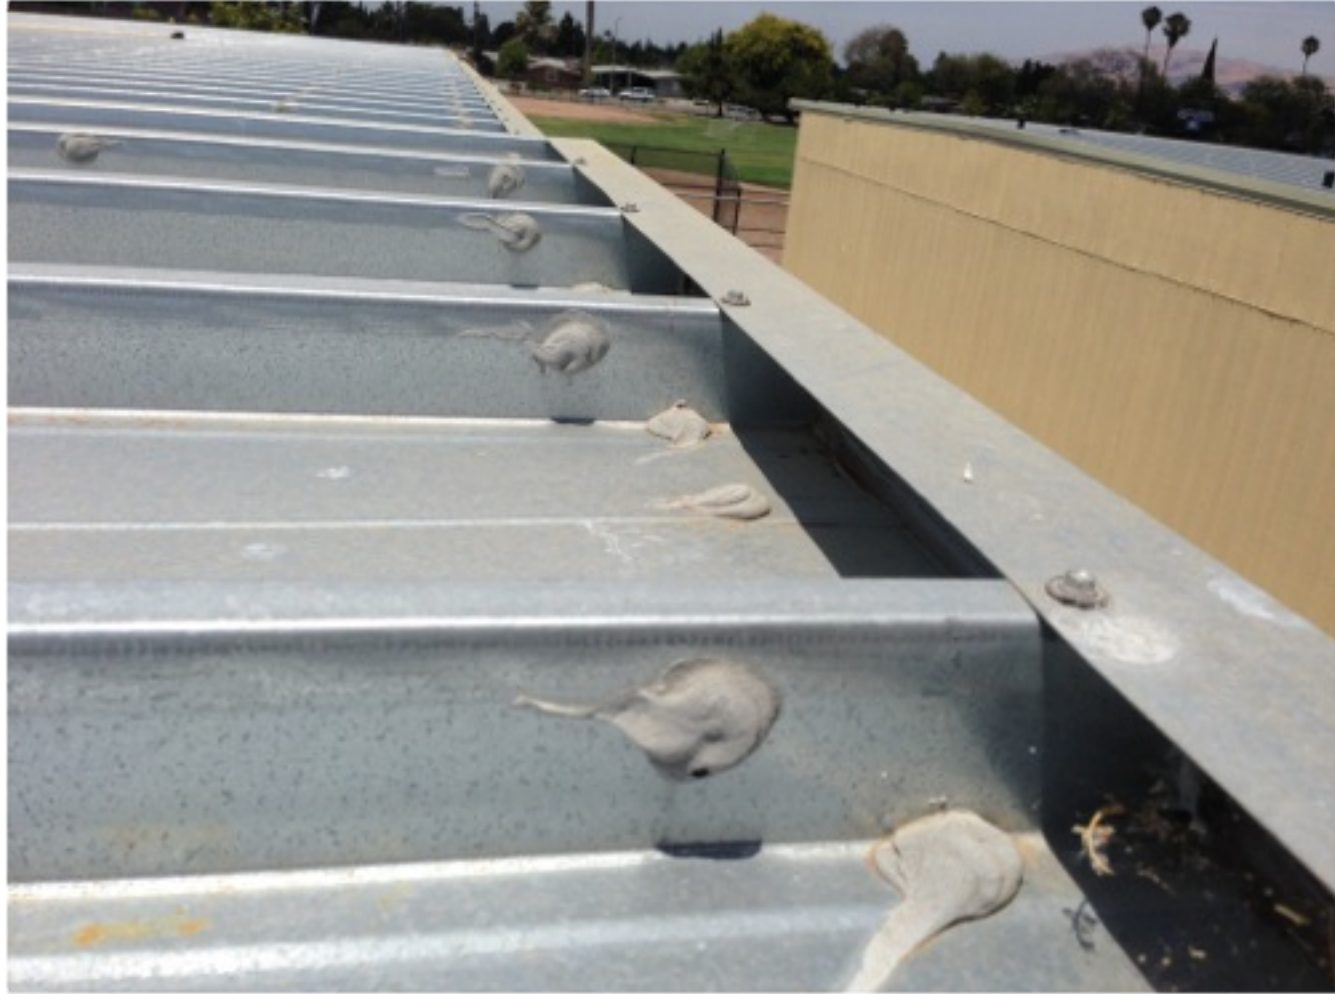
The photo below shows the metal roofs have no signs of fastener/sealant failure.

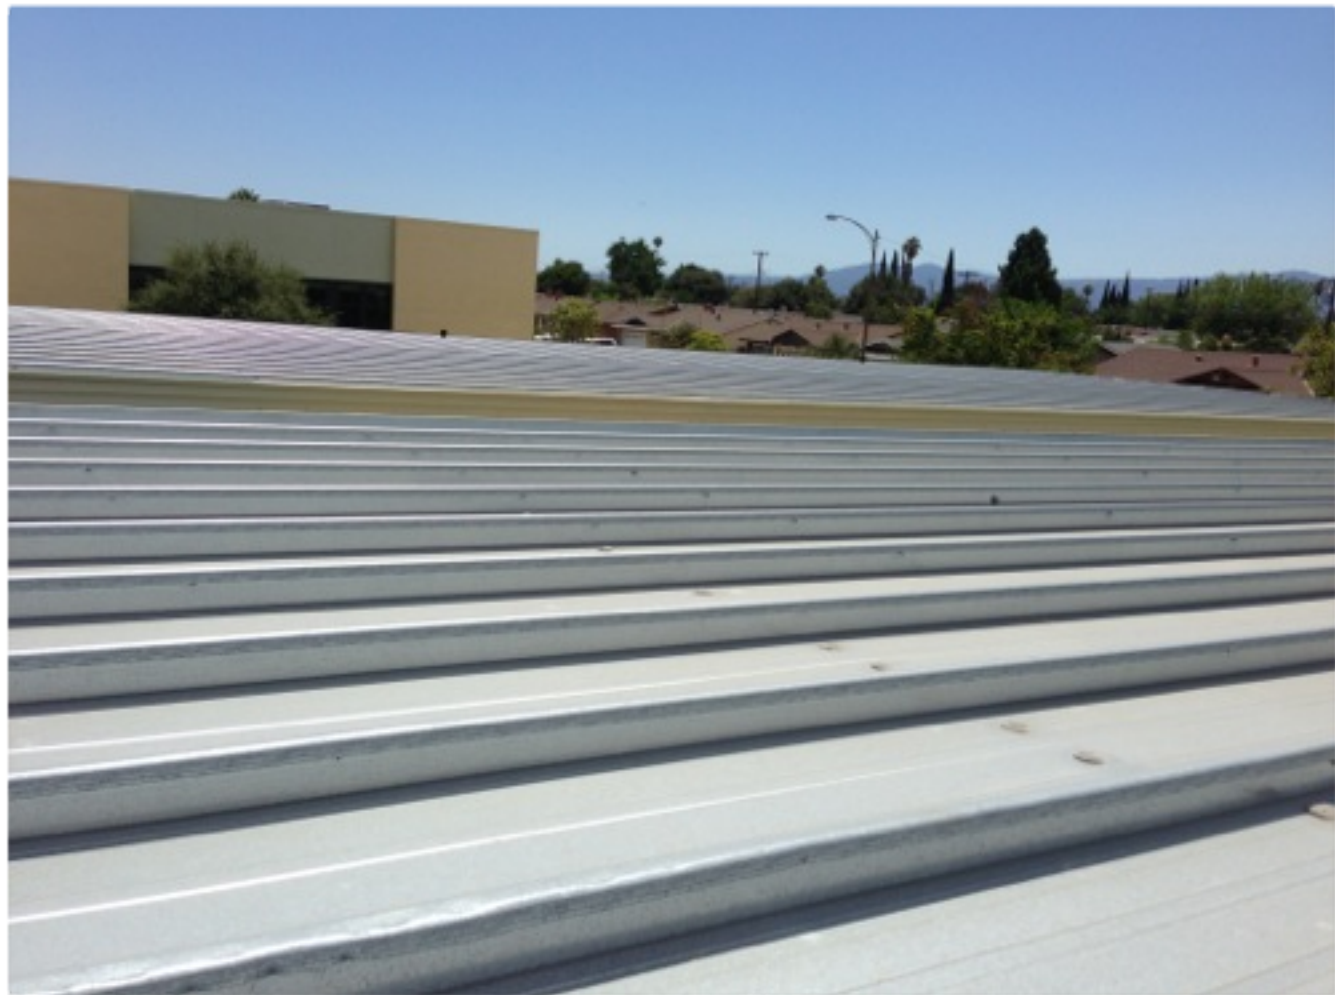
The photo below shows the metal roofs have no signs of rust in the field.
