BUILDING	Main								ENGINEERING		
ROOF SQ FT	34,700				E				INGINEERING SERVICES FOR THE BUILDING ENVELOPE		
ROOF CONSTRUCTION											
ROOF AGE	2013	✓	0-5 YEARS		5-10 YEARS		10-15 YEARS		15+ YEARS		
WARRANTY	UNKNOWN		BUR 10 YEAR	✓	15 YEAR		SS 20 YEAR	✓	30 YEAR		
DECK TYPE	METAL		PLYWOOD	√	PLANK		CONCRETE		LW CONCRETE		
INSULATION	NONE		ISO		FIBER		PERLITE		STYRO		
INSUL THICK	1 INCH		2 INCH		3 INCH		4 INCH		TAPERED		
MEMBRANE	METAL SS	\	SINGLE PLY		BUR	\	MOD BIT		2 SYSTEMS	✓	
MEM SURFACE	COATING		MS CAP	⋖	GRAVEL		SMOOTH				
FLASHINGS	CAPSHEET	✓									
DRAINAGE	JOSAM	V	SCUPPERS		GUTTERS		OVER EDGE				
SLOPE	NONE		BUR 1:12	✓	2:12		3:12		SS 6:12	\checkmark	
ROOF CONDITION - RATINGS (1-10) and RECOMMENDATIONS #											
FIELD	REPAIRS NEEDED								RATING	9	
	RESEAL SEAMS CLEAR ROOF OF DEBRIS				RESEAL BLISTERS or RIDGING				SS RATING	9	
					DE	CK F	REPAIR NEEDED				
	DECK REPAIR SUSPECTED				RESEAL/F	RPLA	CE FASTENERS

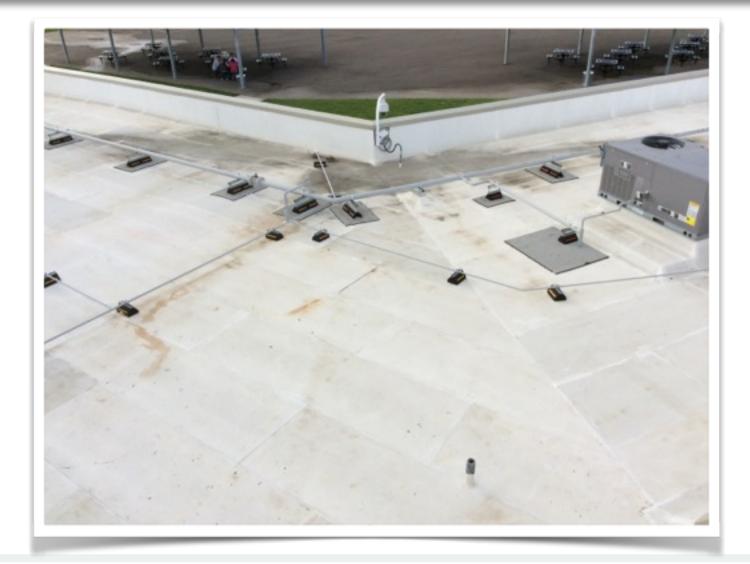
The photo below shows some ponding.

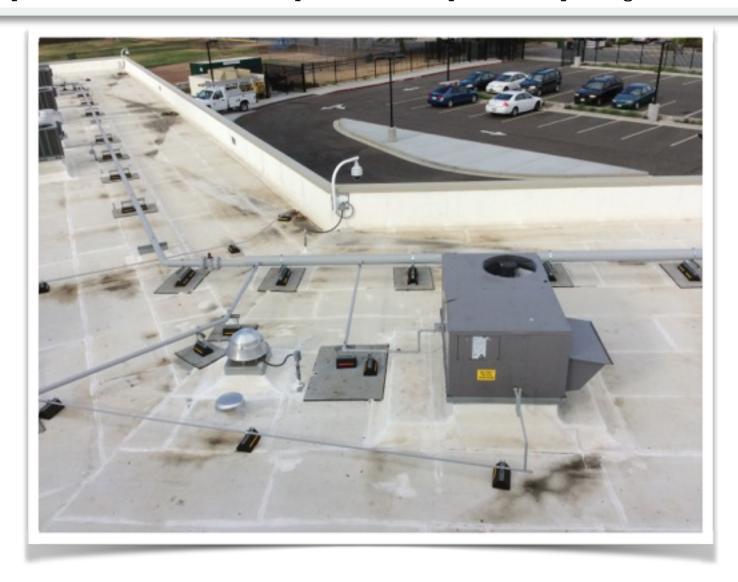
The photo below shows that some repairs have taken place on the ponding areas.
