BUILDING INFORMATION	
FACILITY	Evergreen Valley HS
DATE	October 27, 2014
BUILDING	A and B
ROOF SQ FT	21,600

BUILDING INFORMATION	
FACILITY	Evergreen Valley HS
DATE	October 27, 2014
BUILDING	C Library
ROOF SQ FT	2,100

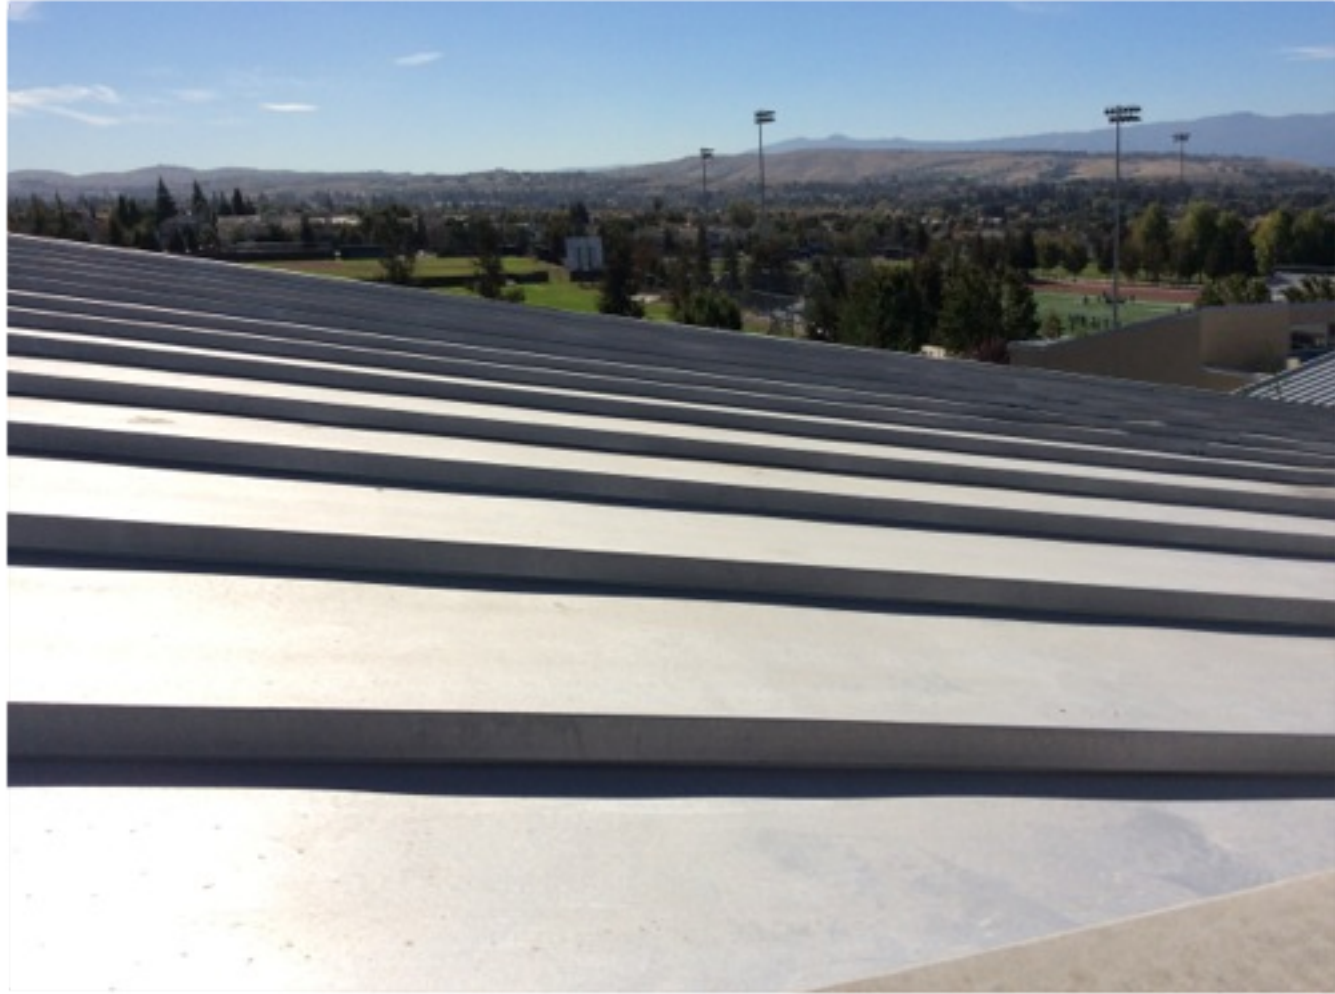
The photo below shows the metal roof in good shape.

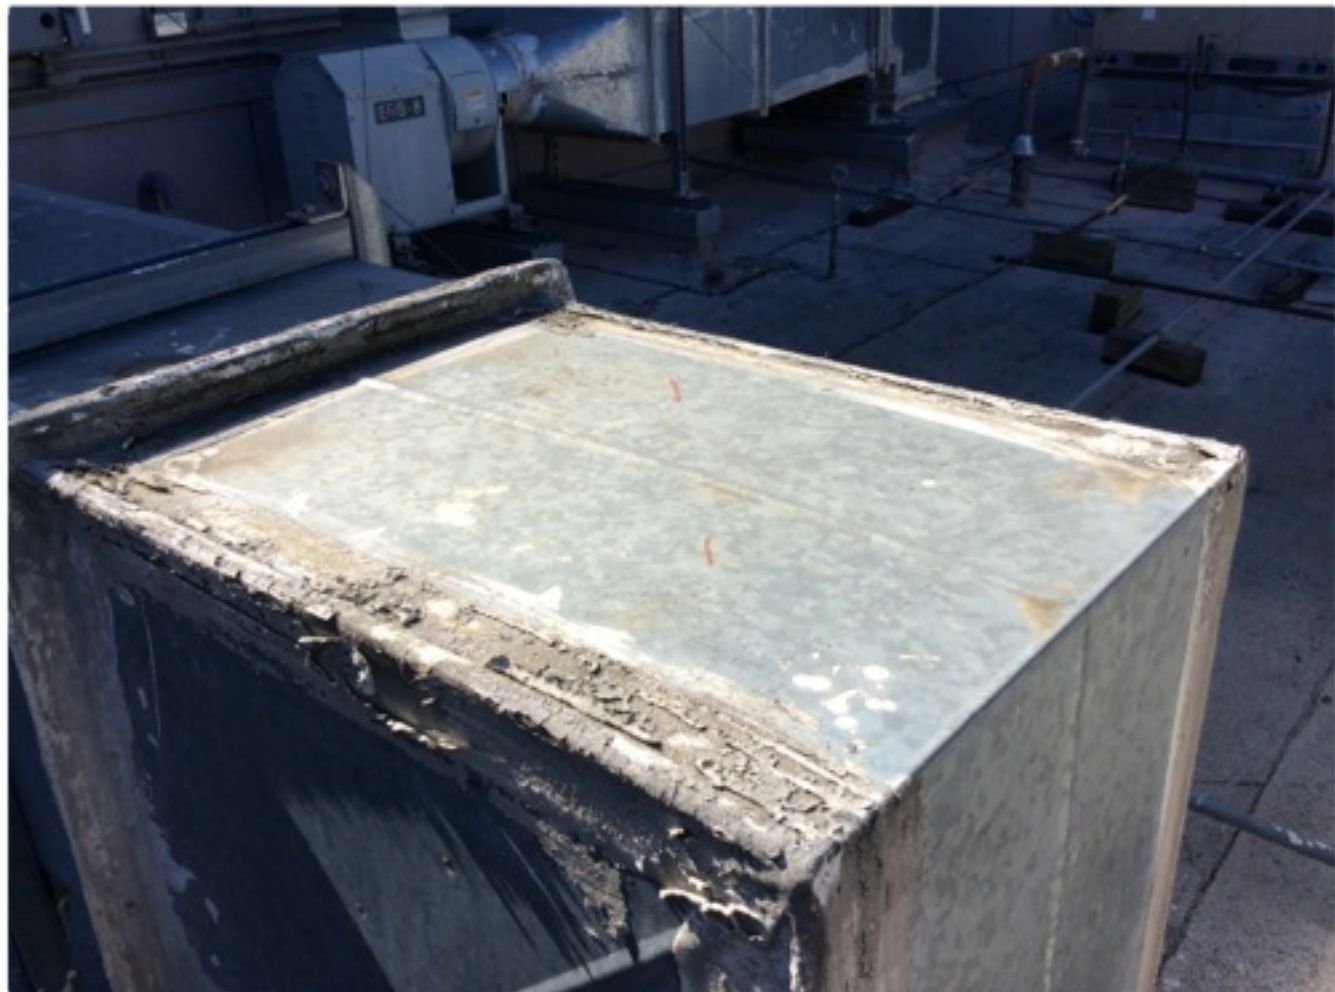
The photo below shows some ducts need to be resealed soon.

ADDITIONAL NOTES
 ROOF IS AGING NORMALLY WITH FIRST SIGNS OF RIDGING AND CRAZE CRACKING. MANAGE CLOSELY TO OBTAIN ANOTHER FIVE YEARS OF LIFE. RESEAL SELECT DUCTWORK IN THE NEXT YEAR OR TWO.

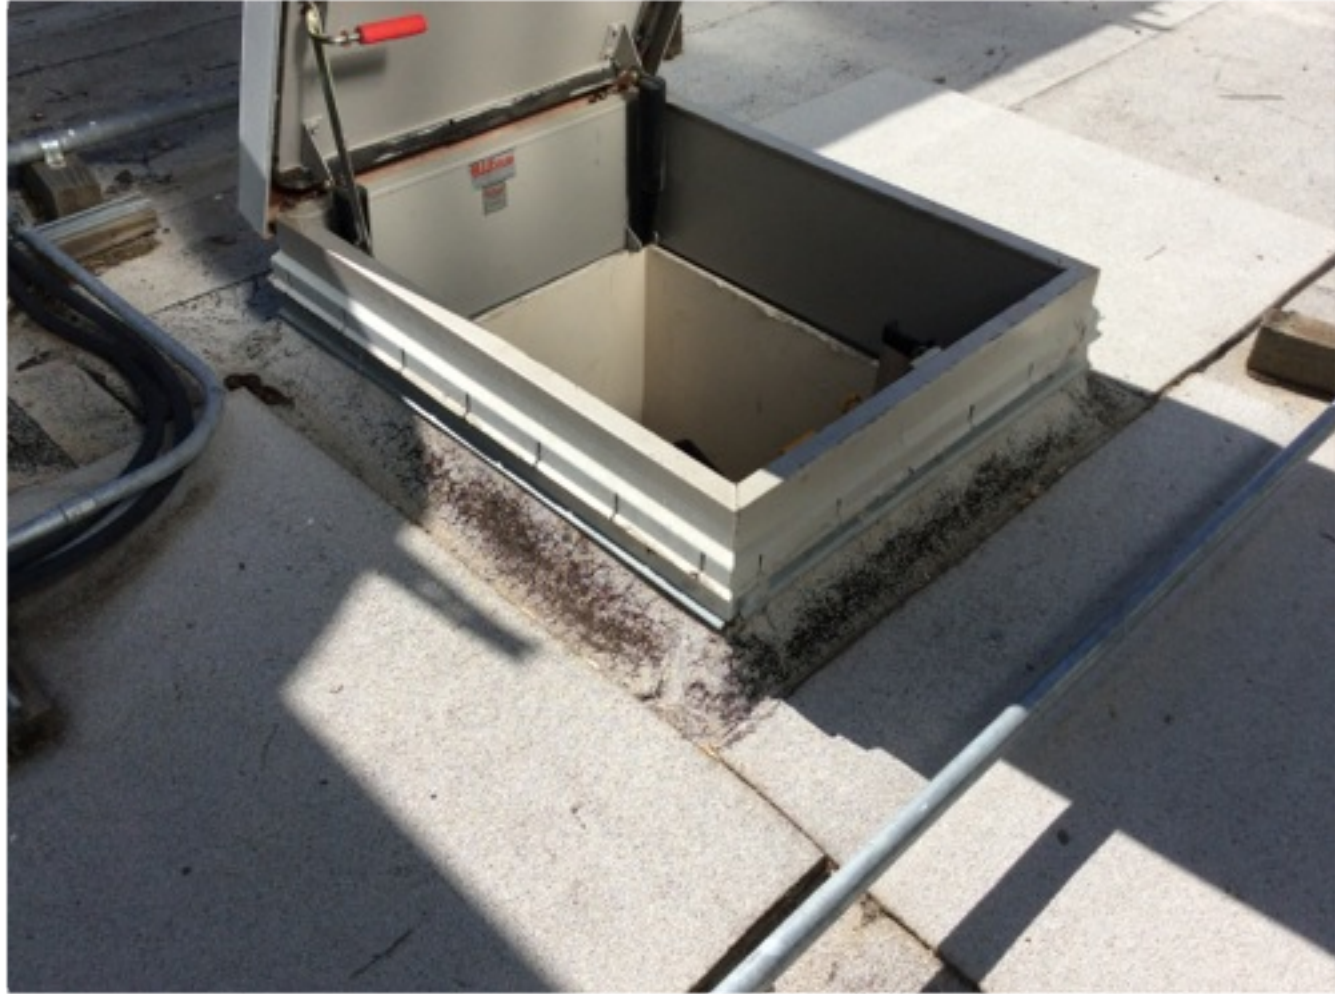
ADDITIONAL NOTES
 ROOF IS AGING POORLY WITH HEAVY CRAZE CRACKING ESPECIALLY ON ALL THE BASE FLASHINGS AND EXCESSIVE PONDING UNDER THE HVAC EQUIPMENT - WHICH ACCELERATES AGING. BUDGET TO REPLACE IN THREE YEARS.

The photo below shows premature aging or wear on the base flashings.

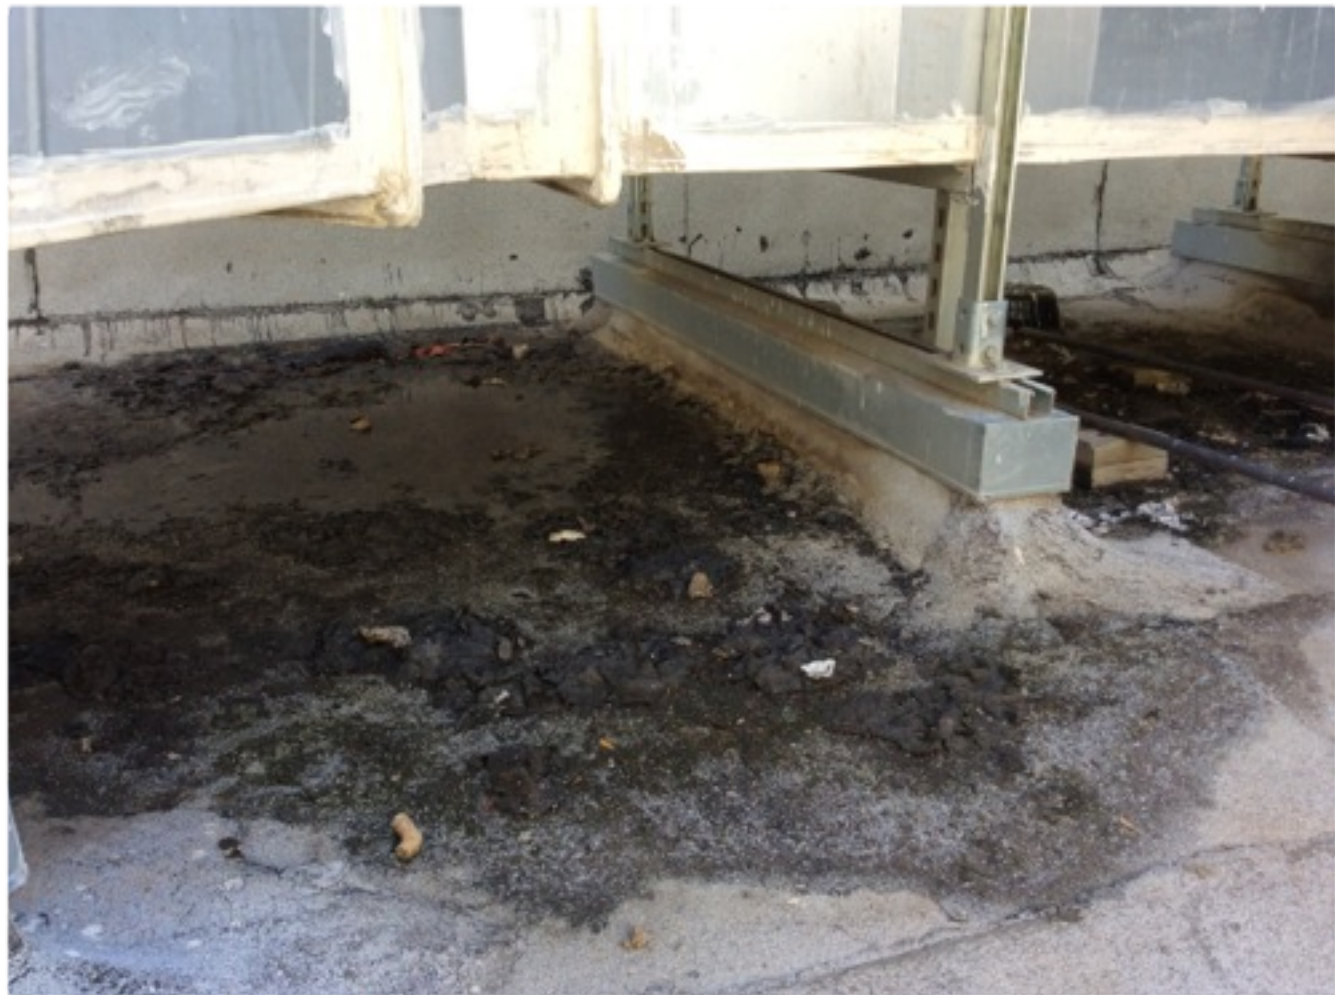
The photo below shows excessive ponding which accelerates aging of the roof system.

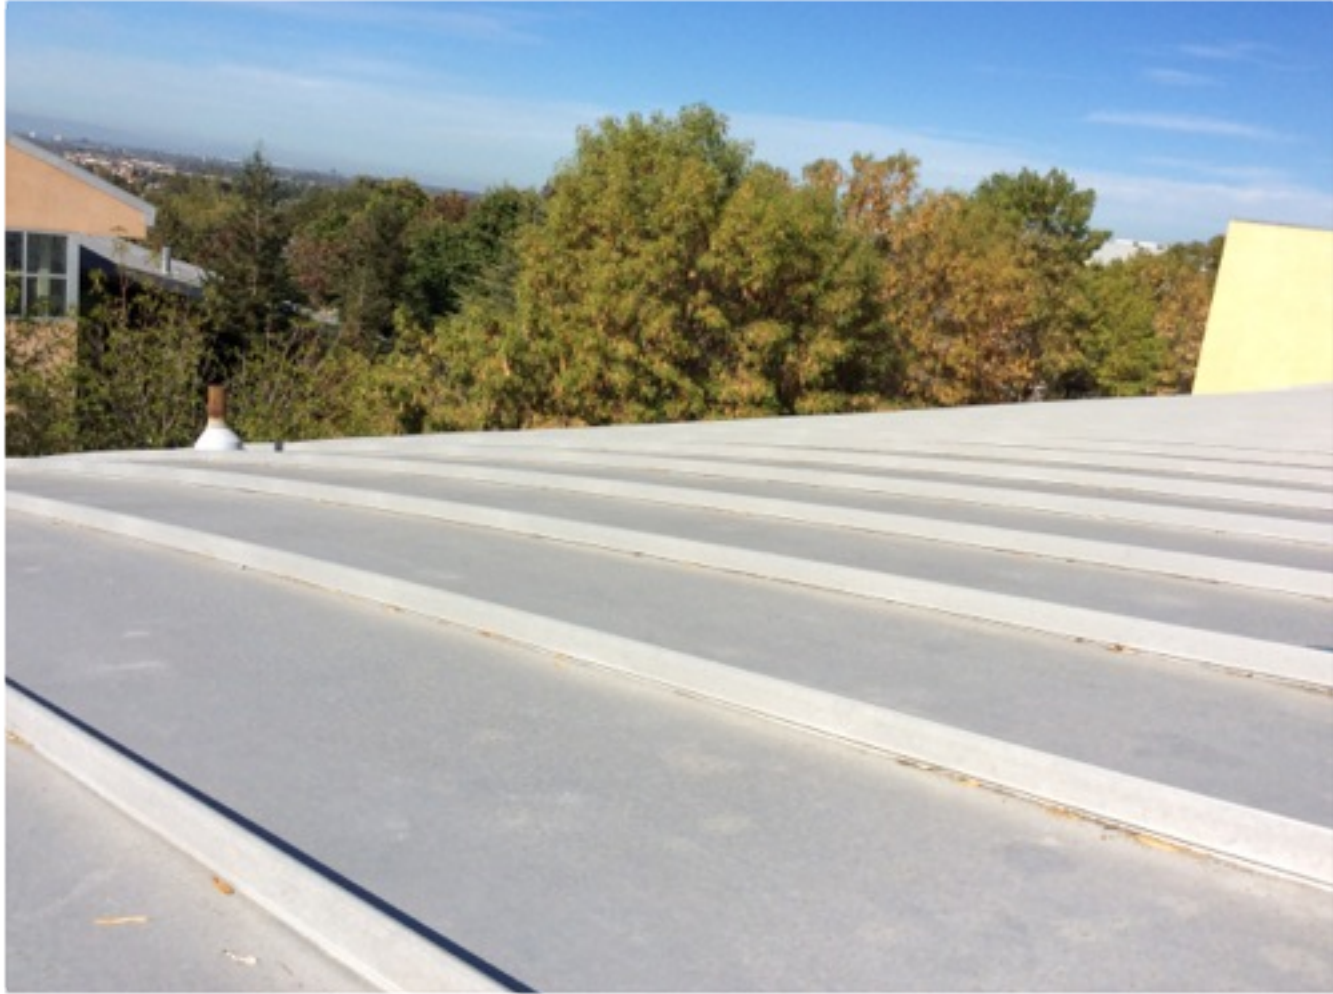
The photo below shows the metal roof in good shape.

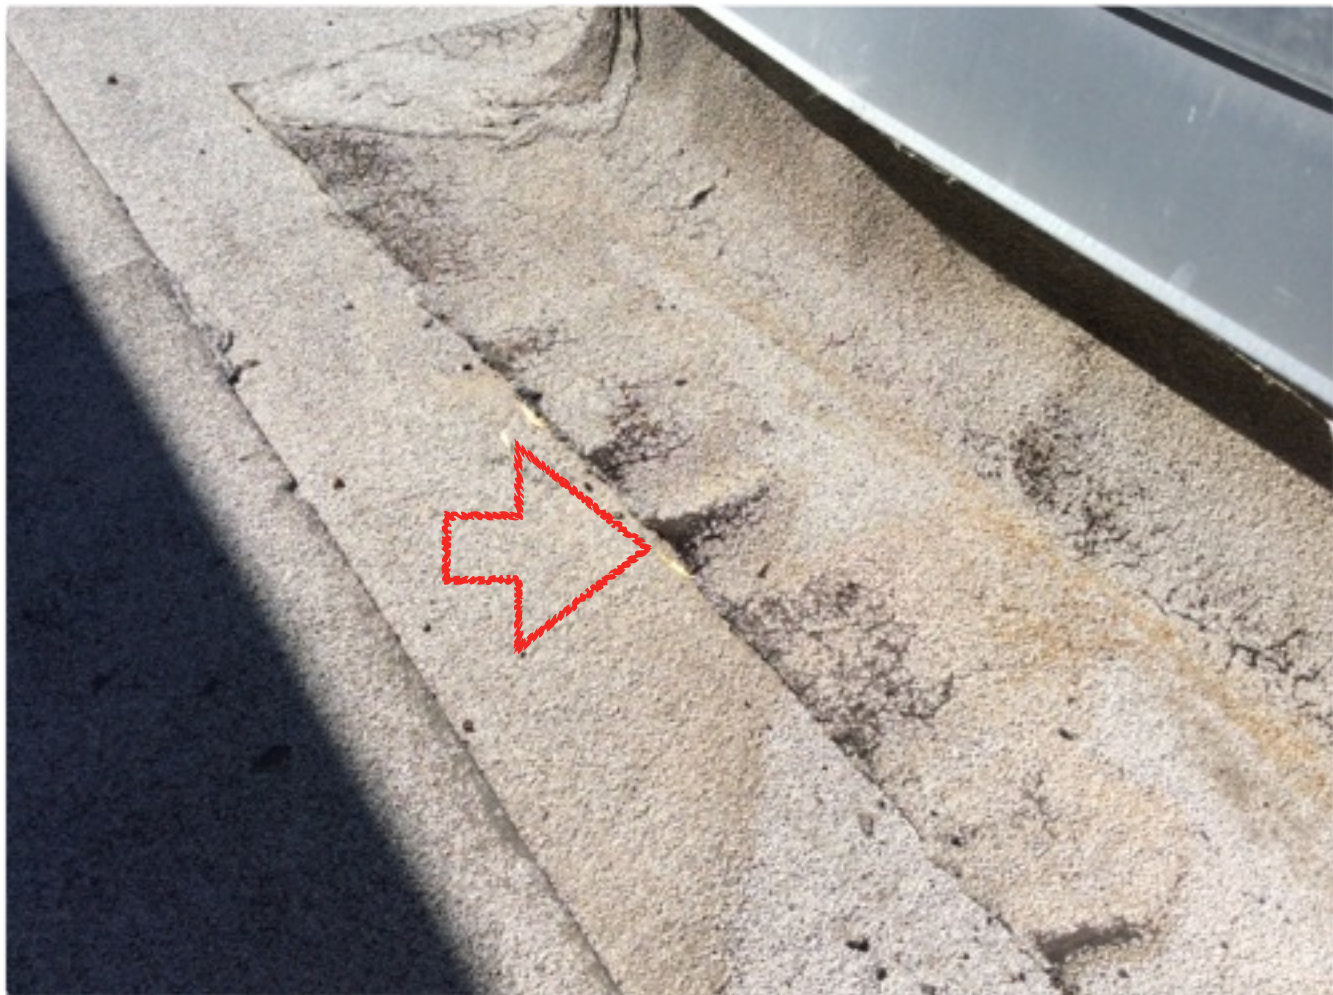
ADDITIONAL NOTES
 ROOF IS AGING NORMALLY WITH FIRST SIGNS OF RIDGING AND CRAZE CRACKING. MANAGE CLOSELY TO OBTAIN ANOTHER FIVE YEARS OF LIFE.

The photo below shows some ridging and normal wear for a roof of this age.

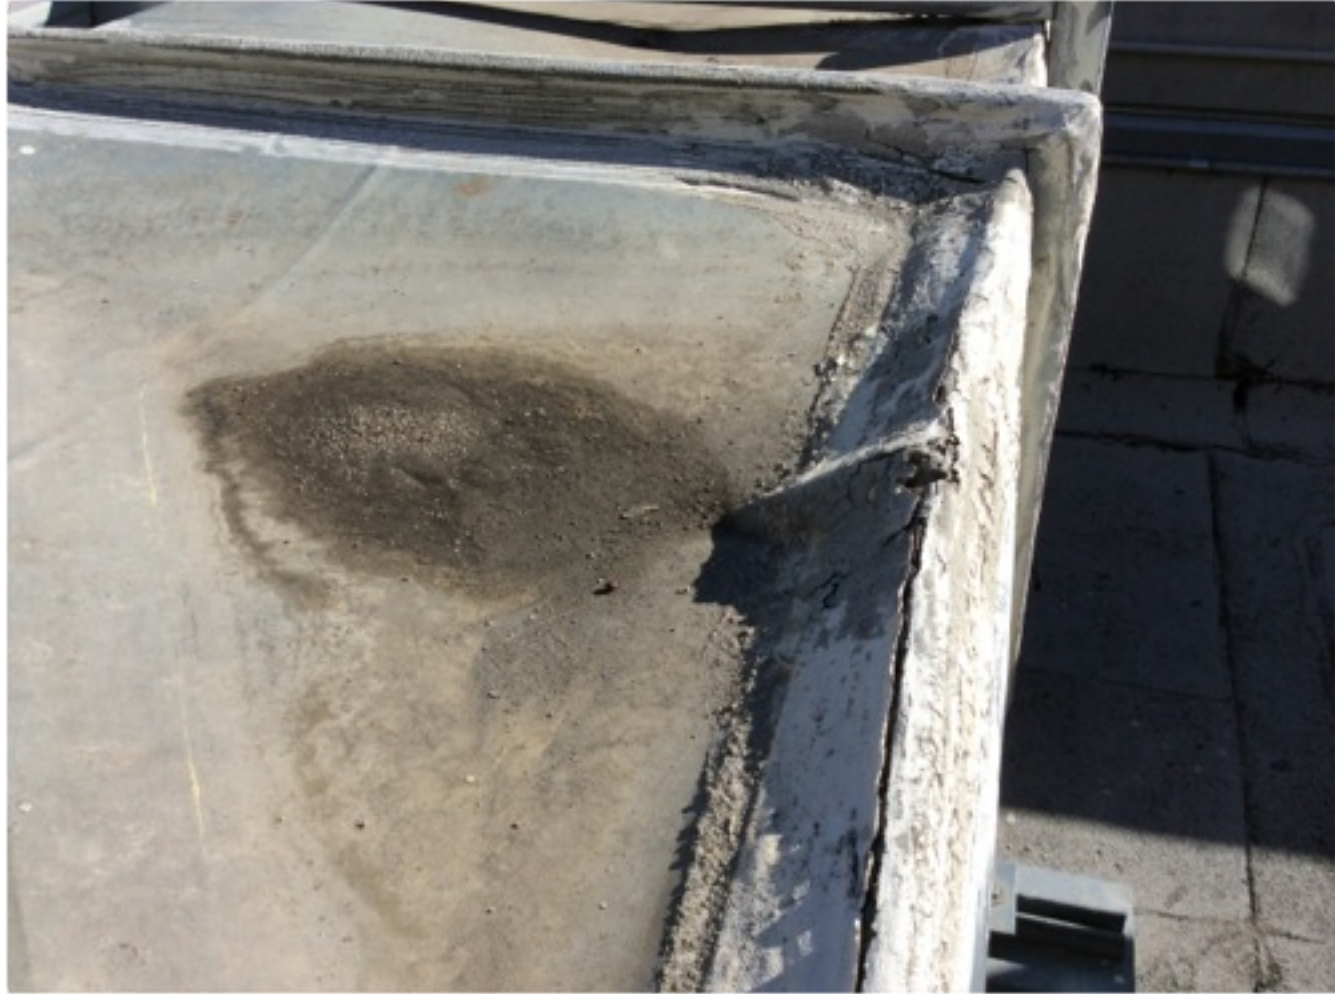
The photo below shows open holes in the AC ducts.

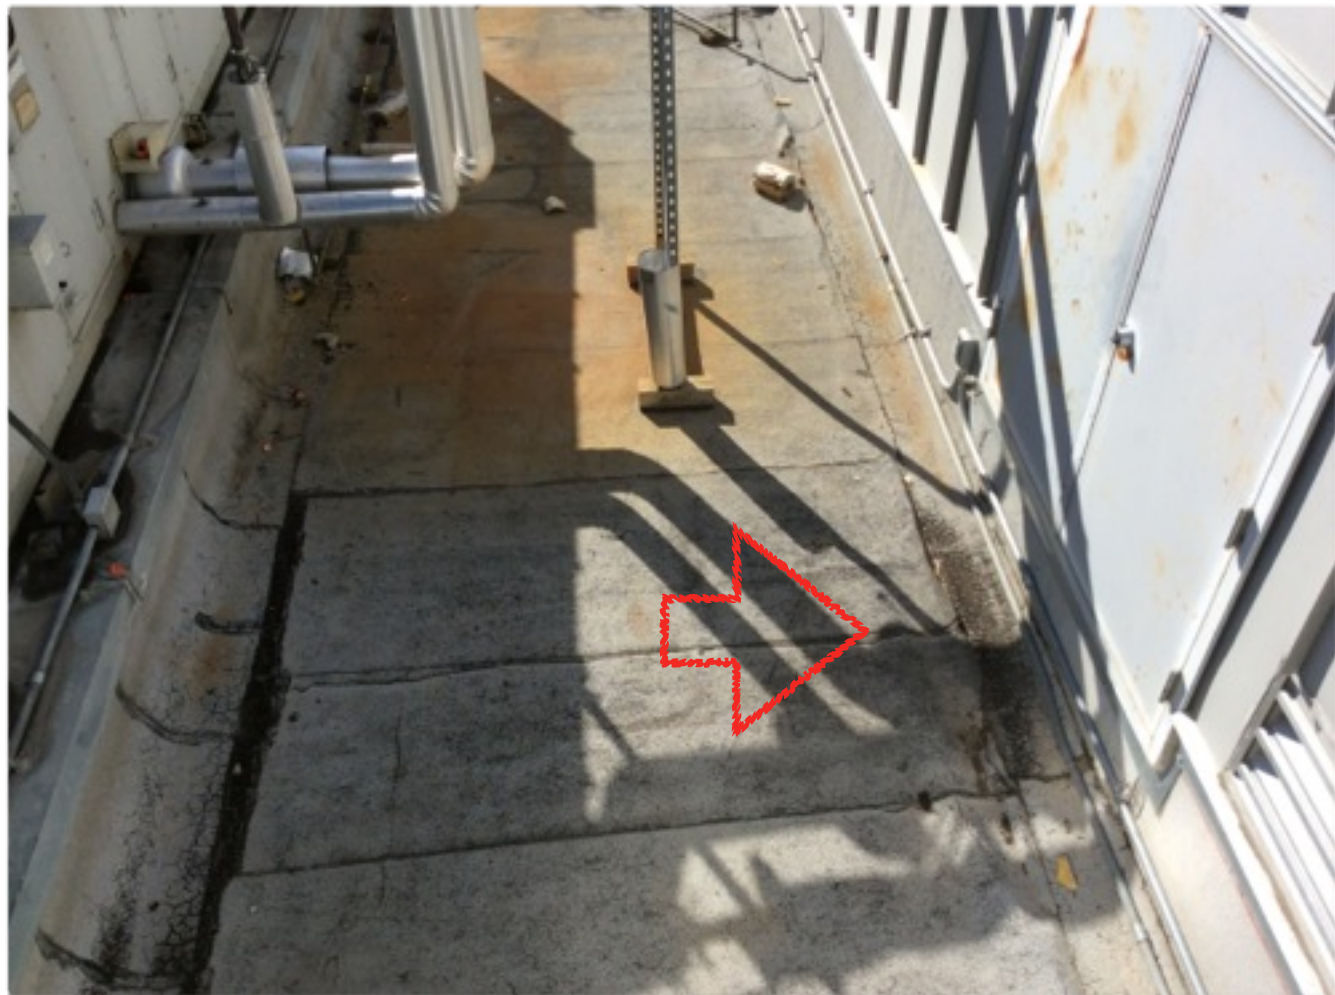
ADDITIONAL NOTES
 IN SURPRISINGLY BAD CONDITION. BRITTLE, RIDGING AND BLISTERING - A BAD COMBINATION THAT EASILY LEADS TO A LEAKING ROOF - AND THIS ROOF IS LEAKING. WE SHOULD ATTEMPT A MANUFACTURERS WARRANTY REPAIR ON THIS FIRST.

The photo below shows open holes and excessive ridging in the membrane.

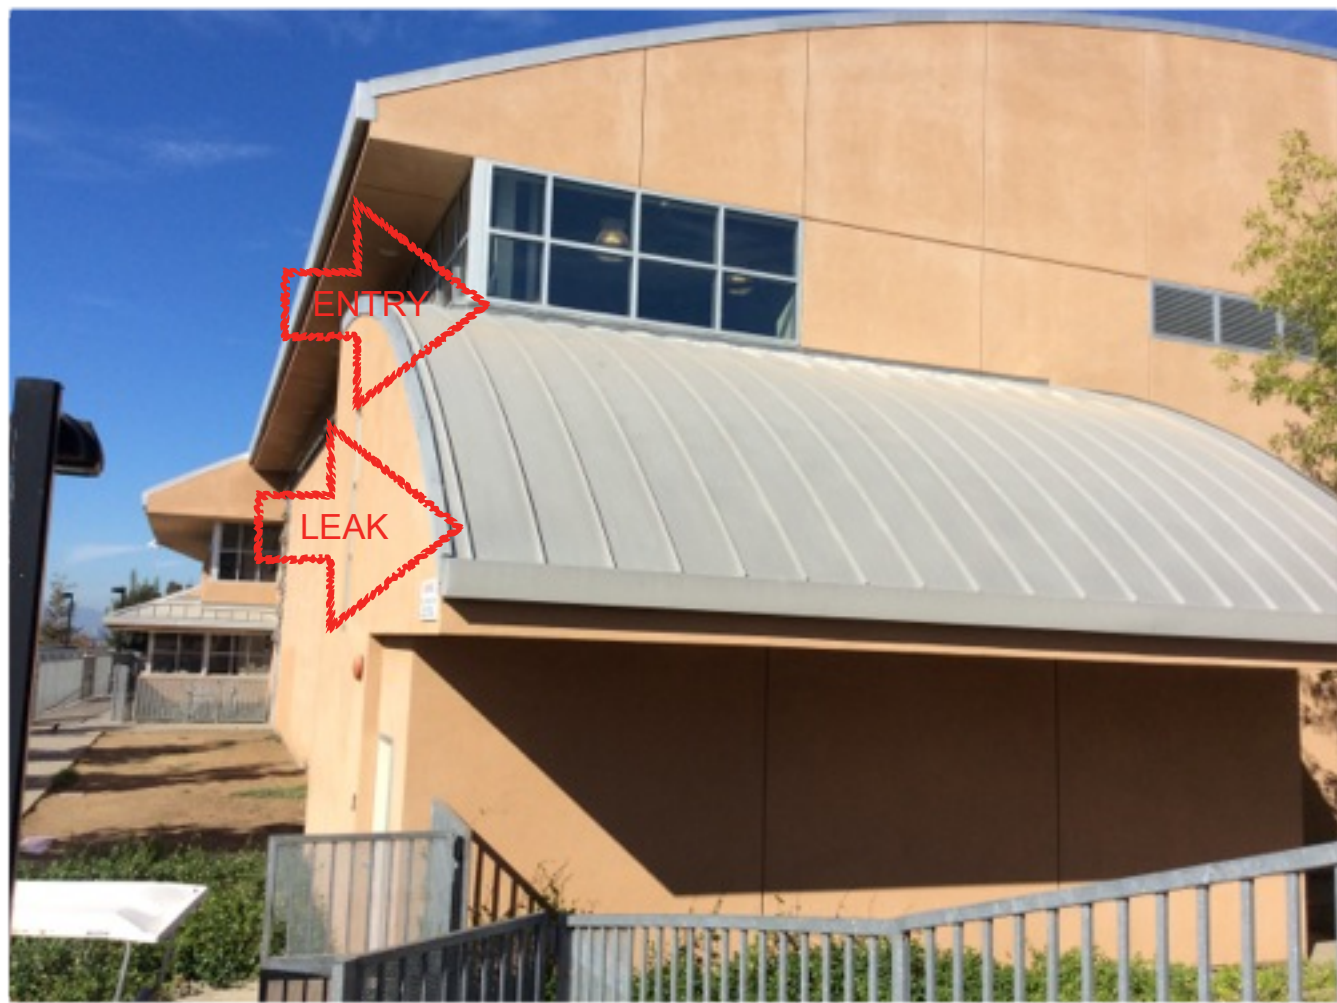
ADDITIONAL NOTES
 ROOF IS AGING POORLY WITH DEEP RIDGING AND HEAVY CRAZE CRACKING ESPECIALLY ON ALL THE BASE FLASHINGS. THE ROOF DOES LEAK BUT IT IS SUSPECTED TO BE A WINDOW OR EXTERIOR WINDOW BASE FLASHING BECAUSE THE LEAK IS AT THE EVE OR BASE OF A SECTION OF METAL STANDING SEAM ROOF.

The photo below locates the internal leak and the suspected point of entry.

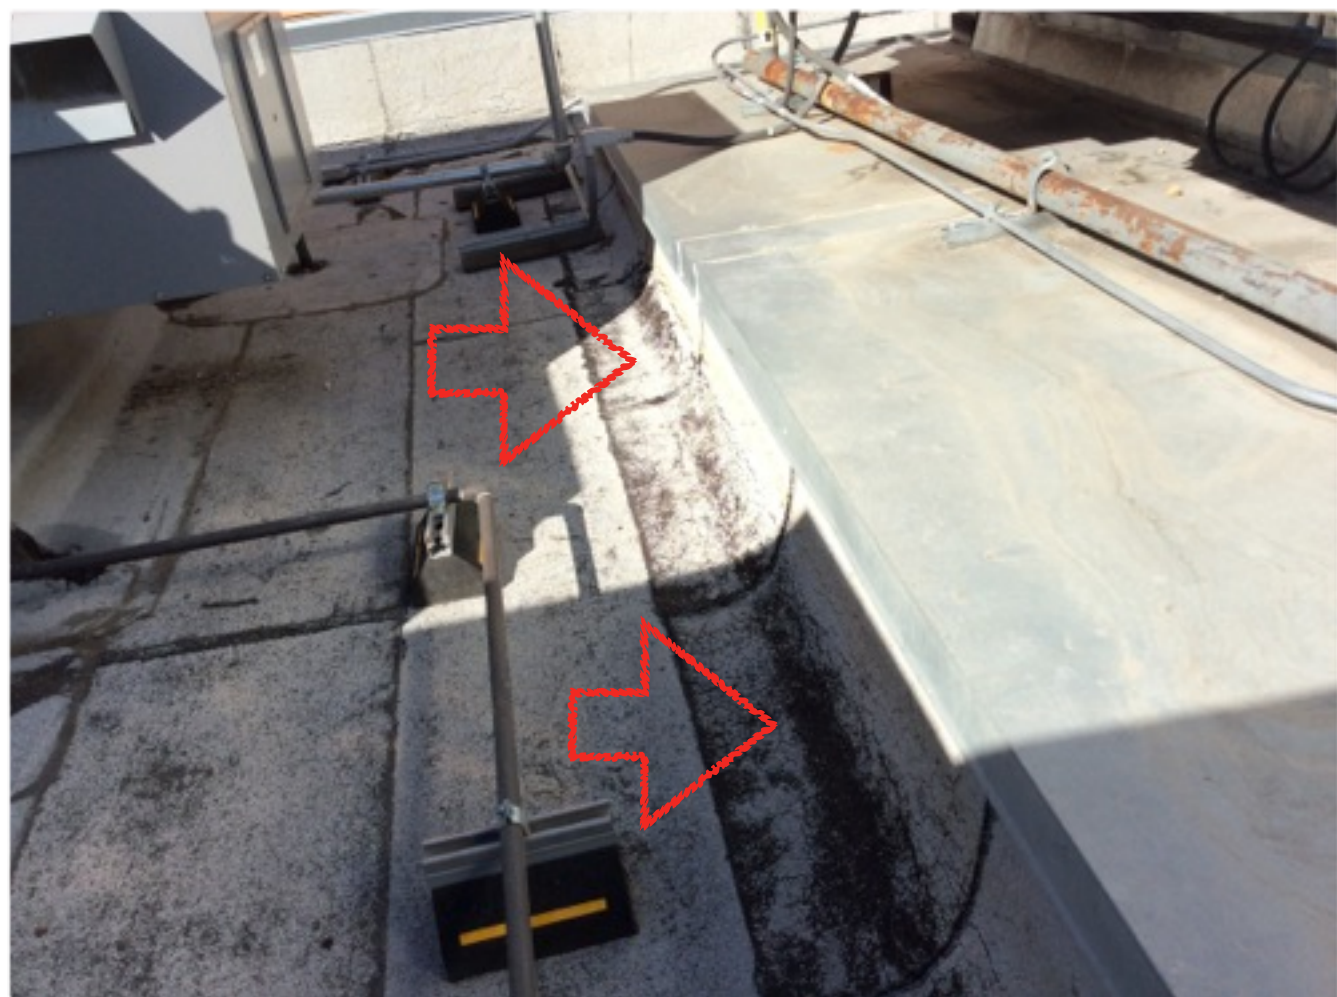
The photo below shows premature aging or wear on the base flashings.

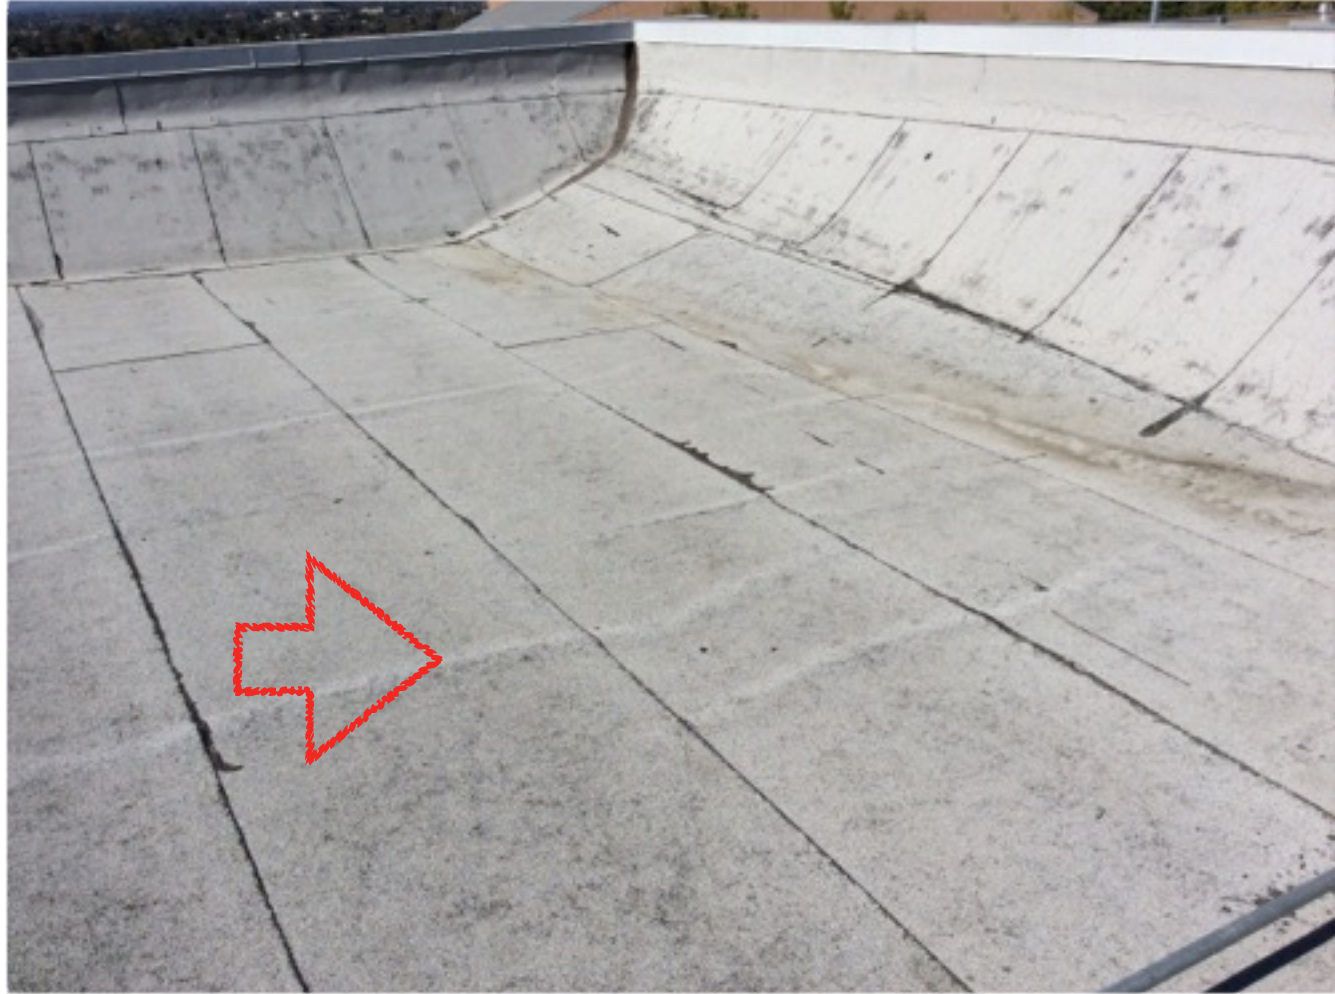
ADDITIONAL NOTES
 ROOF IS AGING POORLY WITH RIDGING, CRAZE CRACKING, AND MANY EXISTING REPAIRS. REPAIR FAILING PATCHES AND MANAGE CLOSELY TO SQUEEZE ANOTHER THREE TO FIVE YEARS OUT OF THIS ROOF.

The photo below shows ridging in the membrane.

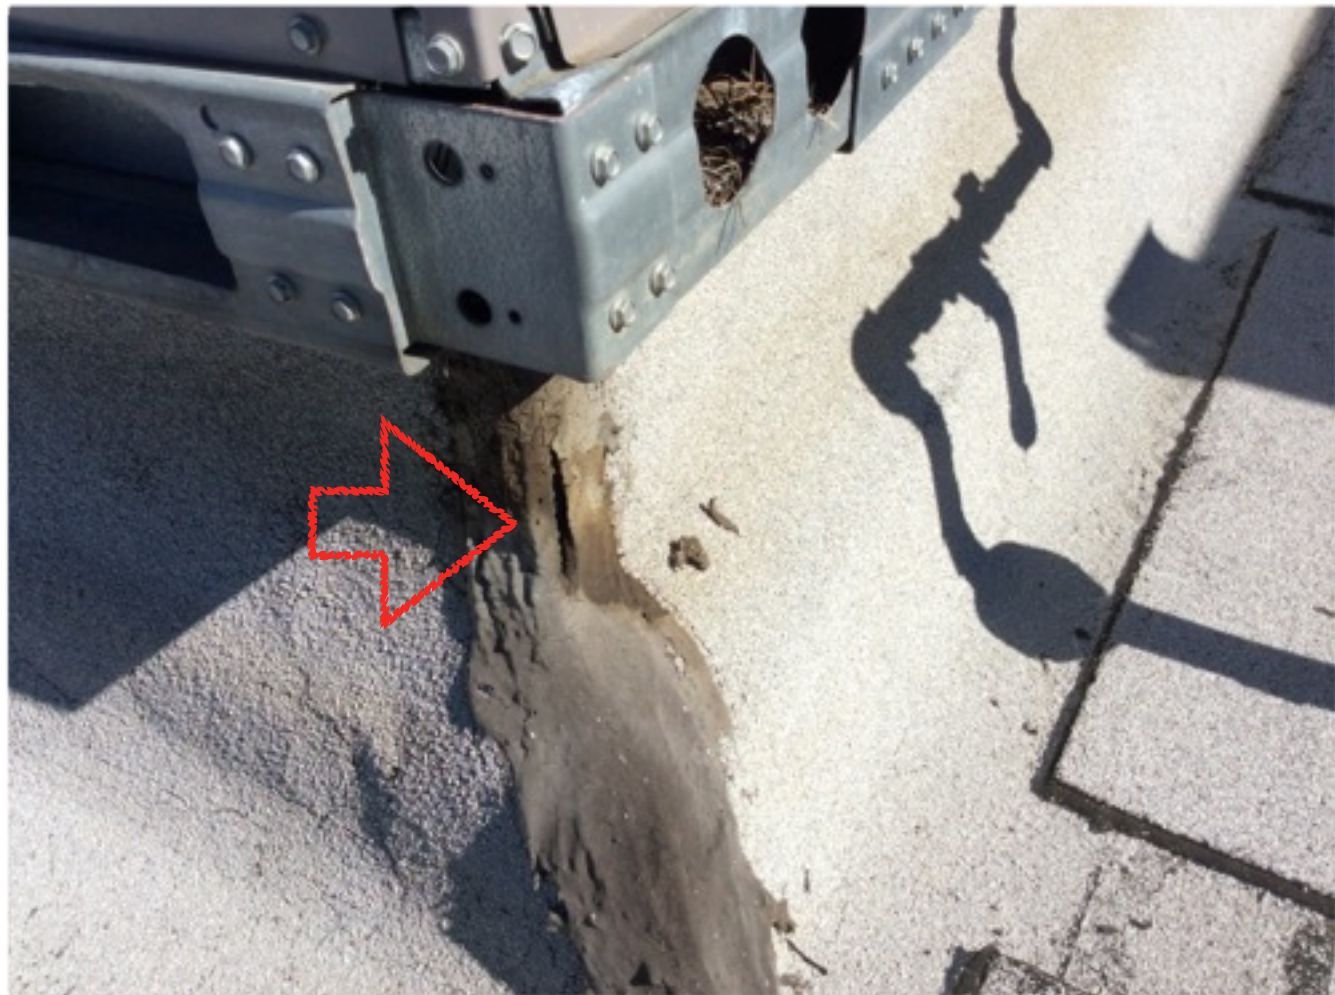
The photo below shows some penetrations need to be resealed.

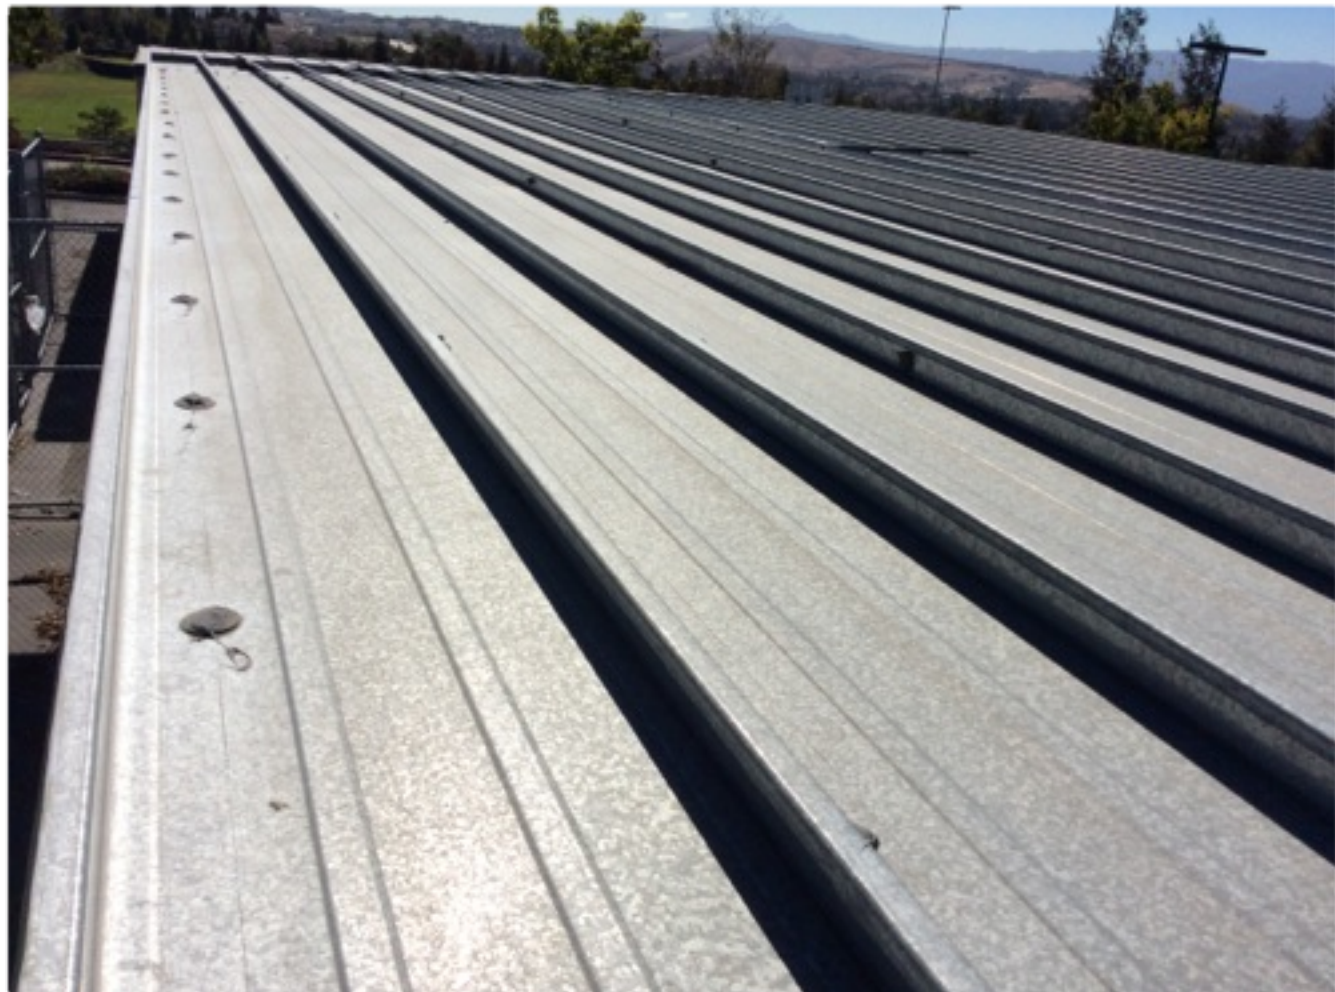
The photo below shows the surface and fastener sealant in good shape.

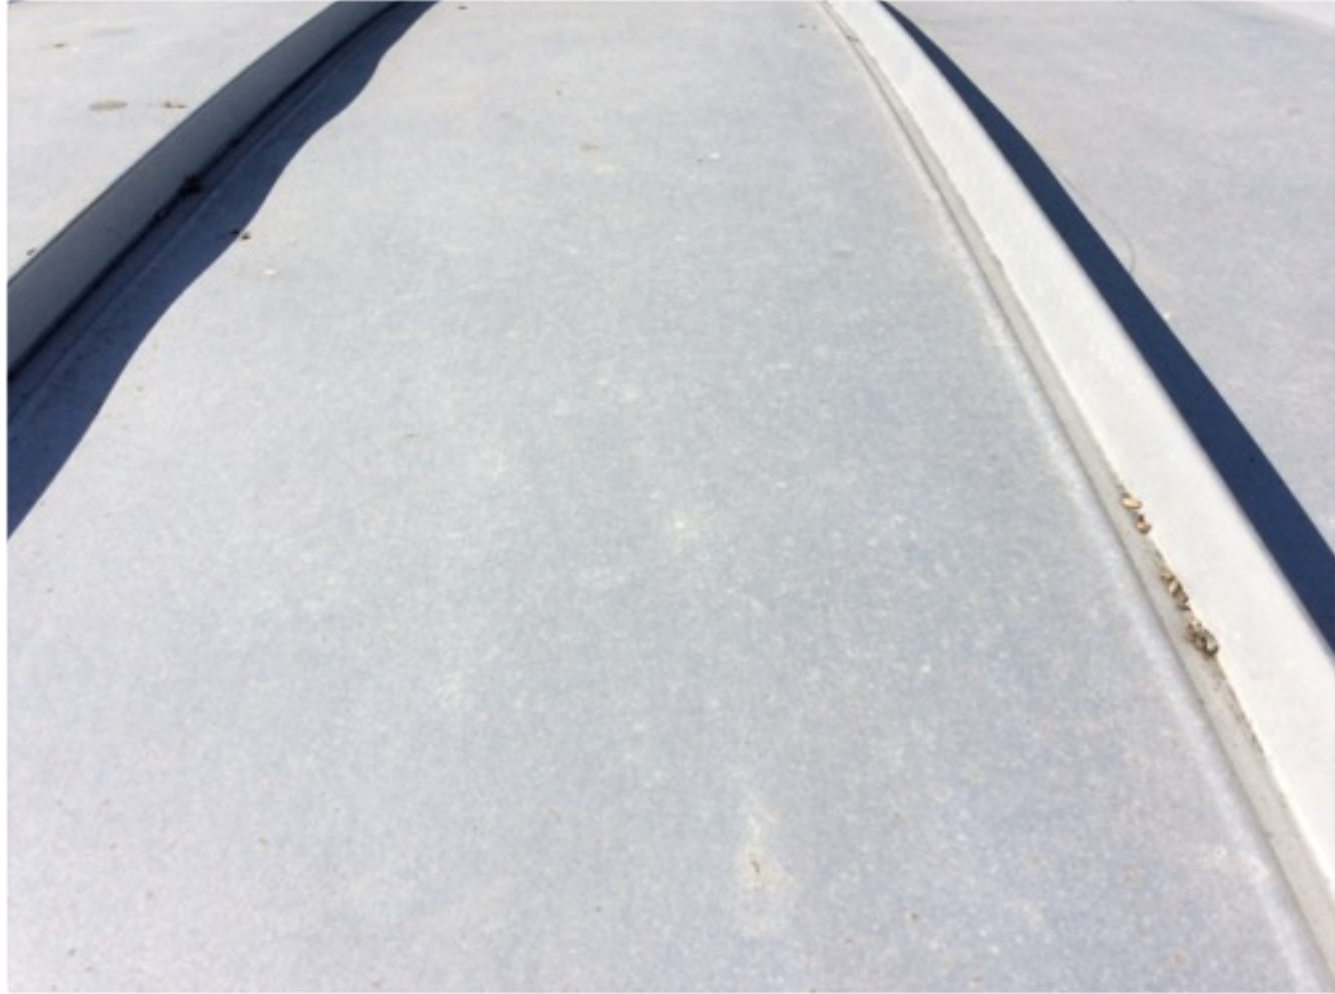
The photo below shows a close up of the metal standing seam roof in good shape.

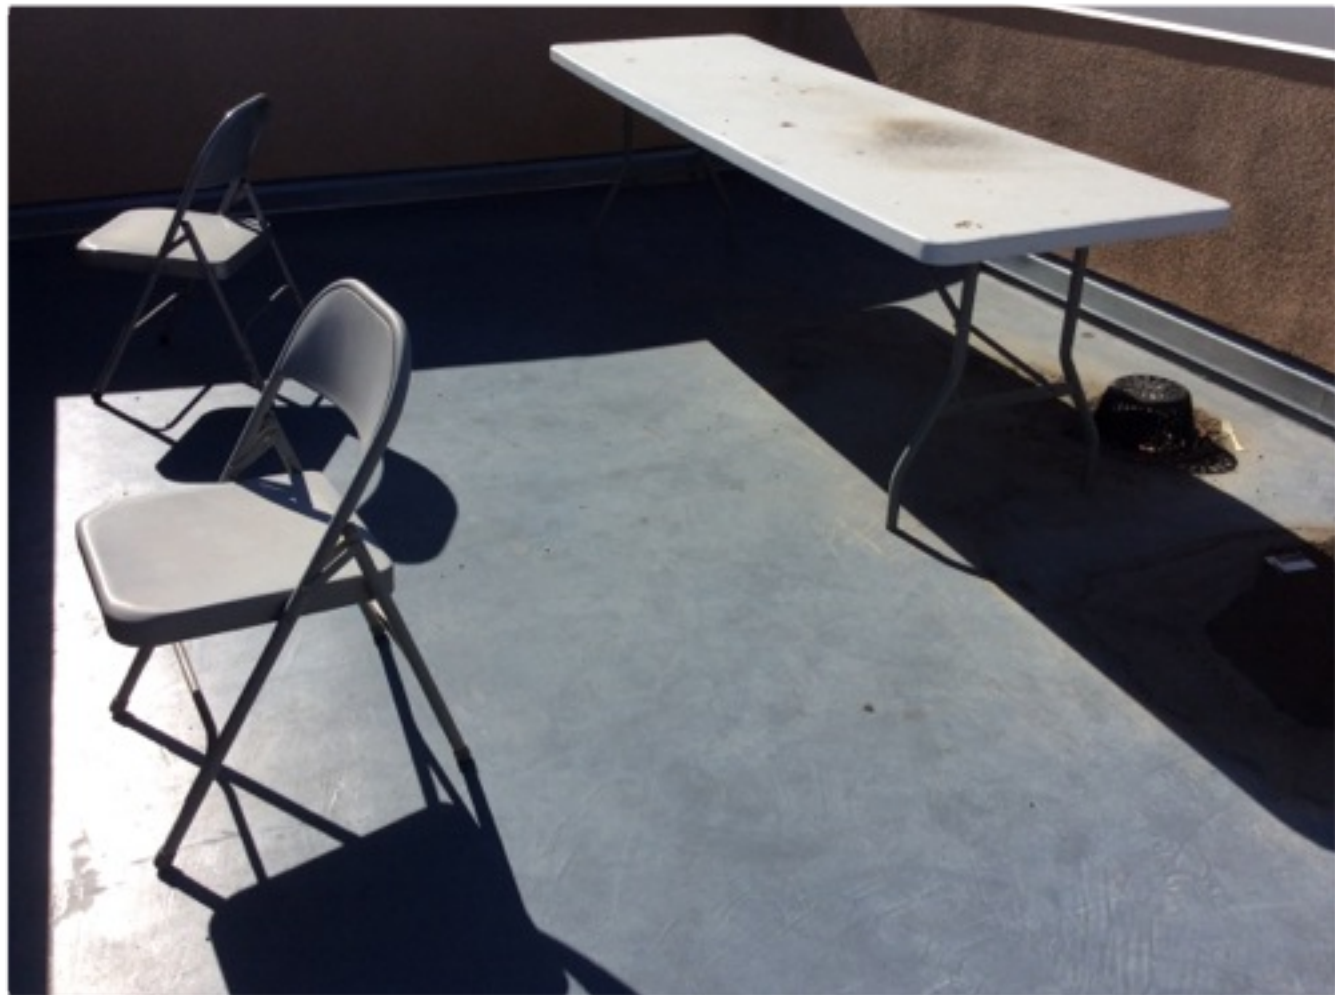
The photo below shows the Pedestrian Traffic Coating (PTC) in good shape.
