BUILDING INFORMATION	
FACILITY	James Lick HS
DATE	August 20, 2014
BUILDING	100 and Administration
ROOF SQ FT	16,000

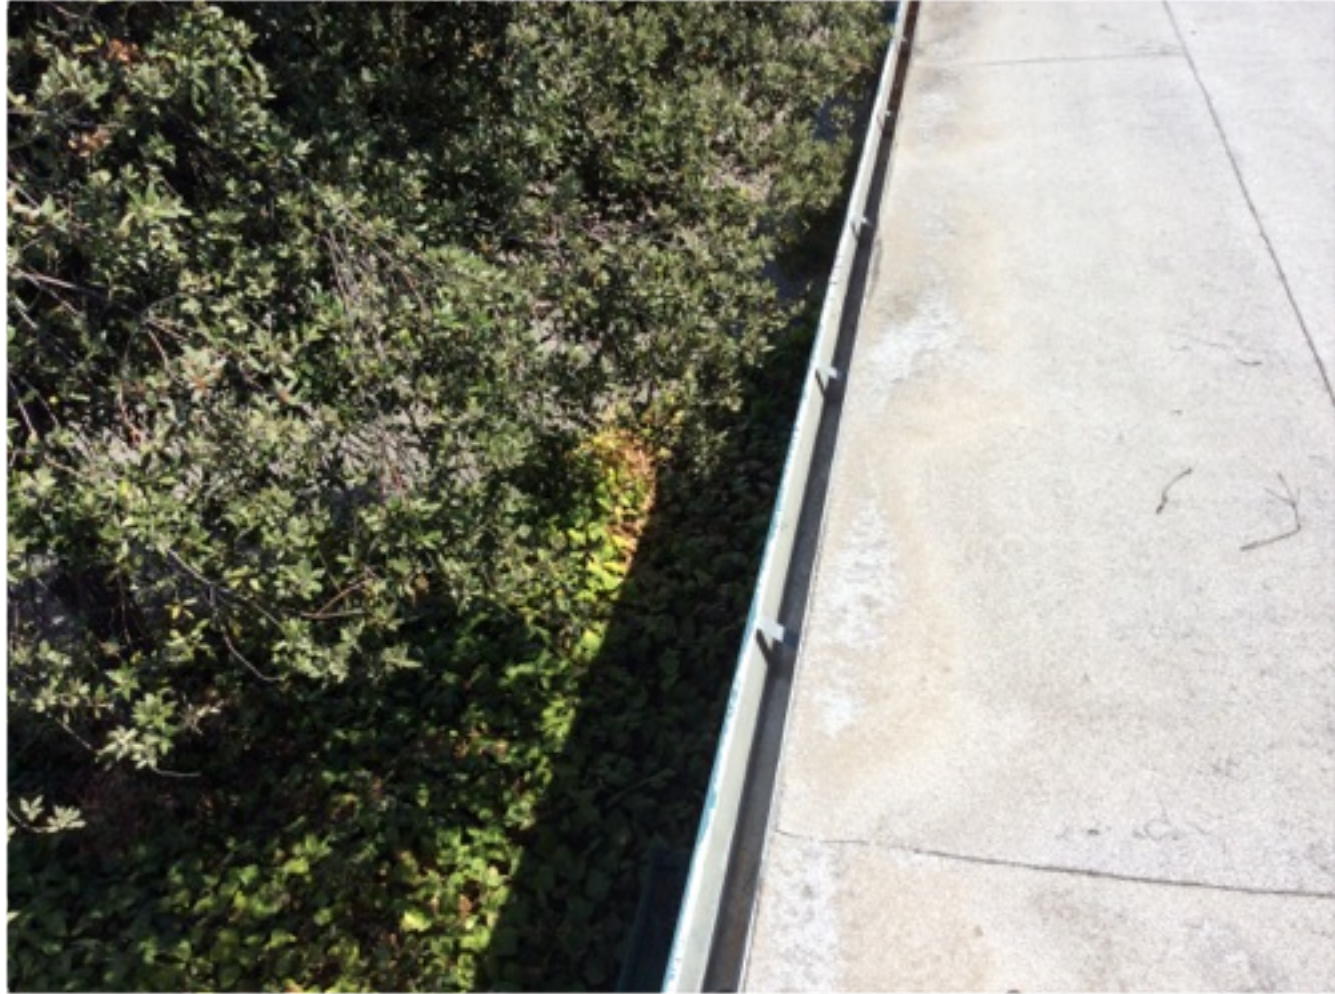
Although the gutters are not rusting it is recommended to coat them when re-roofed.

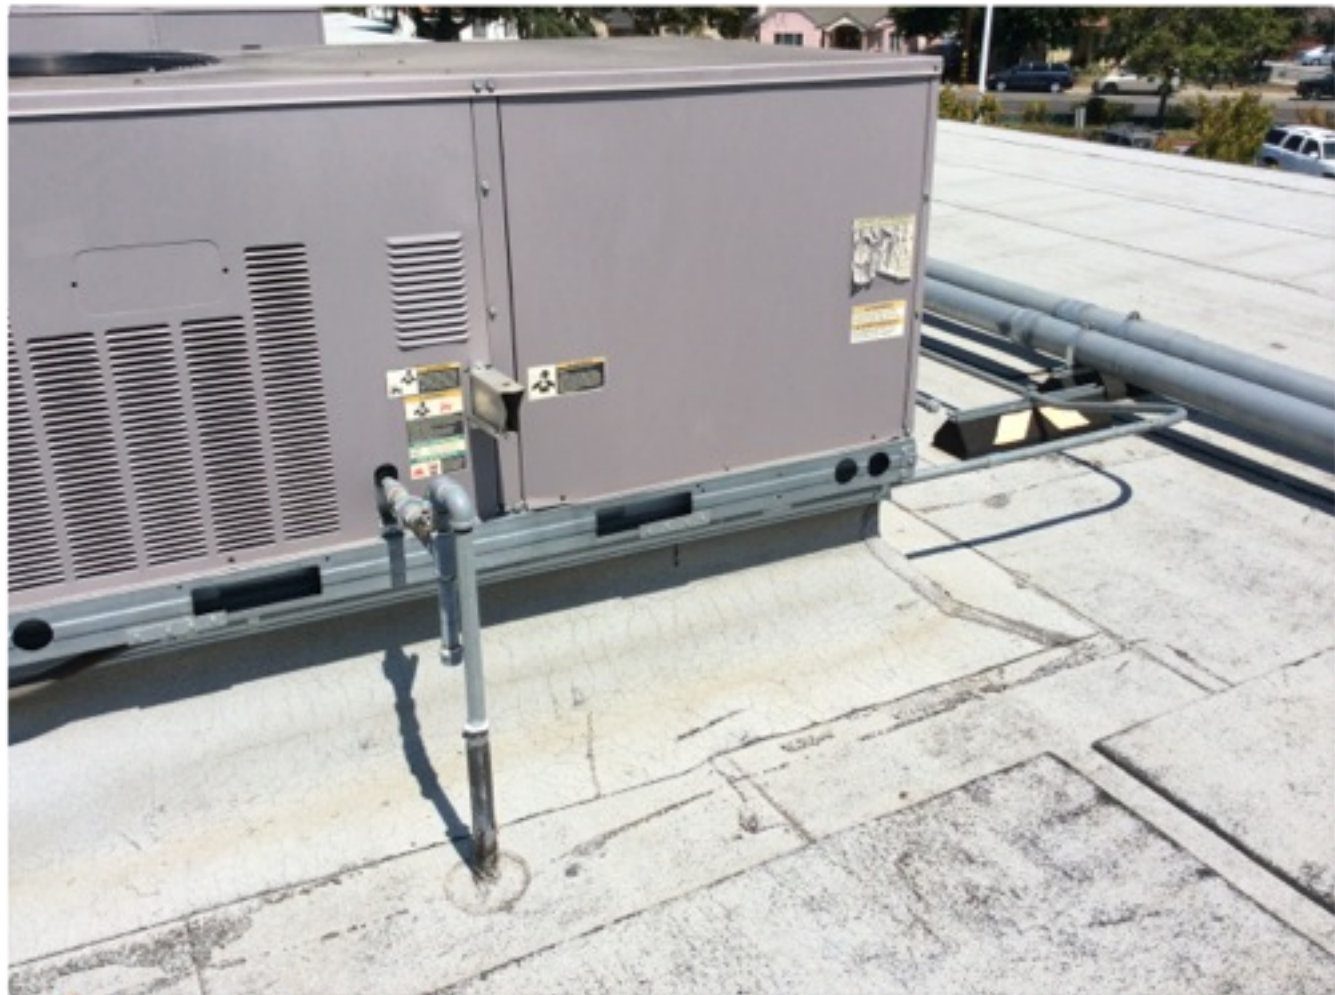
ADDITIONAL NOTES
 THIS ROOF IS SHOWING SOME AGE HOWEVER NO REPAIRS ARE NEEDED. THE ADJACENT CANOPY IS IN POOR CONDITION.

The base flashing on the Admin building is showing signs of aging - some craze cracking.

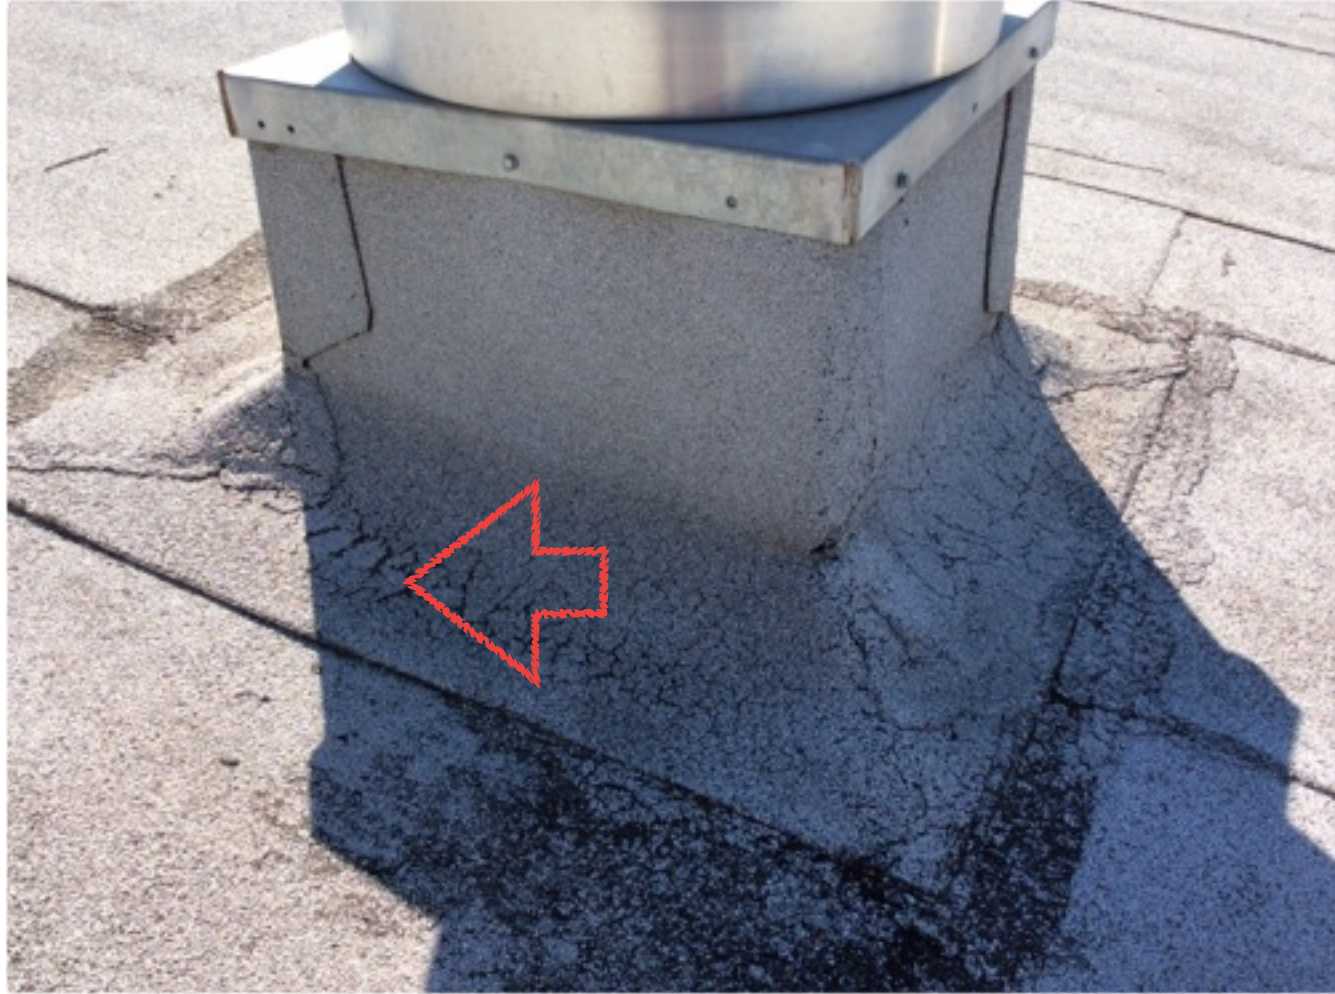
The photo below shows some normal aging - the roof should last another five-plus years.

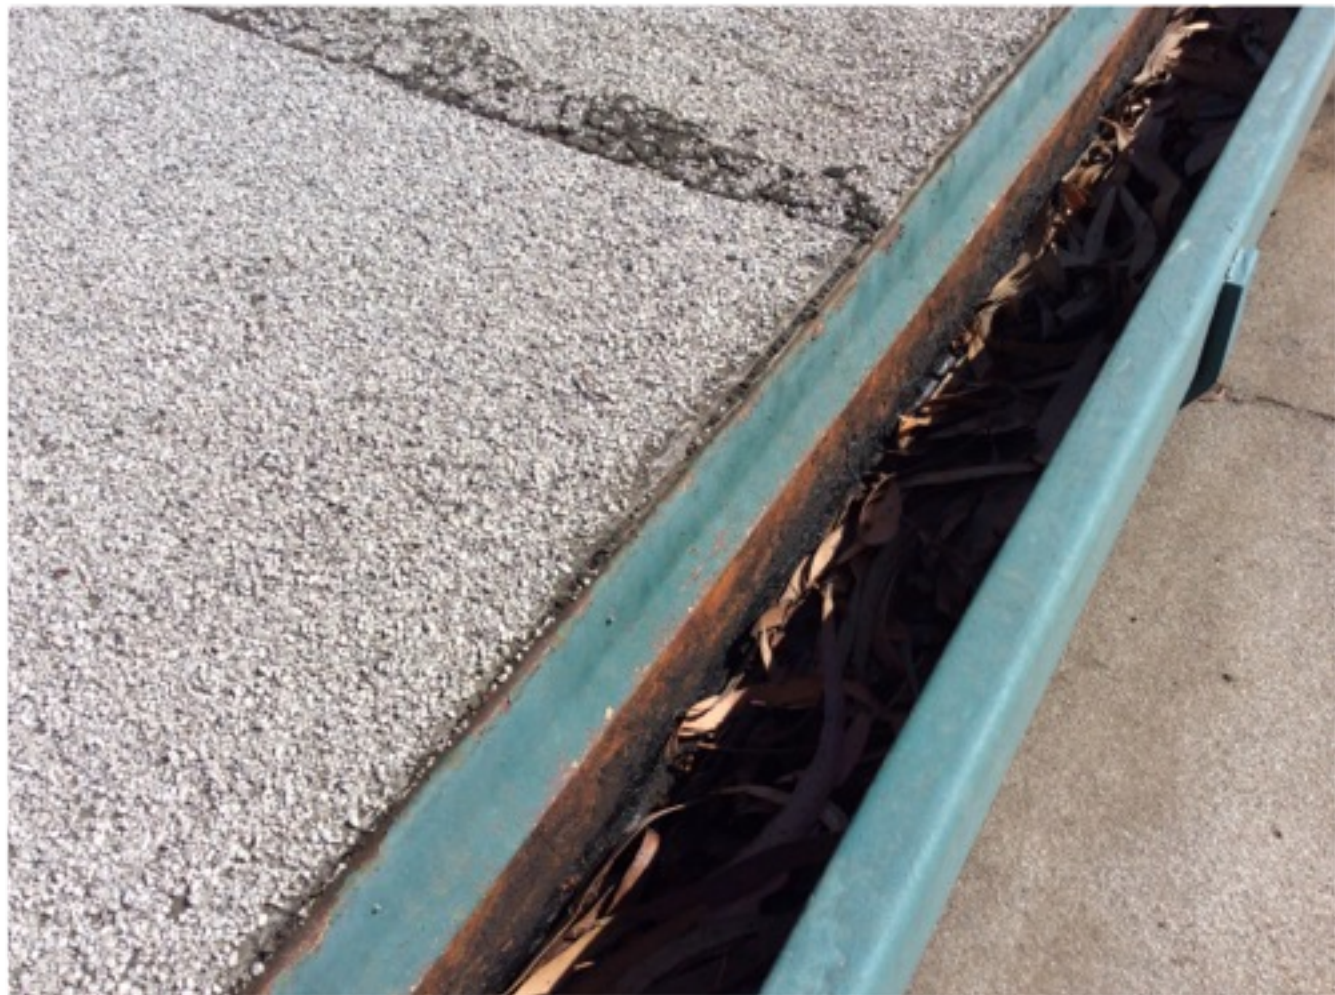
ADDITIONAL NOTES
 THIS ROOF IS AGING WELL - NO REPAIRS NEEDED. THE GUTTERS ARE RUSTING QUITE HEAVILY HOWEVER - CONSIDER ADDING GUTTER COATING TO THE SCOPE OF ANOTHER ROOF PROJECT.

The photo below shows the heavy rust in the gutters - coating them should be considered.

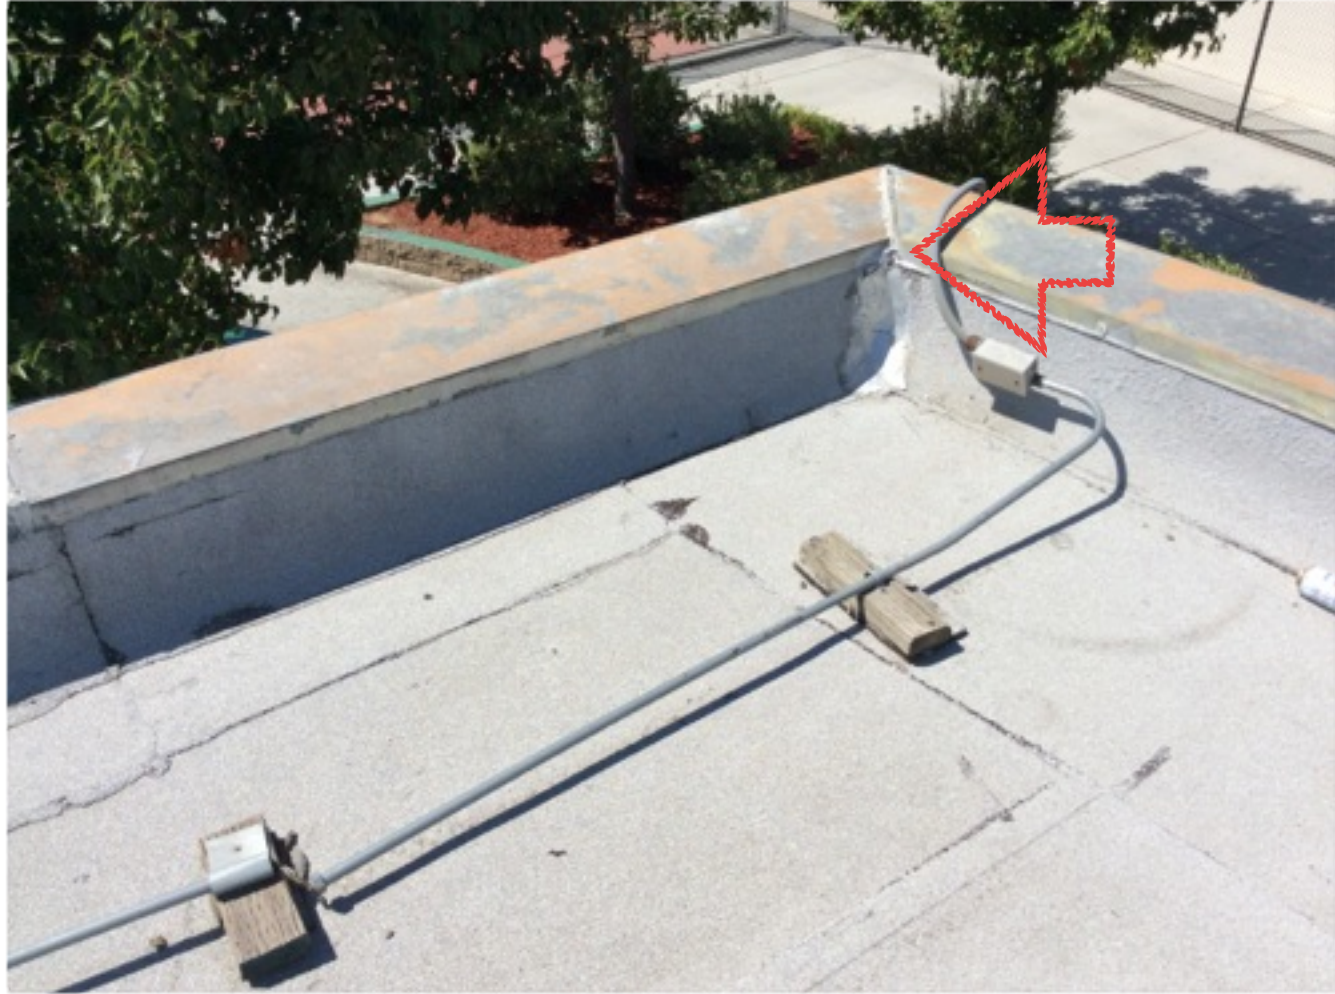
All flashing and penetration seams/joints need to be resealed.

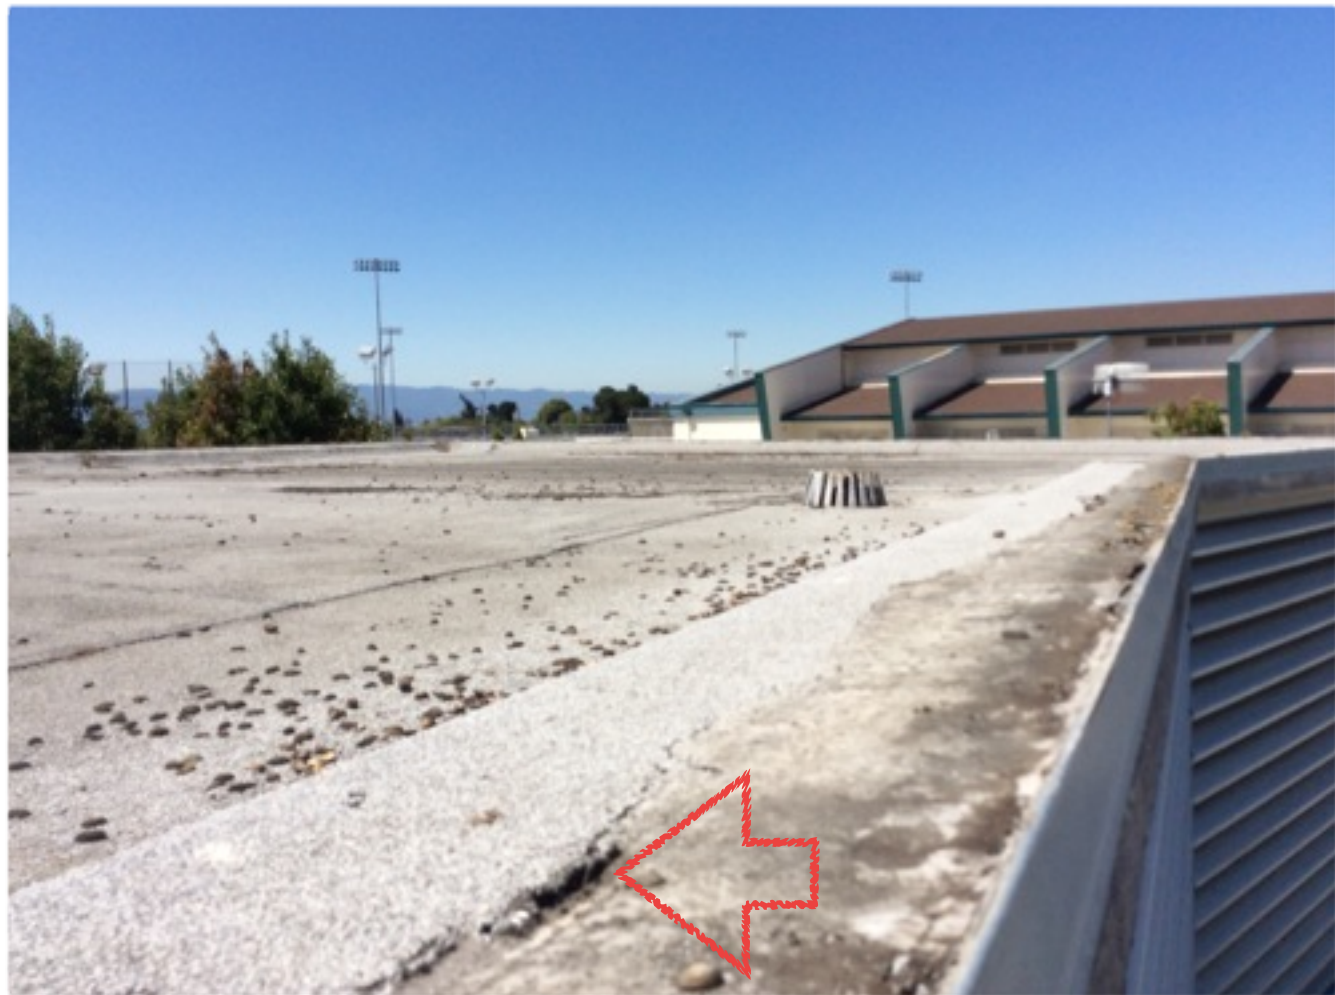
ADDITIONAL NOTES
 ALTHOUGH IN BAD SHAPE FOR ITS AGE, WITH REPAIRS THE SYSTEM SHOULD LAST ANOTHER FIVE YEARS. HOWEVER THE FIELD RIDGING IS TOO NUMEROUS TO REPAIR AND MAY DICTATE WHEN THE SYSTEM ULTIMATELY FAILS.

The photo below shows the edge detail failing.

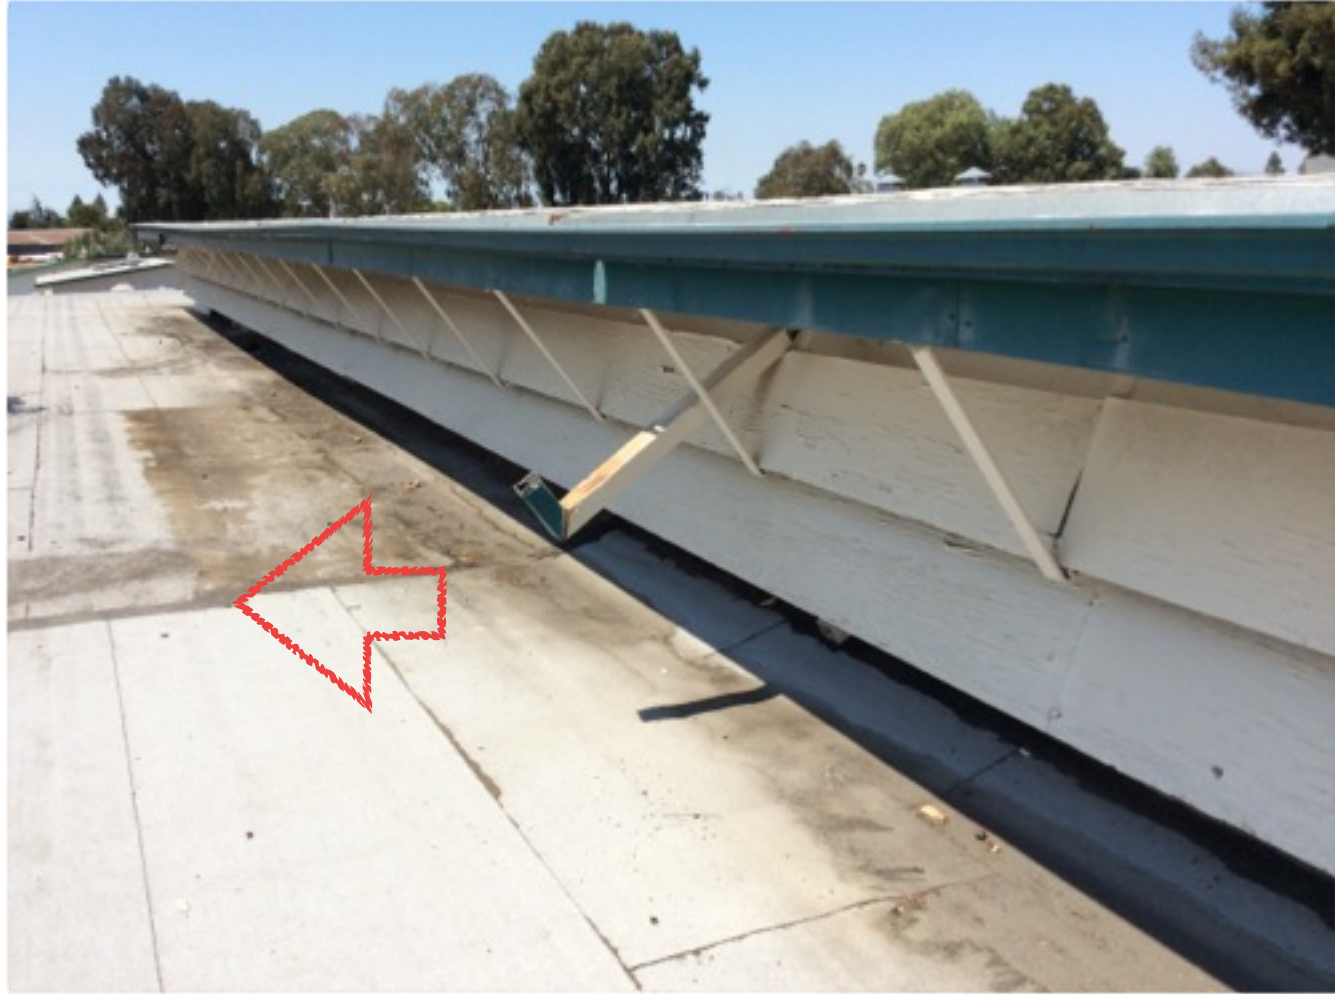
The photo below shows excessive ponding and signs of leaks.

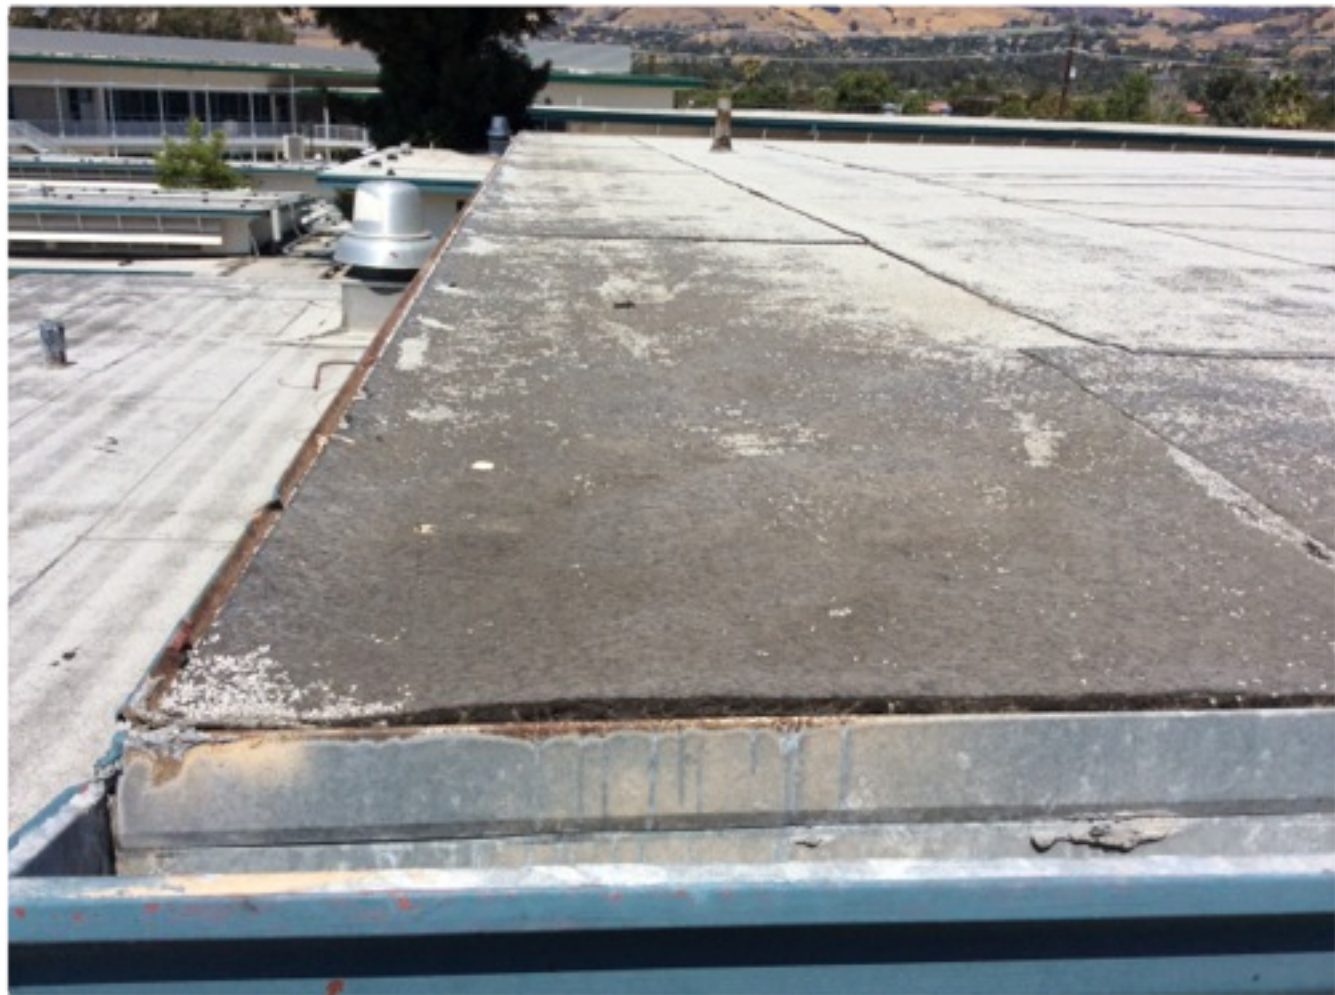
ADDITIONAL NOTES
 ALTHOUGH THESE TWO ROOFS LOOK MUCH BETTER THAN 400, 600, AND 700 THEY ARE MANY YEARS PAST THEIR EXPECTED LIFESPAN. CORE CUTS REVEALED THE DECK AS HAVING EXTENSIVE DRYROT - AT LEAST AROUND THE PERIMETER EAVES. IT IS UNSAFE TO WALK ON THE ROOF PERIMETER.

It is suspected that most of the decking over the eaves has dryrot.

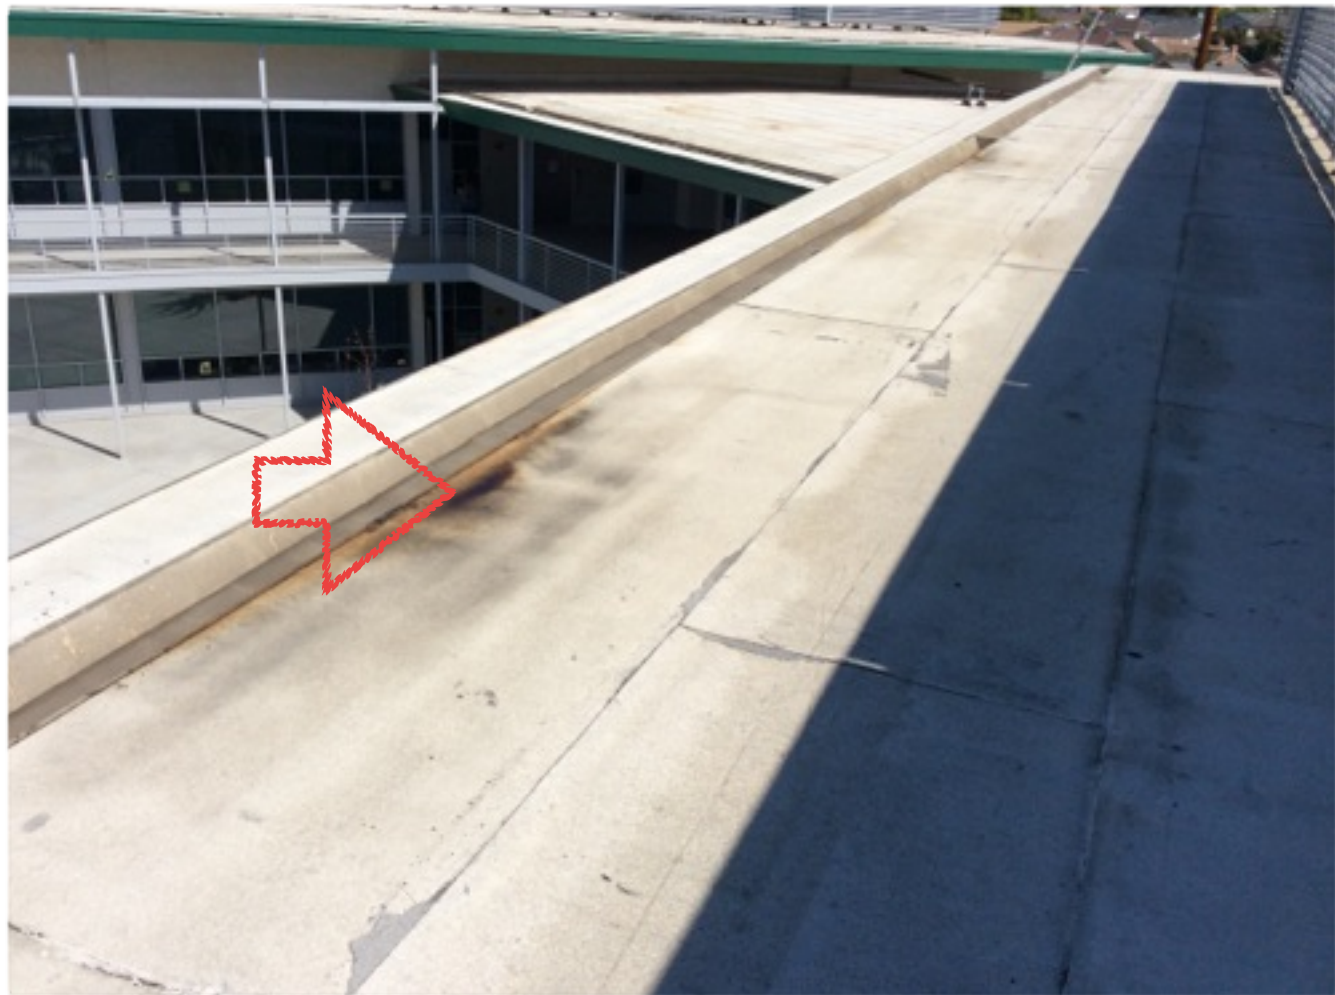
ADDITIONAL NOTES
 THIS IS A NEW ROOF AND SHOULD LAST FIFTEEN YEARS. HOWEVER IT IS LEAKING AND HAS SOME BLISTERS THAT NEED TO BE REPAIRED - HOPEFULLY UNDER WARRANTY. THE BLISTERS ARE A SIGN OF MOISTURE UNDER THE FELTS. ALSO REPAIR GAPS AT EDGE METAL PONDING LOCATIONS.

The photo below shows some ponding at the edge flashing.

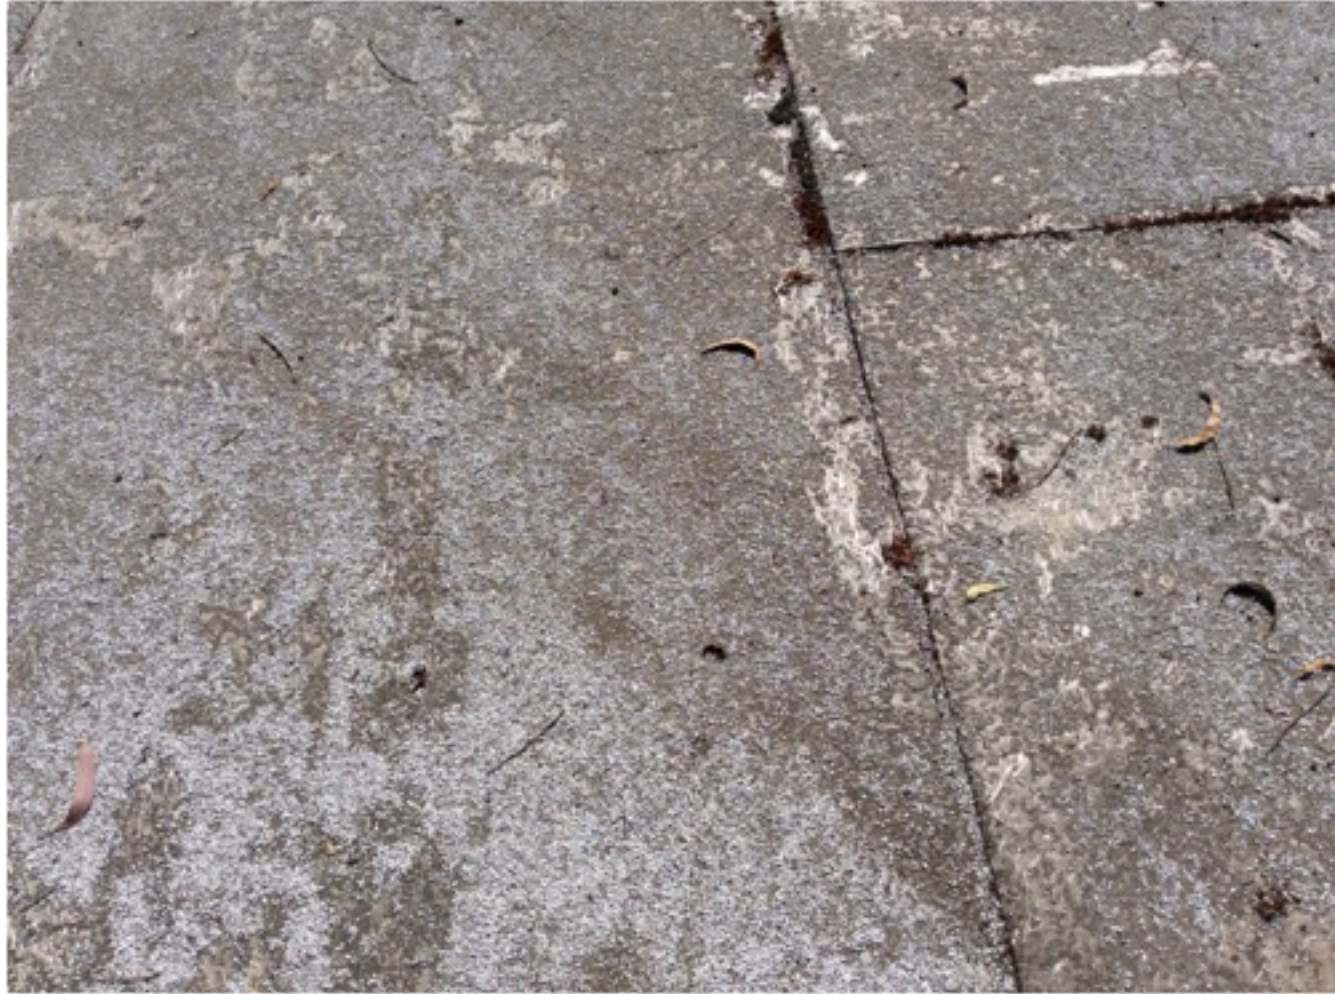
The photo below shows the fibers exposed - the roof is well past it's end.

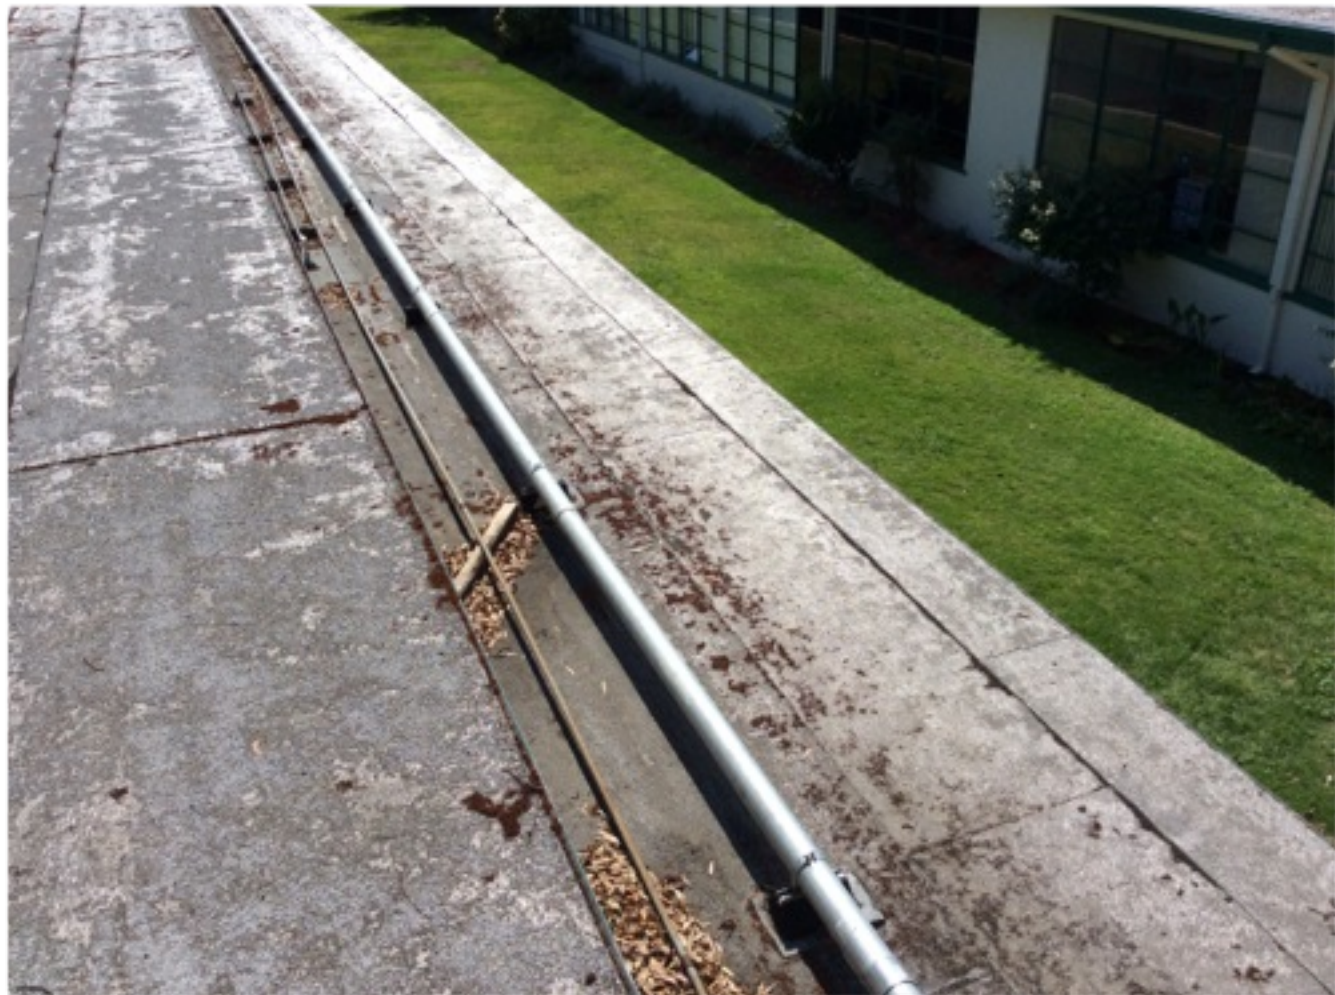
The attached canopy needs to be added to the Scope for roof replacement.

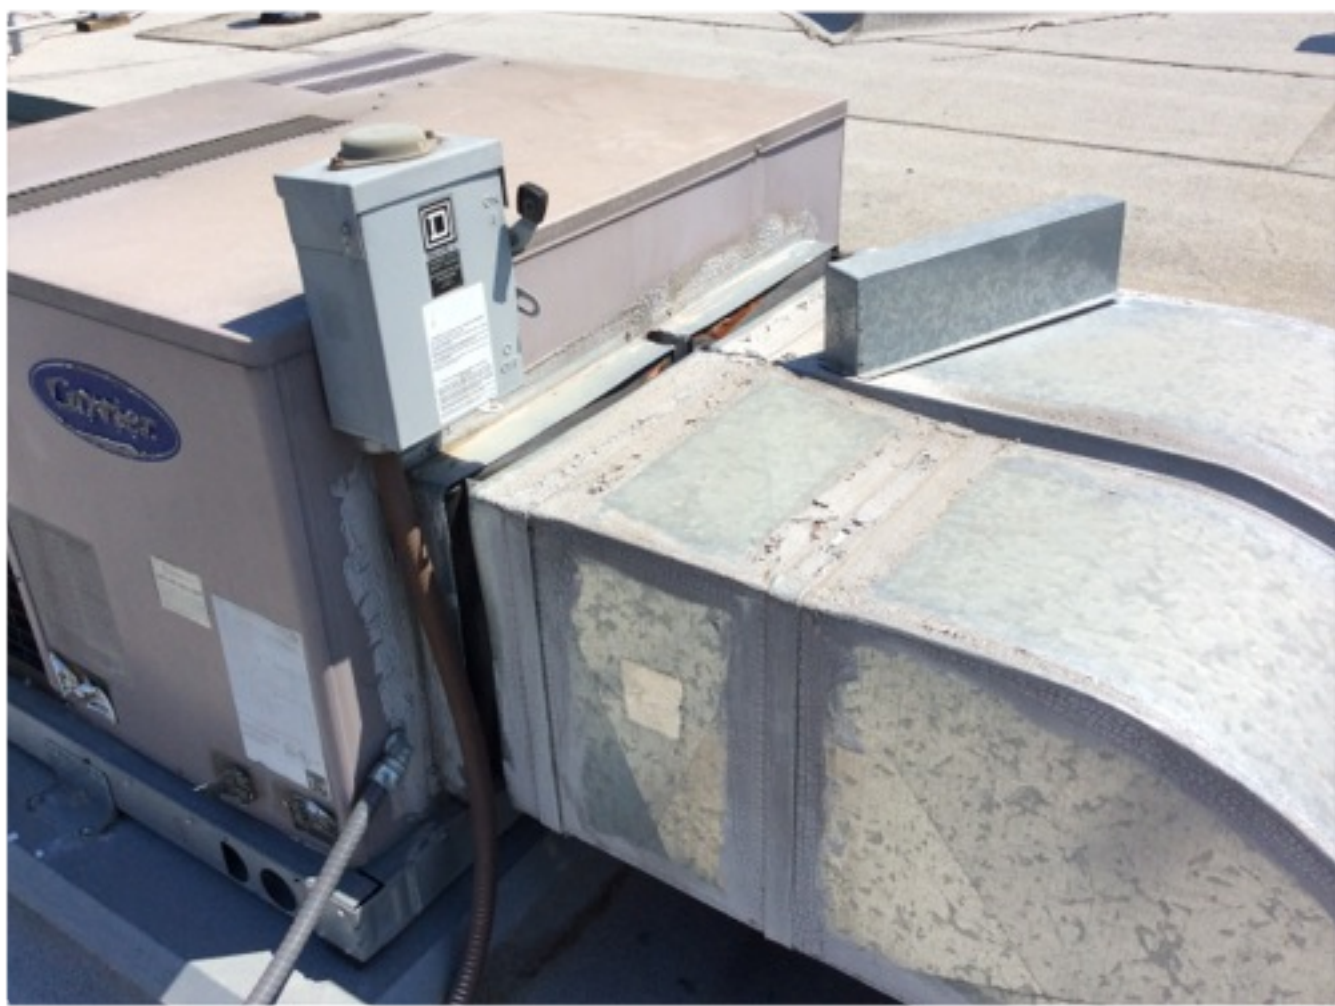
The photo below shows that the AC ducts may need to be resealed soon.

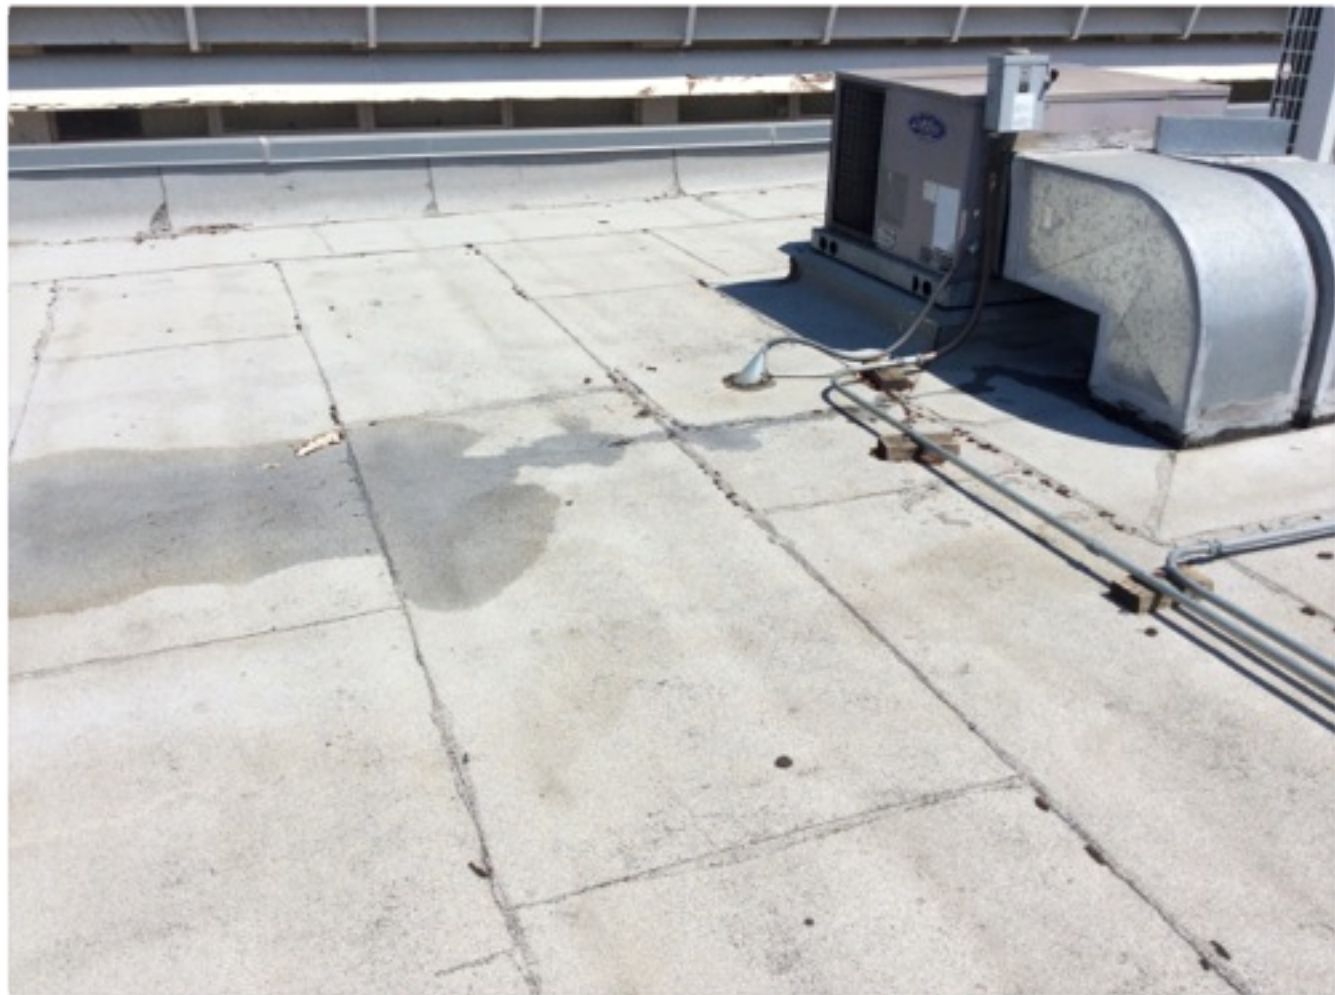
Prevent AC units from leaking directly on the roof.

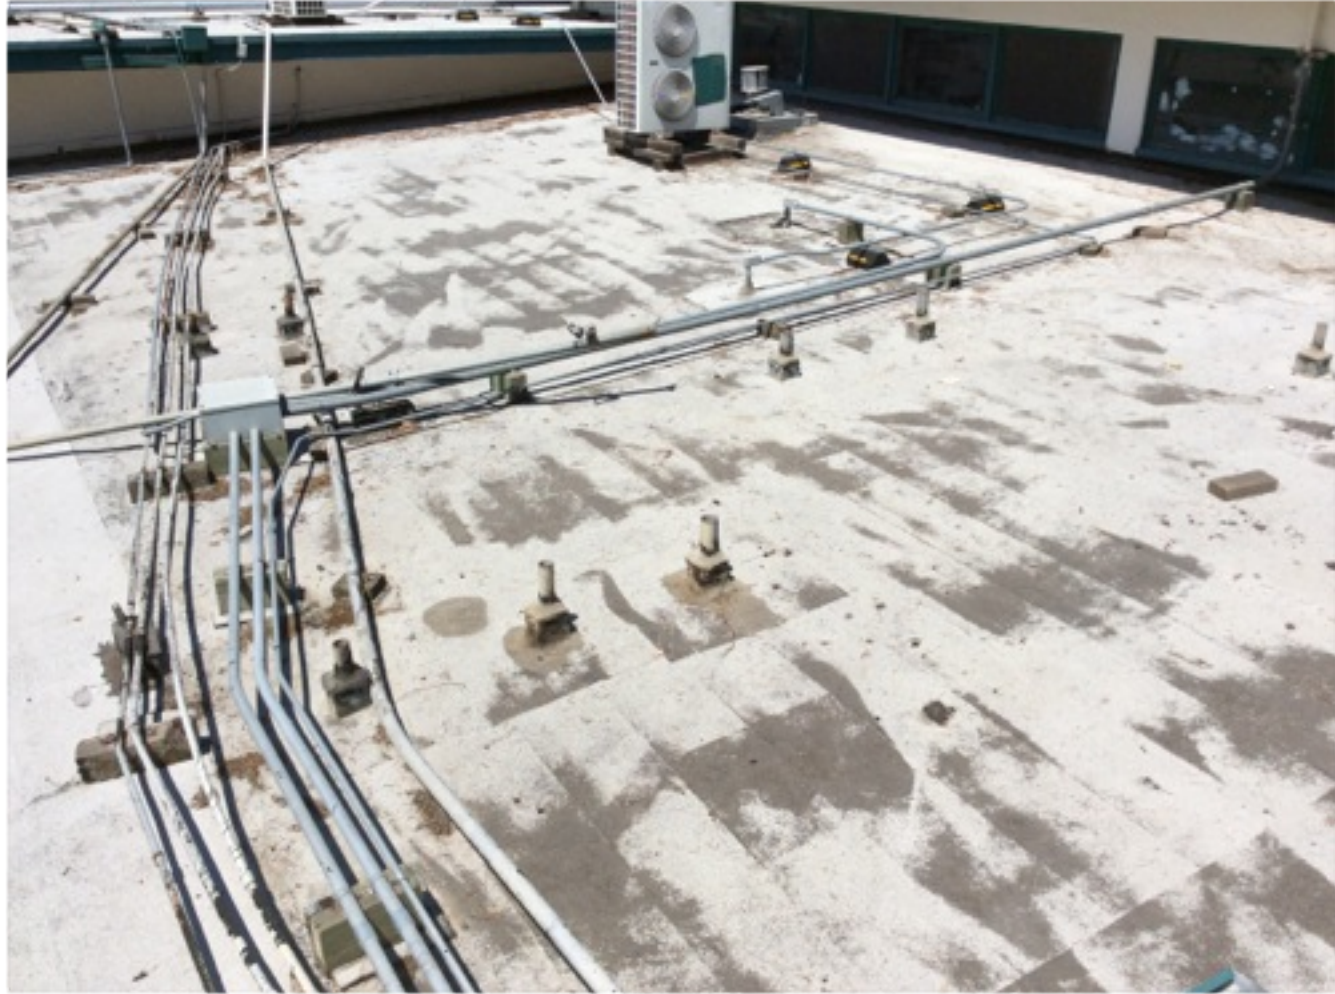
The photo below shows the fibers exposed - the roof is well past it's end.

ADDITIONAL NOTES
 THIS ROOF SHOULD BE INCLUDED IN THE CURRENT ROOF REPLACEMENT SCOPE. MANY OF THE PIPE SUPPORTS CAN BE REUSED.

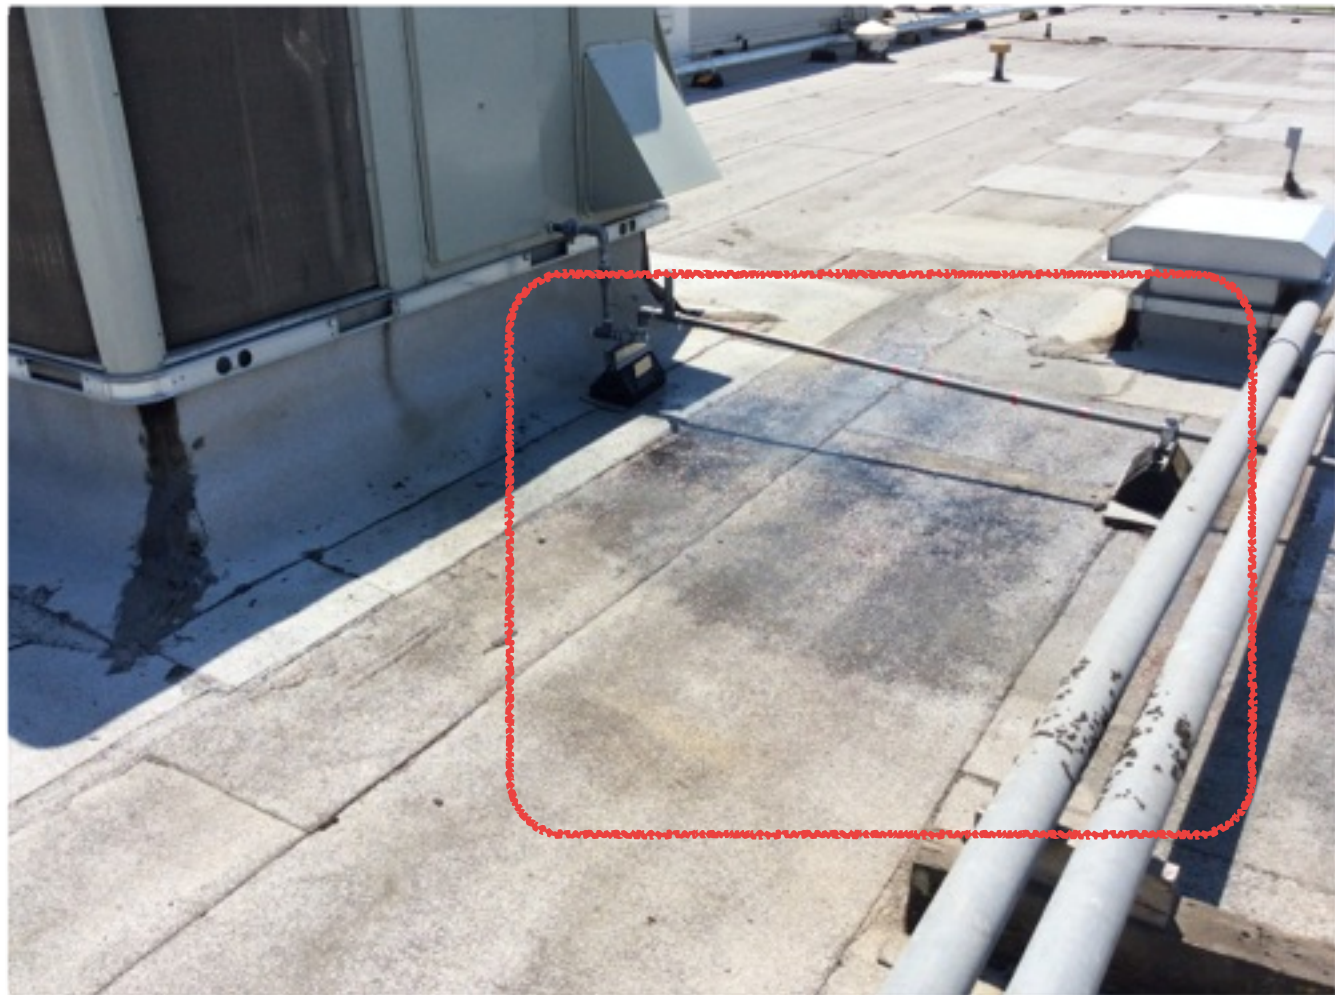
Some repairs are needed on AC units.

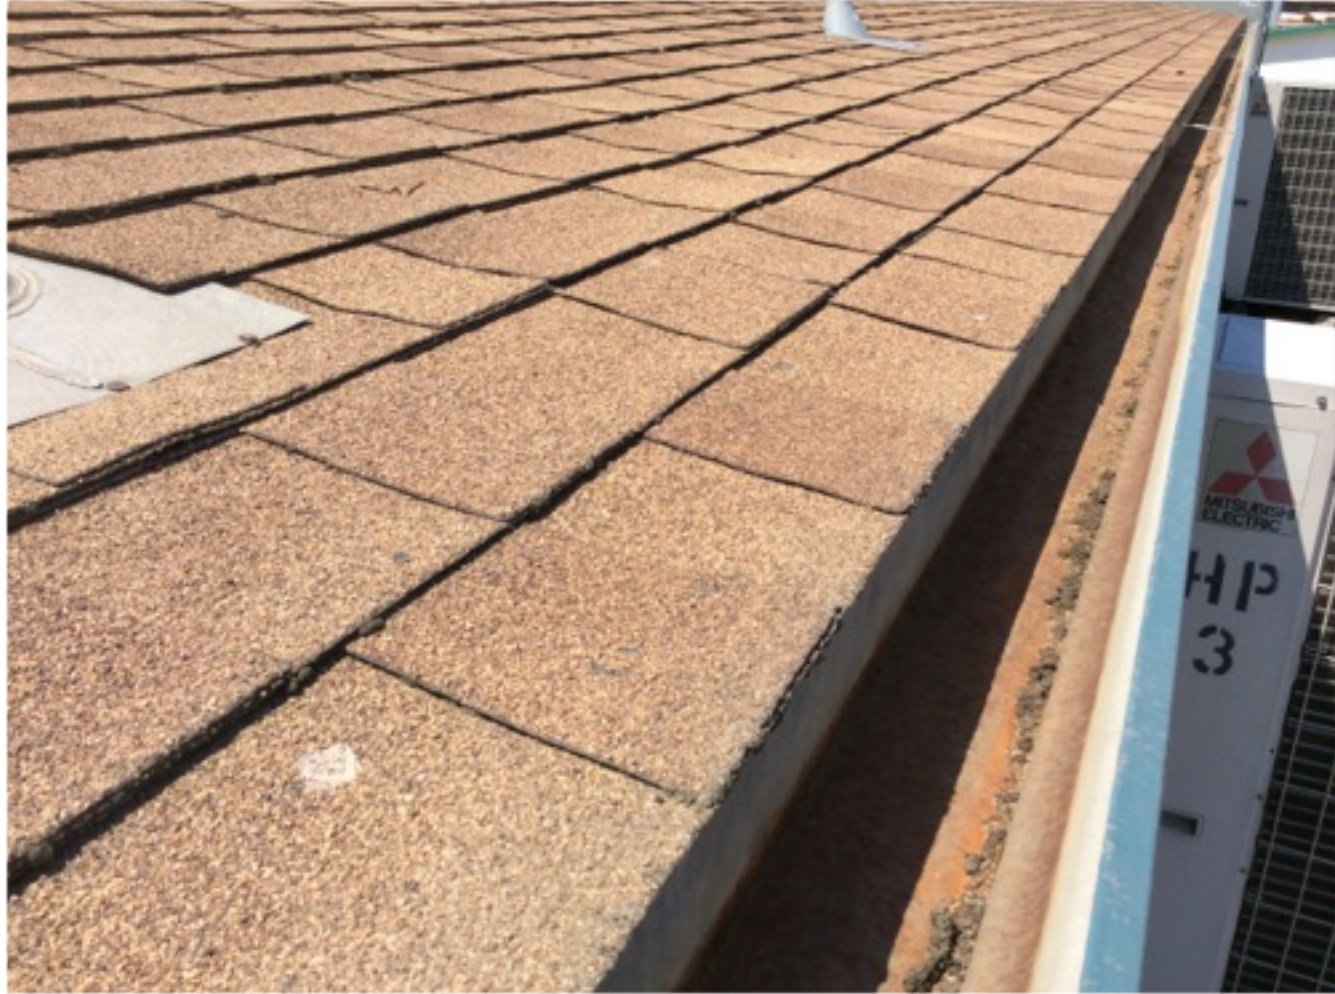
The photo below shows the gutters are rusting heavily.

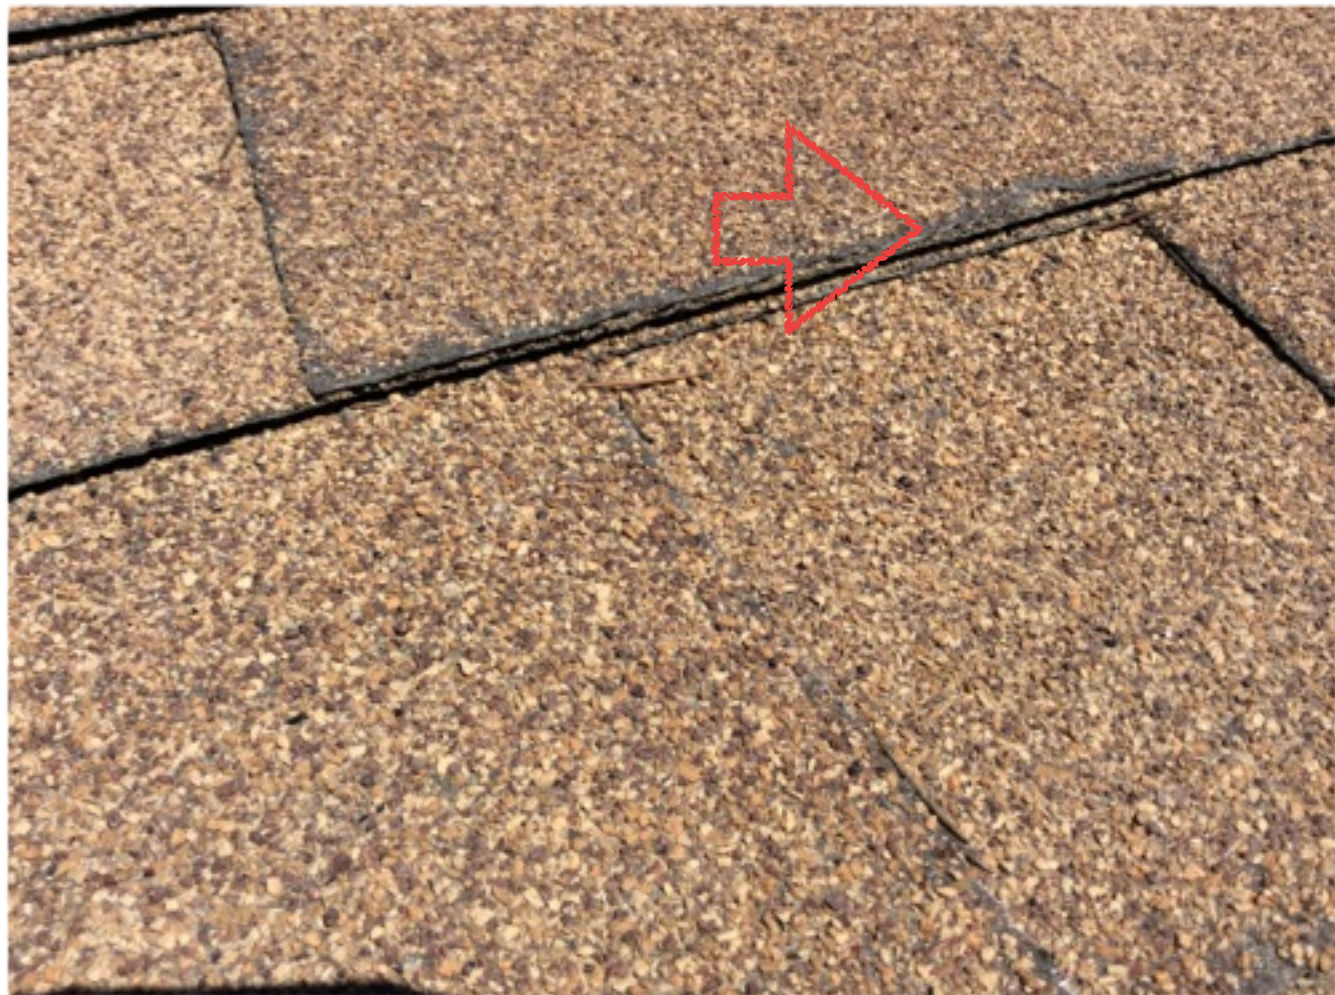
The shingles are showing some wear.
