BUILDING INFORMATION	
FACILITY	James Lick HS
DATE	August 20, 2014
BUILDING	100 and Administration
ROOF SQ FT	16,000

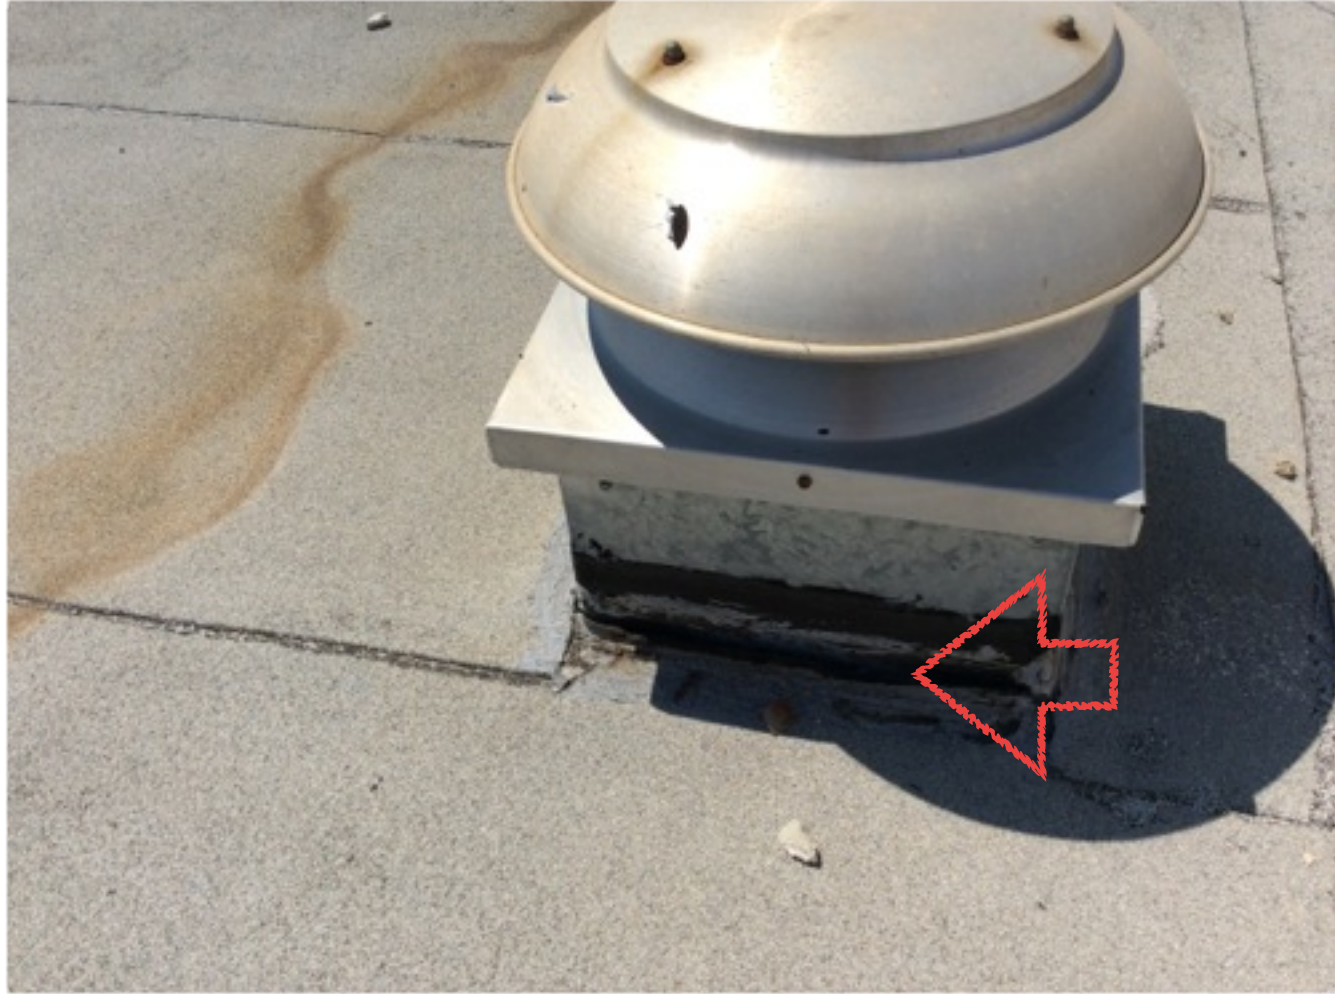
The photo below shows the need for penetration repairs.

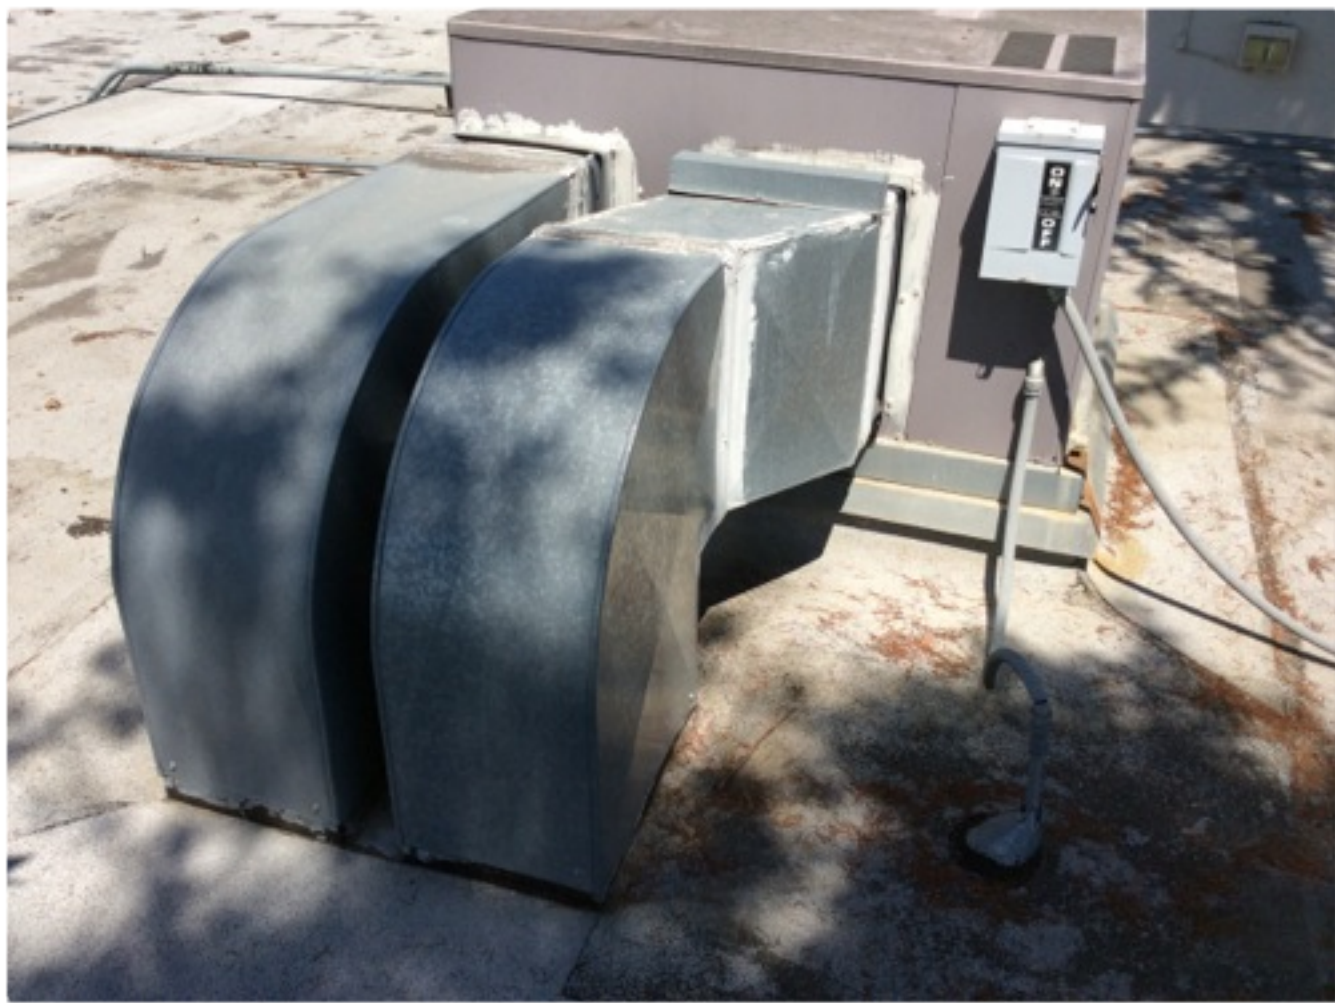
The photo below shows the AC ducts in need of being resealed and recoated.

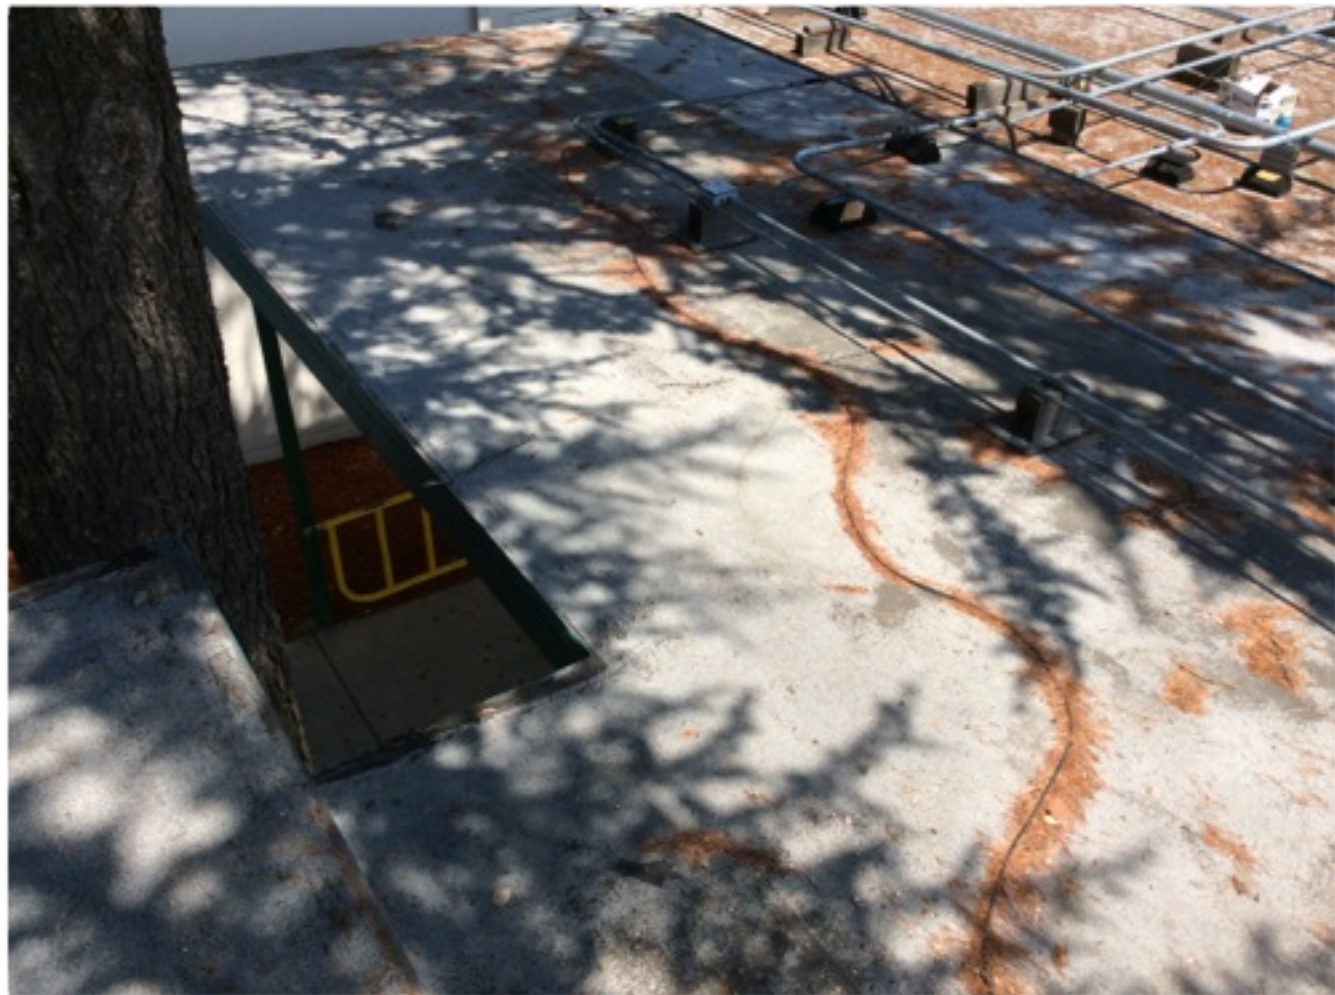
The Book Room Canopy should be added to the scope for roof replacement.

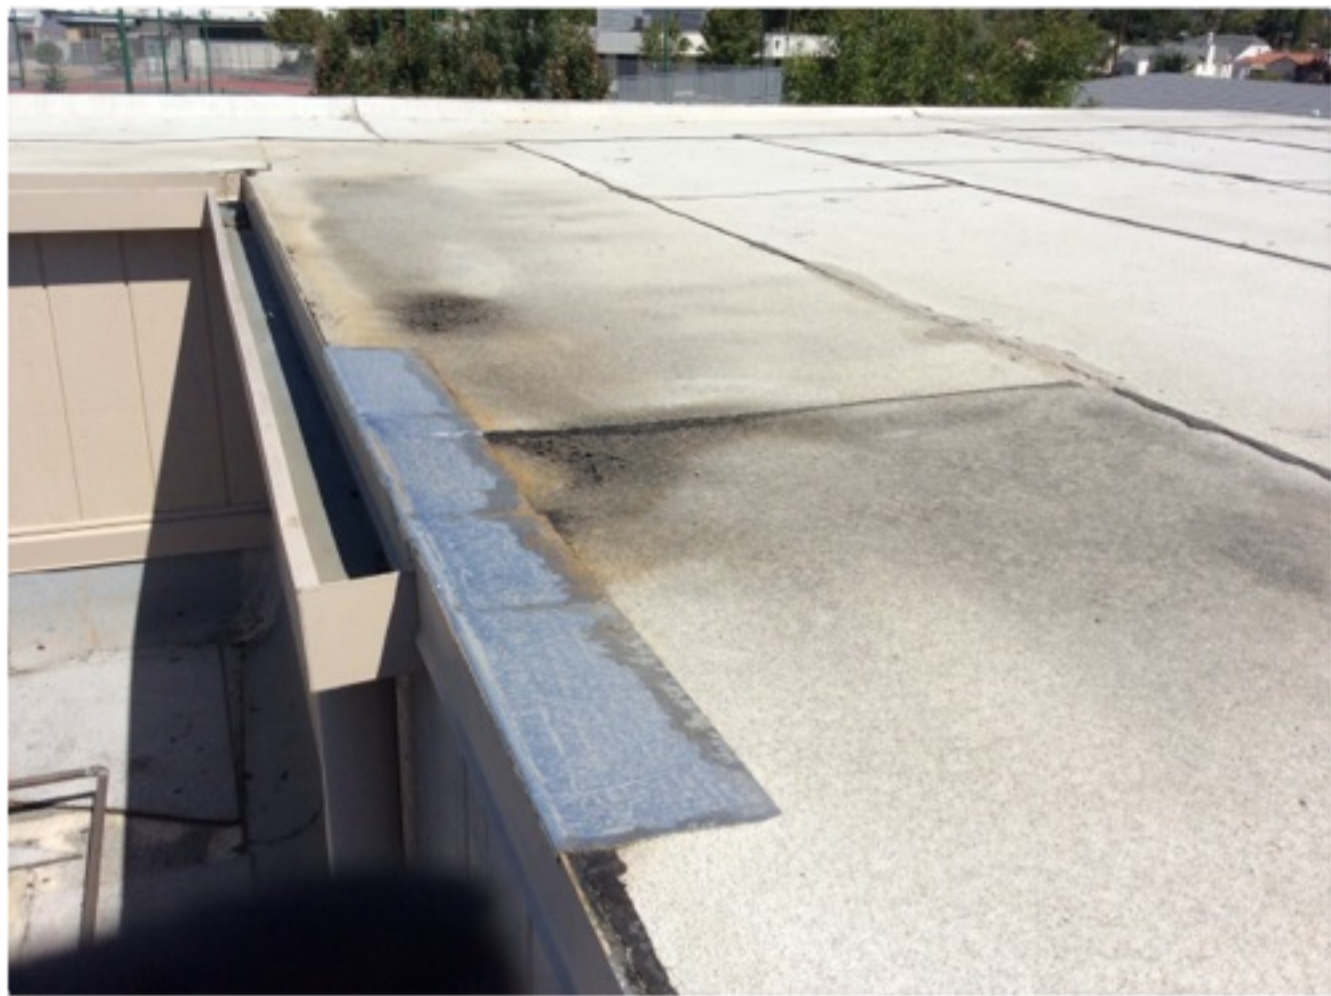
The photo below shows ponding and leaking issues at the perimeter of the upper roof.

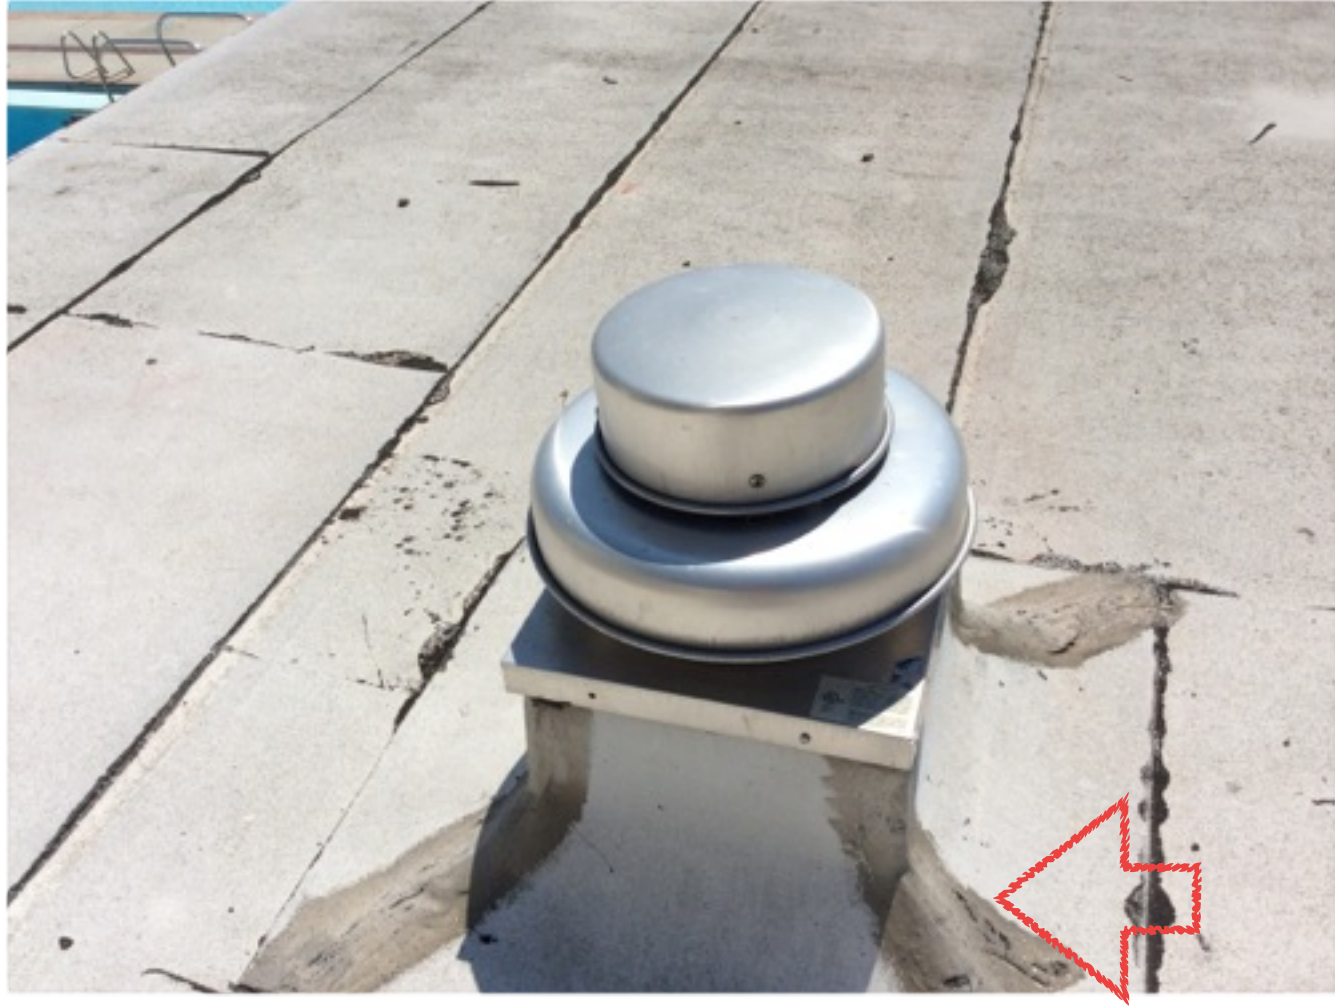
The photo below shows the need for penetration repairs.

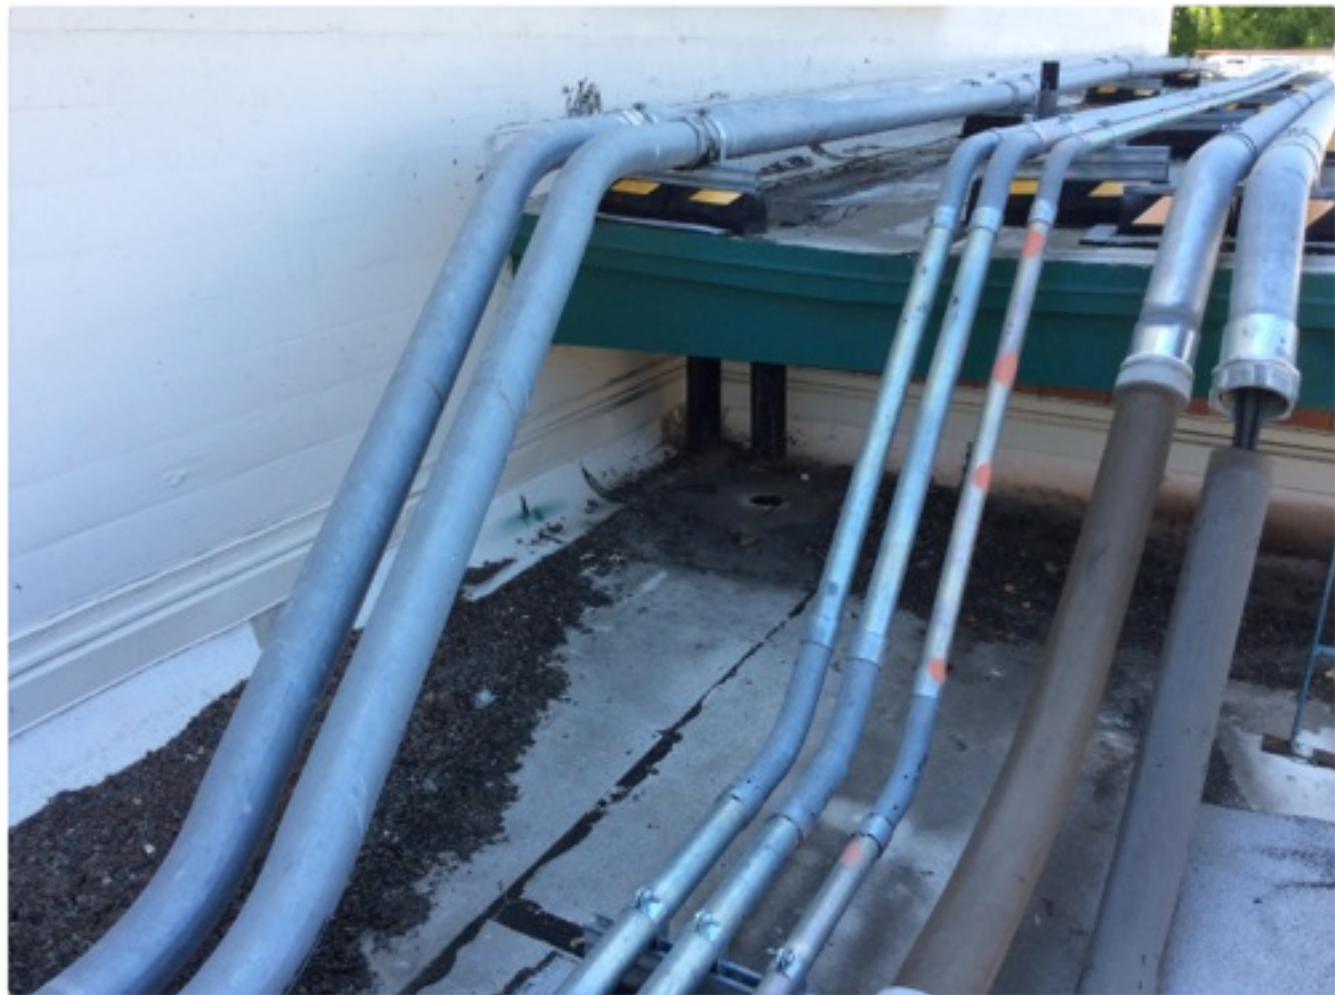
Some drains need to be cleared and debris removed.

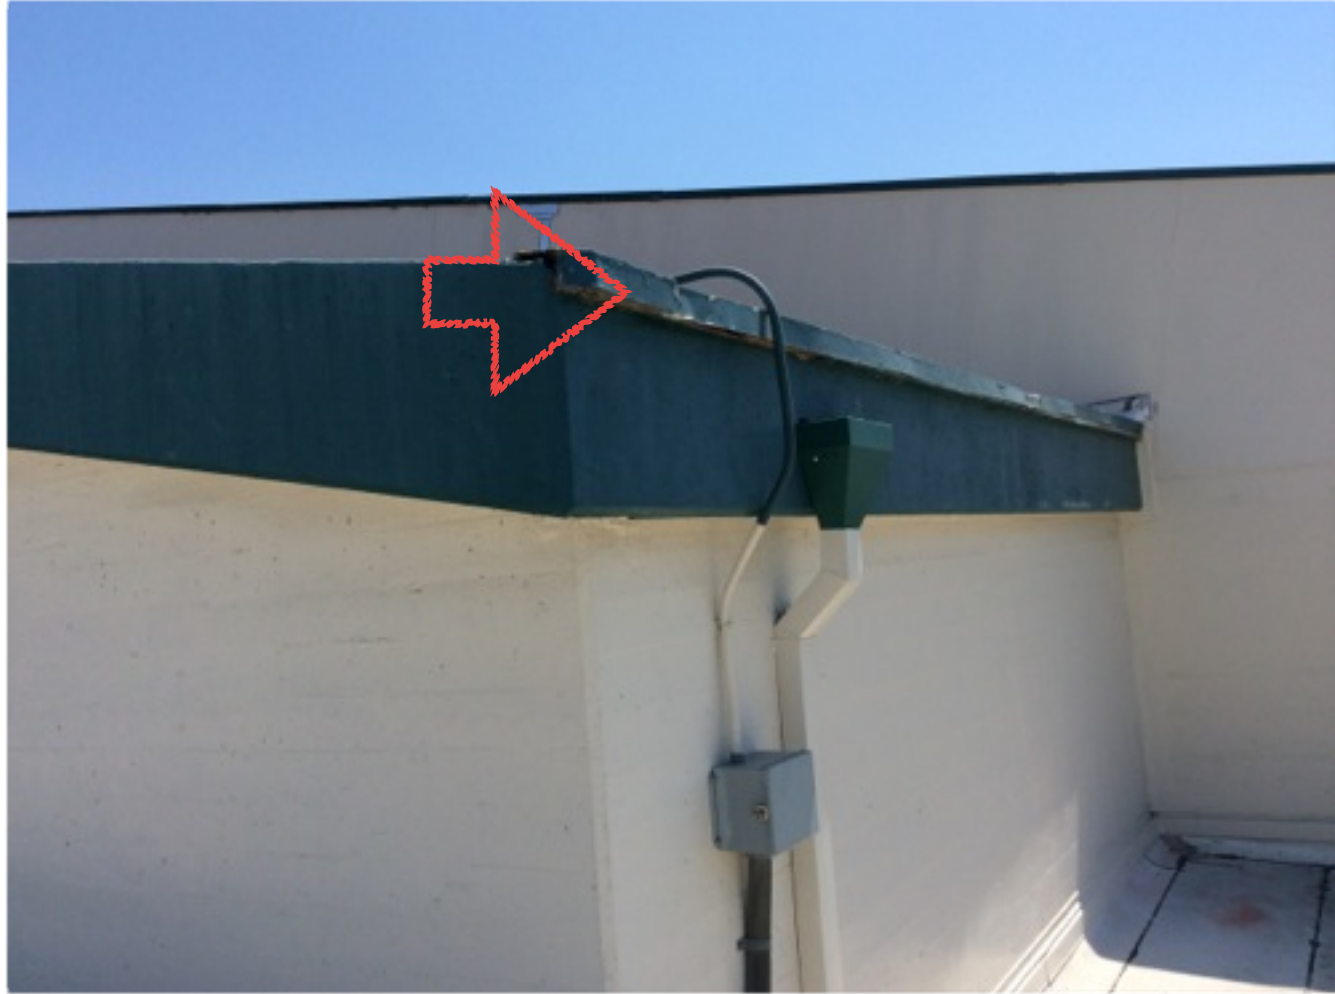
The photo below shows the cap flashing in bad shape.

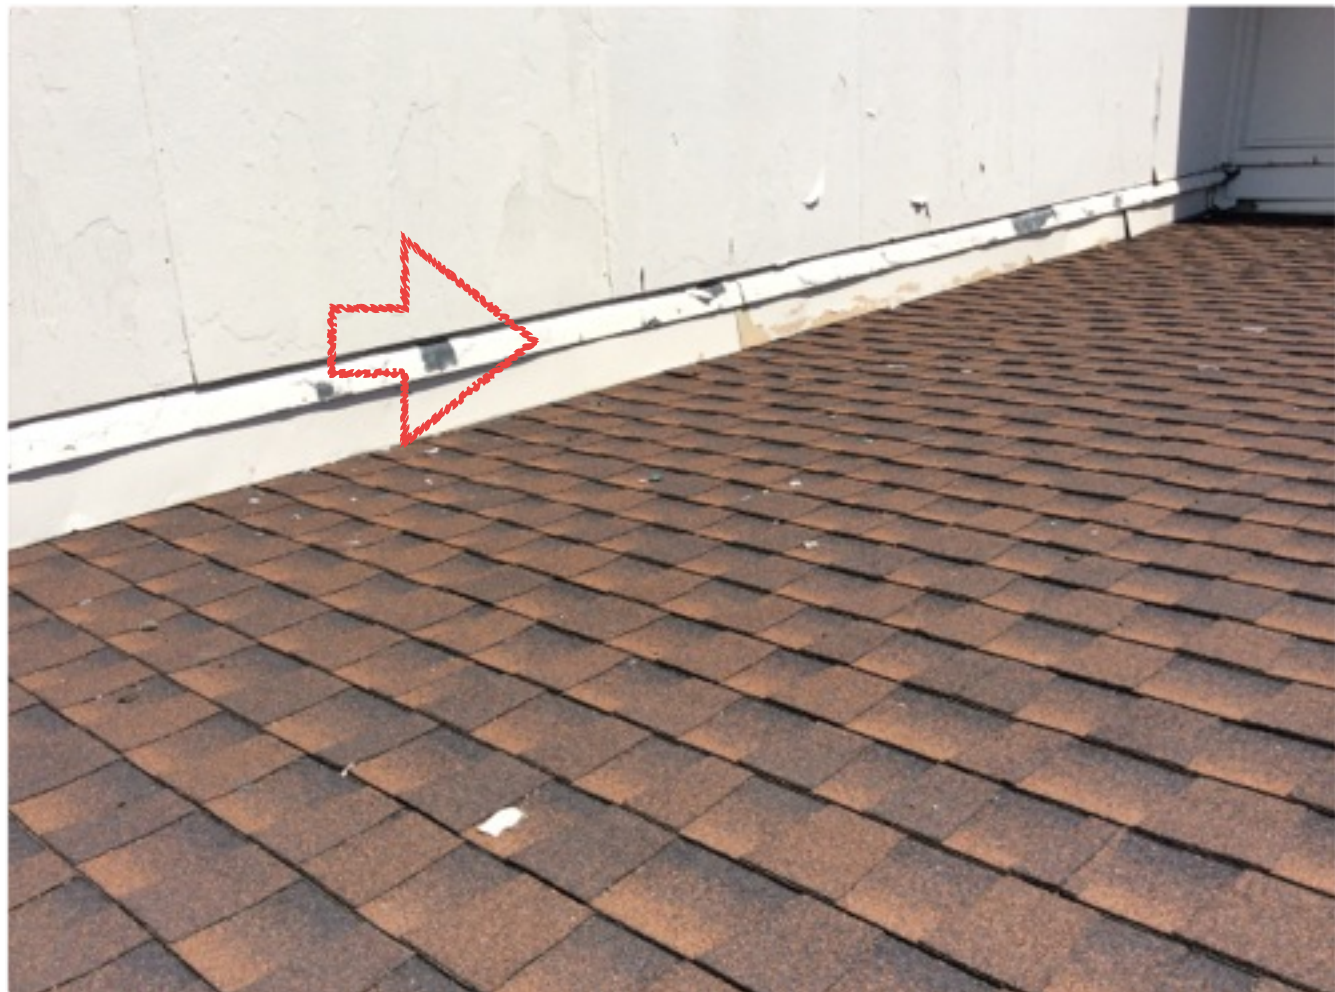
The wall flashing is quite rough and may eventually cause problems in the system.

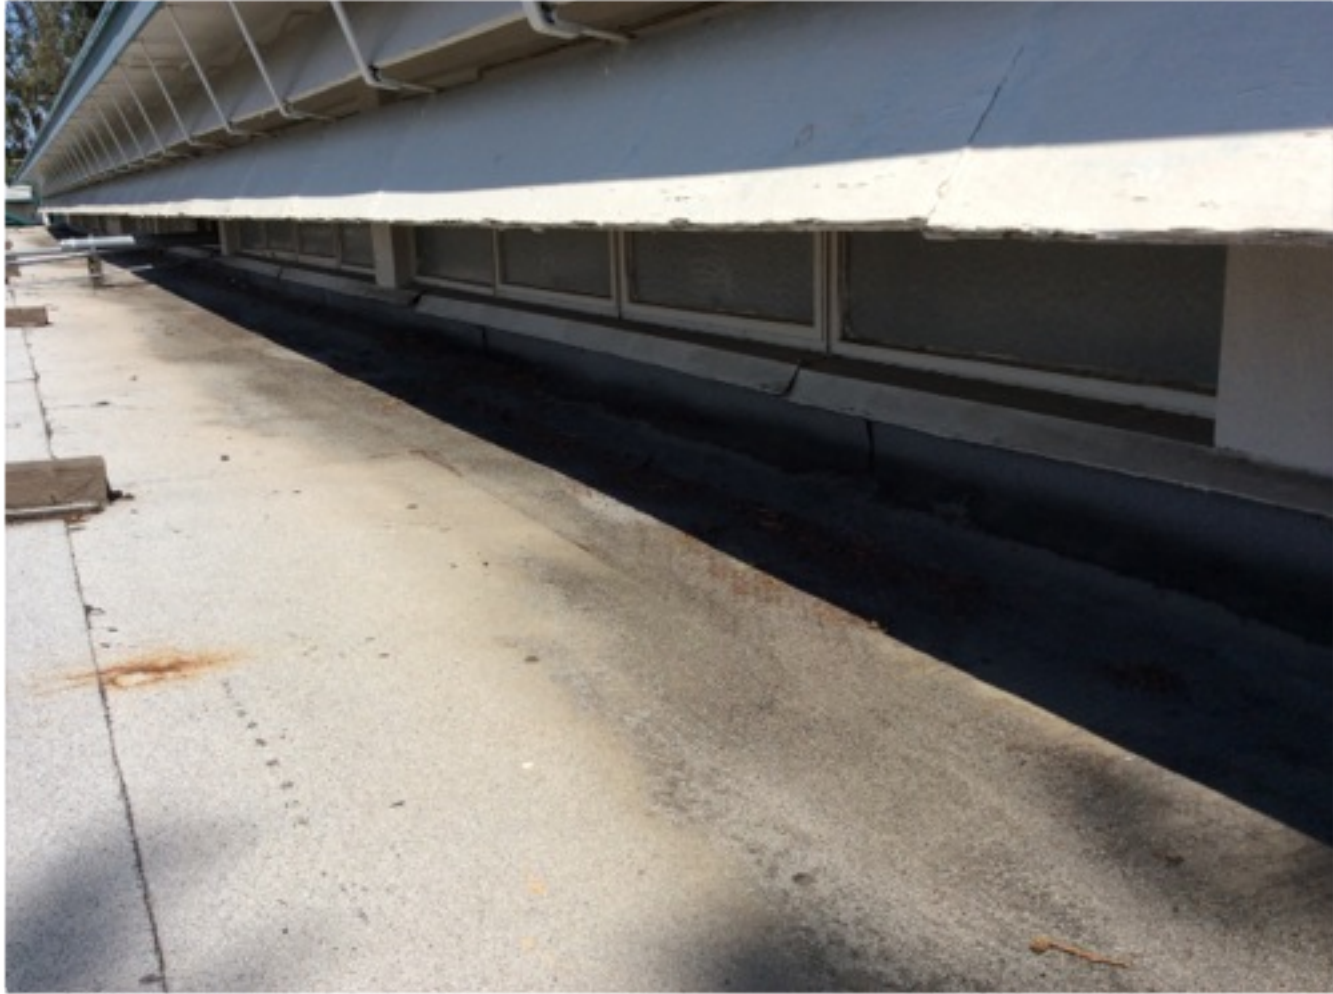
The photo below shows excessive ponding next to building 700.

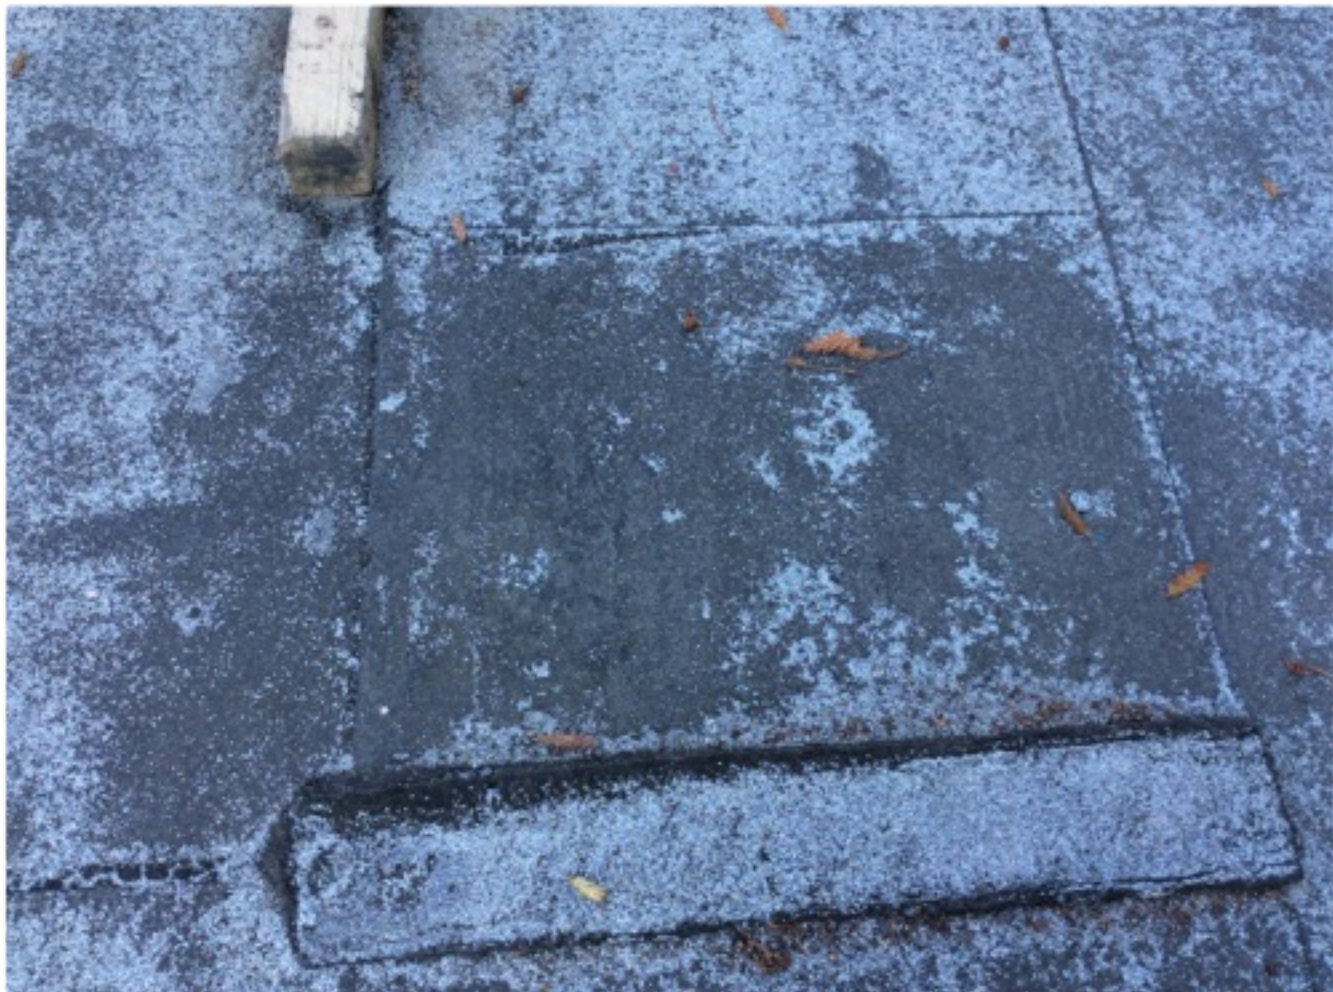
The roof is worn and close to exposing the membrane fibers.

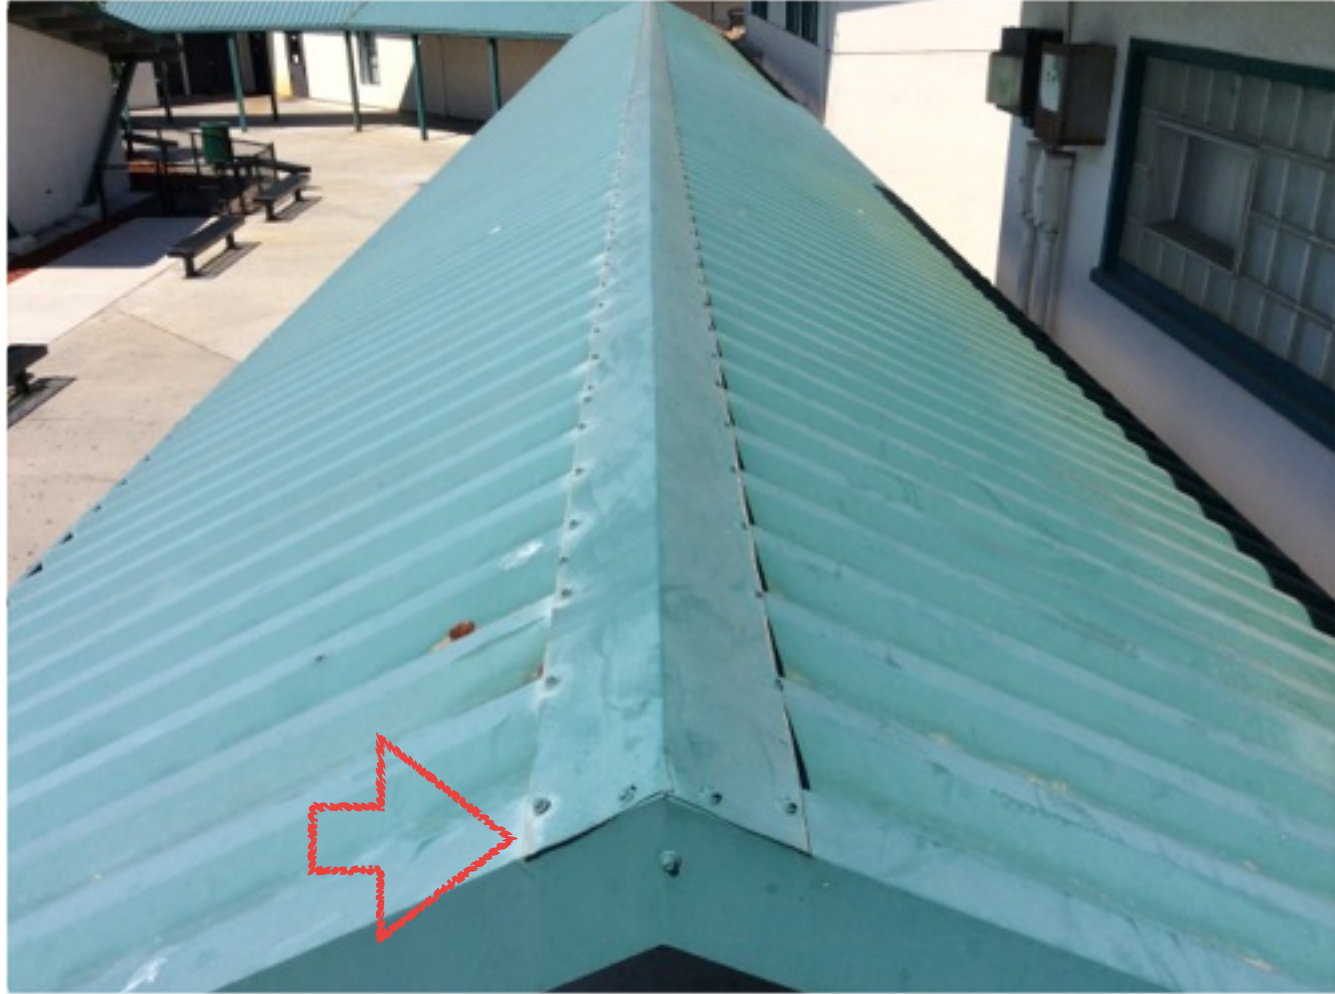
The photo below shows the beginning signs of rust.

If managed and recoated within the next few years, these roofs should last for decades.

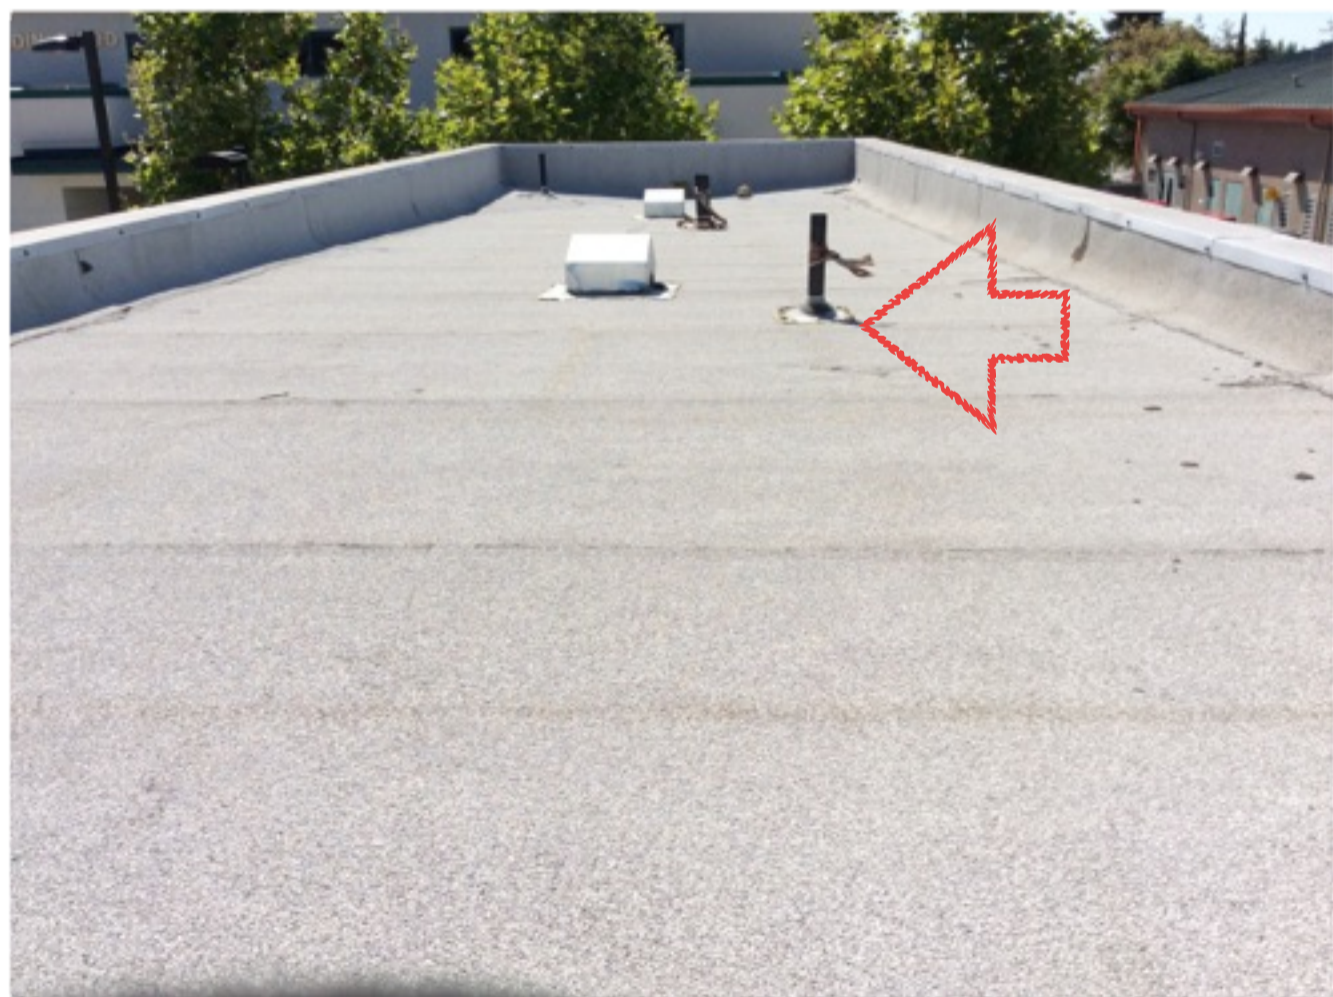
An overview photo from the roof level. Reseal the penetration flashings every 3-5 years.
