BUILDING	M1						E	NOINEERIN	INEERIN IG SERVICES FOR THE BUILDING ENVE	G
ROOF SQ FT	10,500								o centres for the buttons con-	
ROOF CONSTRU	JCTION									
ROOF AGE	SS 2007	⋖	0-5 YEARS		5-10 YEARS	✓	10-15 YEARS		15+ YEARS	
DECK TYPE	METAL		PLYWOOD	✓	PLANK		CONCRETE		LW CONCRETE	
INSULATION	NONE	\checkmark	ISO		FIBER		PERLITE		STYRO	
INSUL THICK	1 INCH		2 INCH		3 INCH		4 INCH		TAPERED	
MEMBRANE	METAL SS	\	SINGLE PLY		BUR	✓	MOD BIT		TWO SYSTEMS	✓
MEM SURFACE	COATING	✓	MS CAP	✓	GRAVEL		SMOOTH	√		
FLASHINGS	CAPSHEET	\checkmark								
DRAINAGE	JOSAM	✓	SCUPPERS		SS GUTTERS	~	OVER EDGE			
SLOPE	NONE		1:12	\checkmark	2:12		3:12		SS 6:12	\checkmark
ROOF CONDITIO	ON - RATINGS (1-1	0) ar	nd RECOMMENDA	1OITA	NS					#
FIELD		RE	EPAIRS NEEDED						RATING	7
			RESEAL SEAMS		В	LIST	ERS or RIDGING		SS RATING	8
	CLEA	AR R	OOF OF DEBRIS		DE	CK F	REPAIR NEEDED			
	DECK	REPA	AIR SUSPECTED		ſ	иЕМ	BRANE BRITTLE			
PITCH/POND		RE	EPAIRS NEEDED						RATING	7

BUILDING INFOR	RMATION
FACILITY	Independence HS
DATE	July 21, 2014
BUILDING	Portables 1-24, Portable Restrooms 1 and 2
ROOF SQ FT	31,000

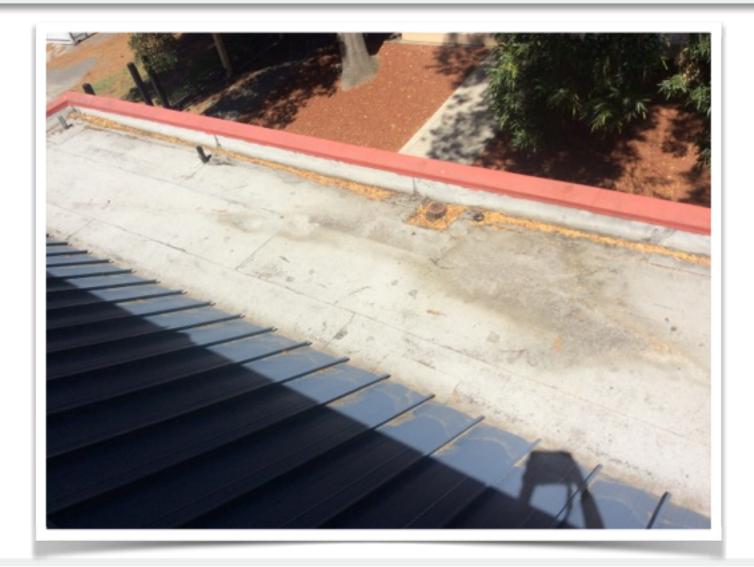
The photo below shows the lower roof sections in marginal condition.

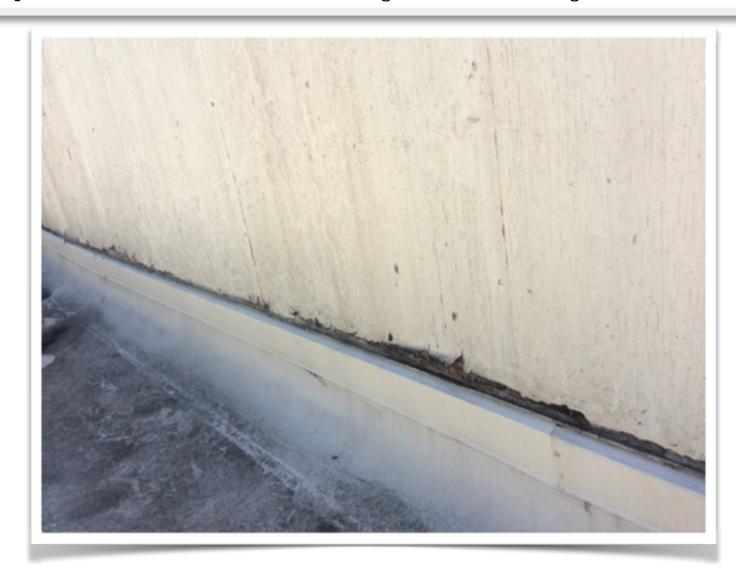
The photo below shows the south walls coating and sealant is failing.

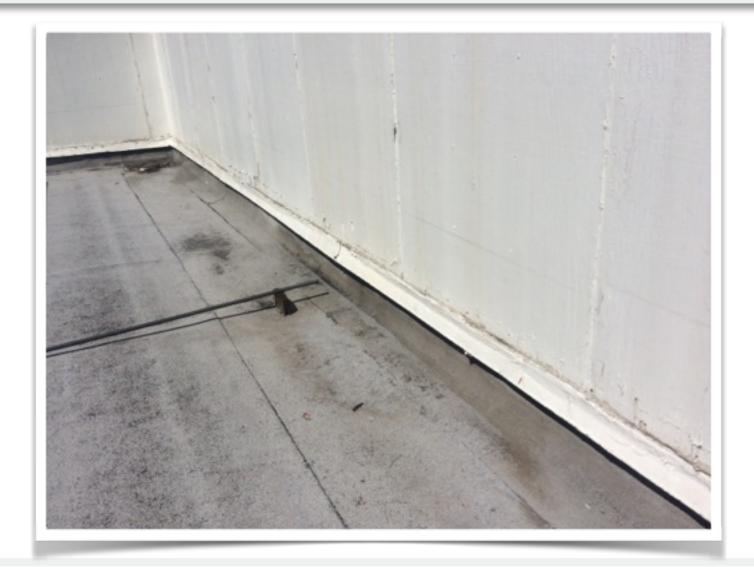
The photo below shows the wall coating and flashing failing.

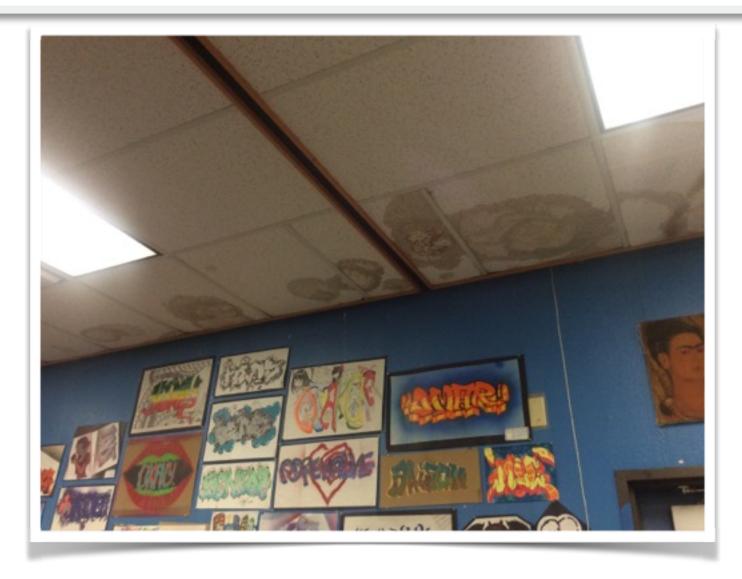
The photo below shows directly below the photo above.

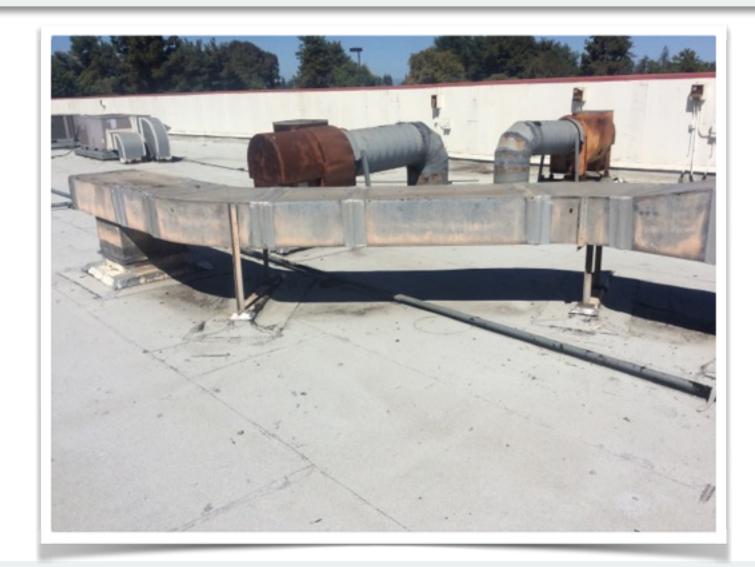
The photo below shows that the AC duct needs to be sealed and all the curbs raised.

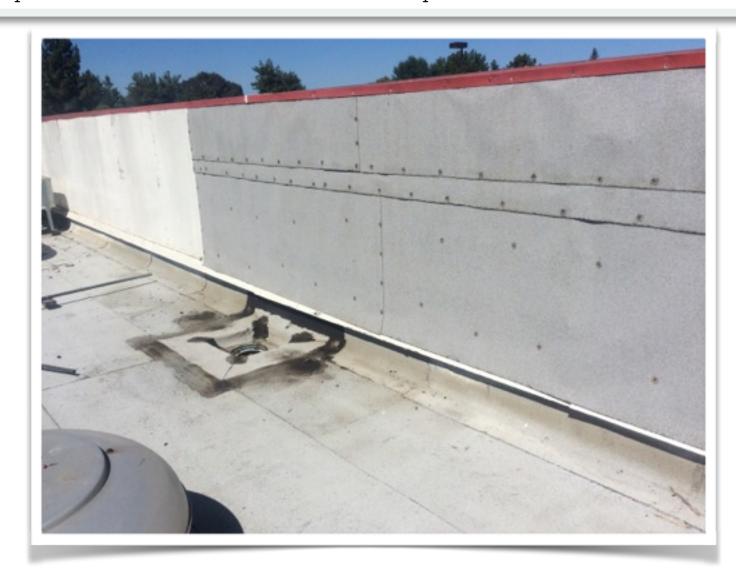
The photo below shows evidence of leaks and wall problems.

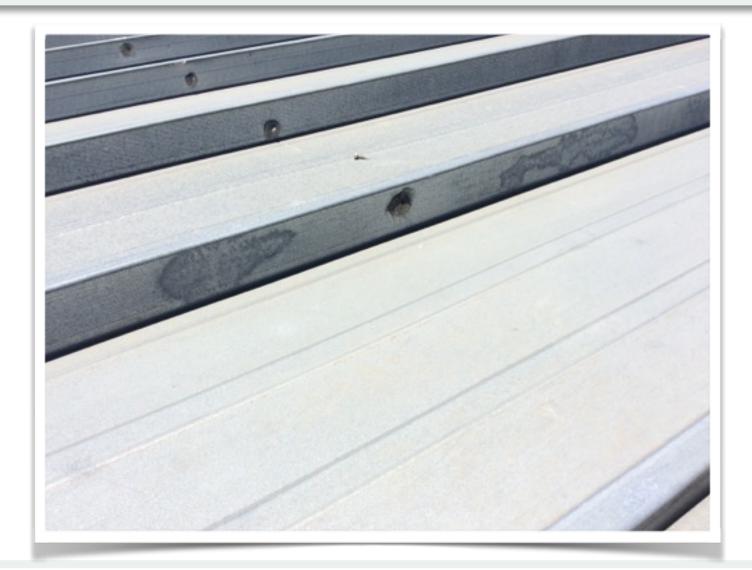
ALTHOUGH THE METAL ROOFS ARE IN GREAT SHAPE THE GALVANIZED COATING HAS A LIFESPAN OF ABOUT 10-15 YEARS. THE NEED FOR A COATING IS BASED SOLEY ON THE ESTIMATE (GUESS IN THIS CASE) OF THE ROOF AGE.

The photo below shows no signs of rust yet.

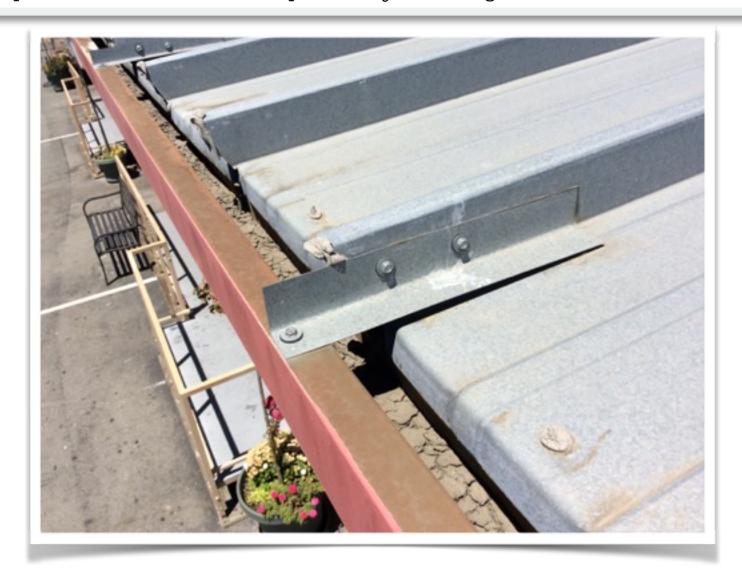
The photo below shows the need to periodically clean the gutters.
