BUILDING INFORMATION	
FACILITY	Phoenix HS
DATE	October 17, 2014
BUILDING	Portables T3, T4, T5, T6, T7
ROOF SQ FT	4,400

ADDITIONAL NOTES
THIS METAL ROOF IS IN MARGINAL CONDITION. INSPECT METAL ROOFS REGULARLY FOR SIGNS OF RUST.

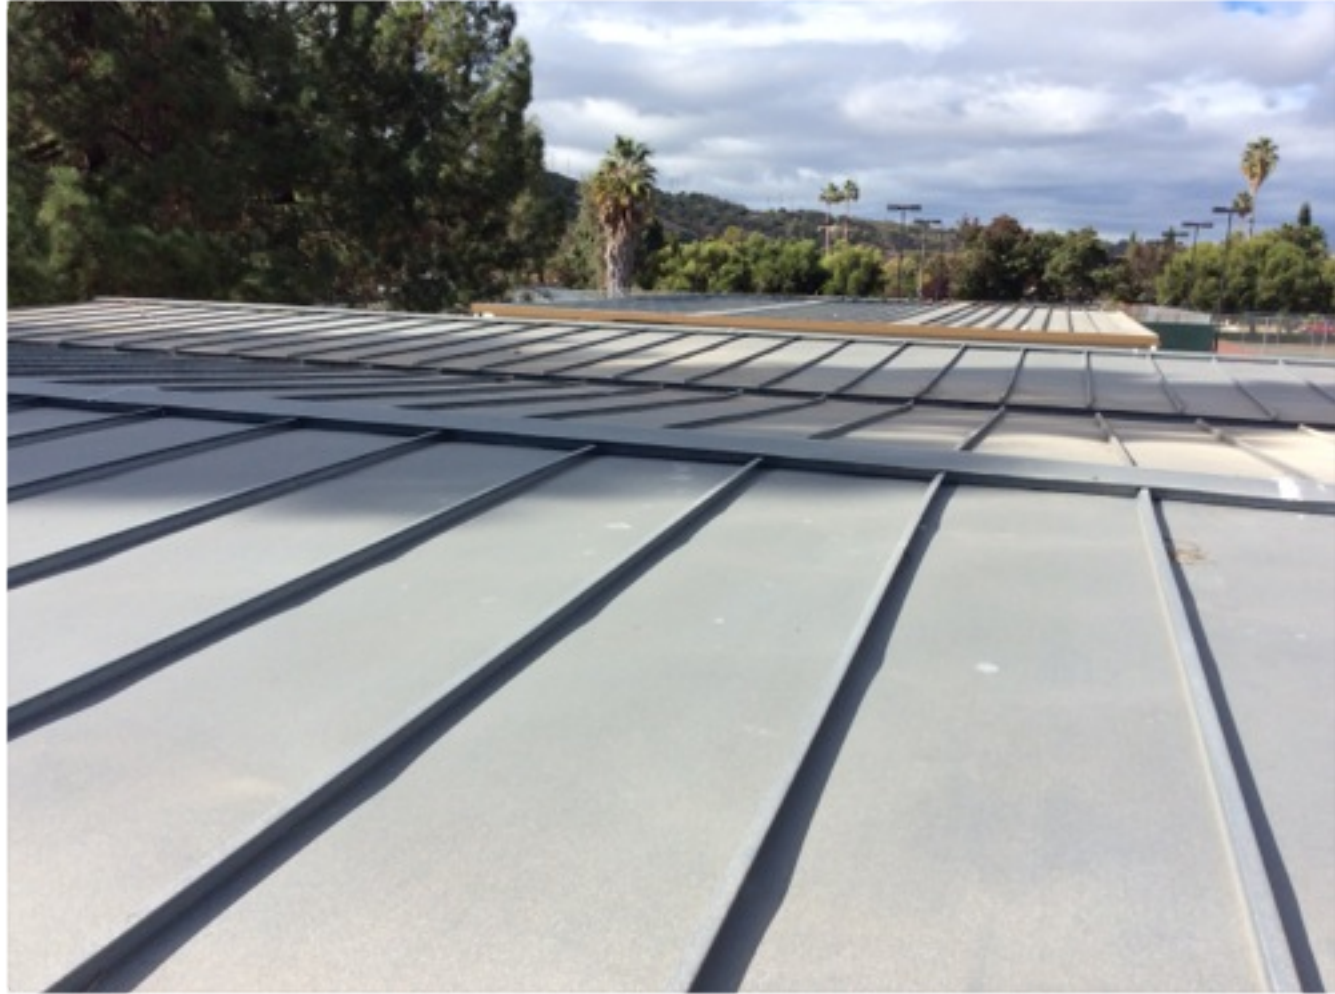
An overview photo from the roof level.

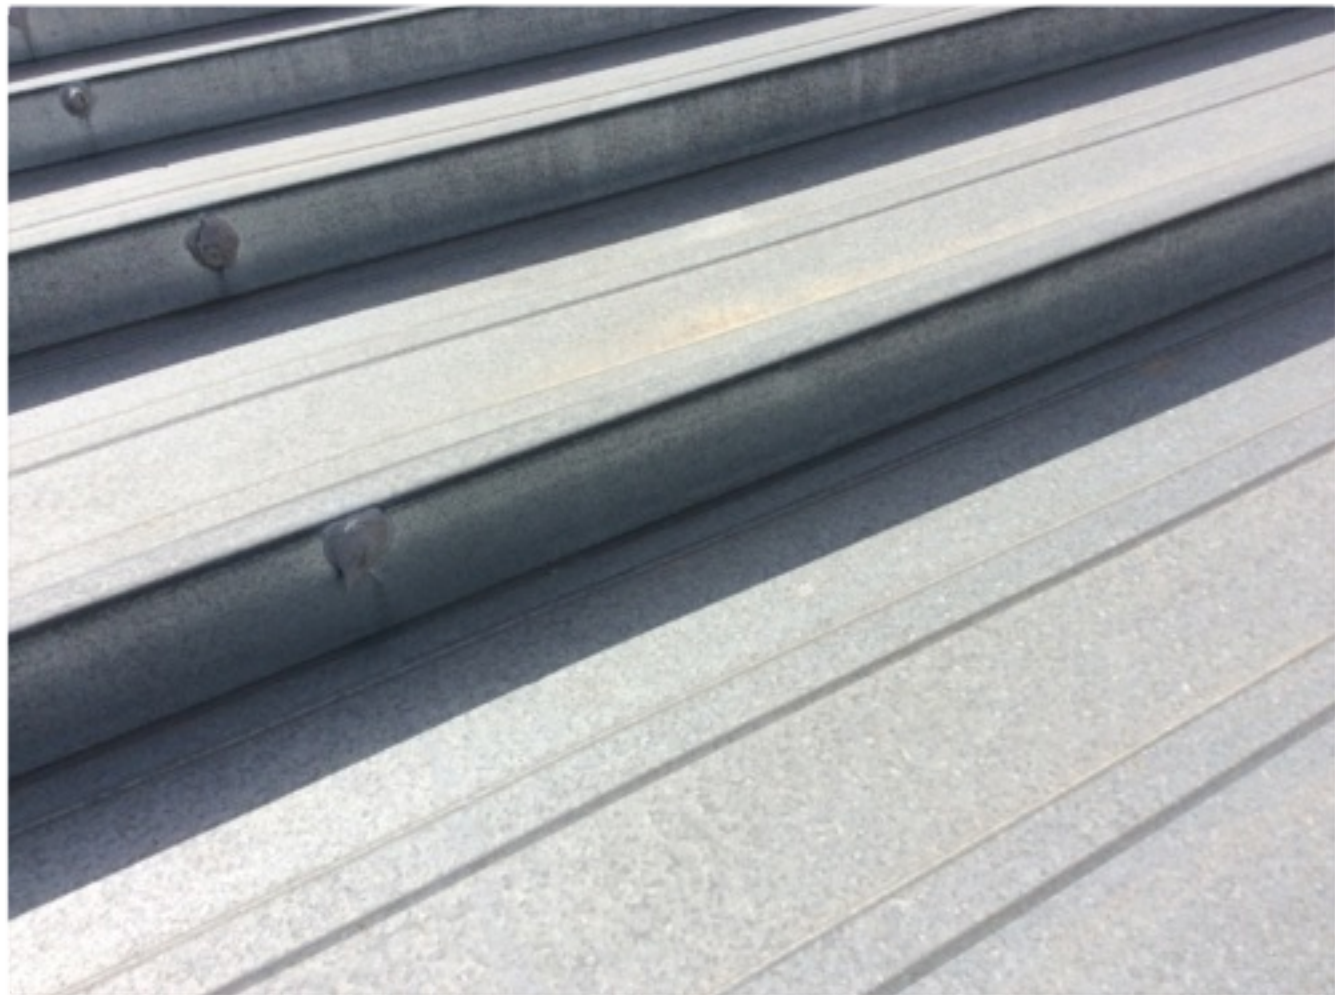
The photo below shows no signs of rust.
