BUILDING INFORMATION	
FACILITY	James Lick HS
DATE	August 20, 2014
BUILDING	100 and Administration
ROOF SQ FT	16,000

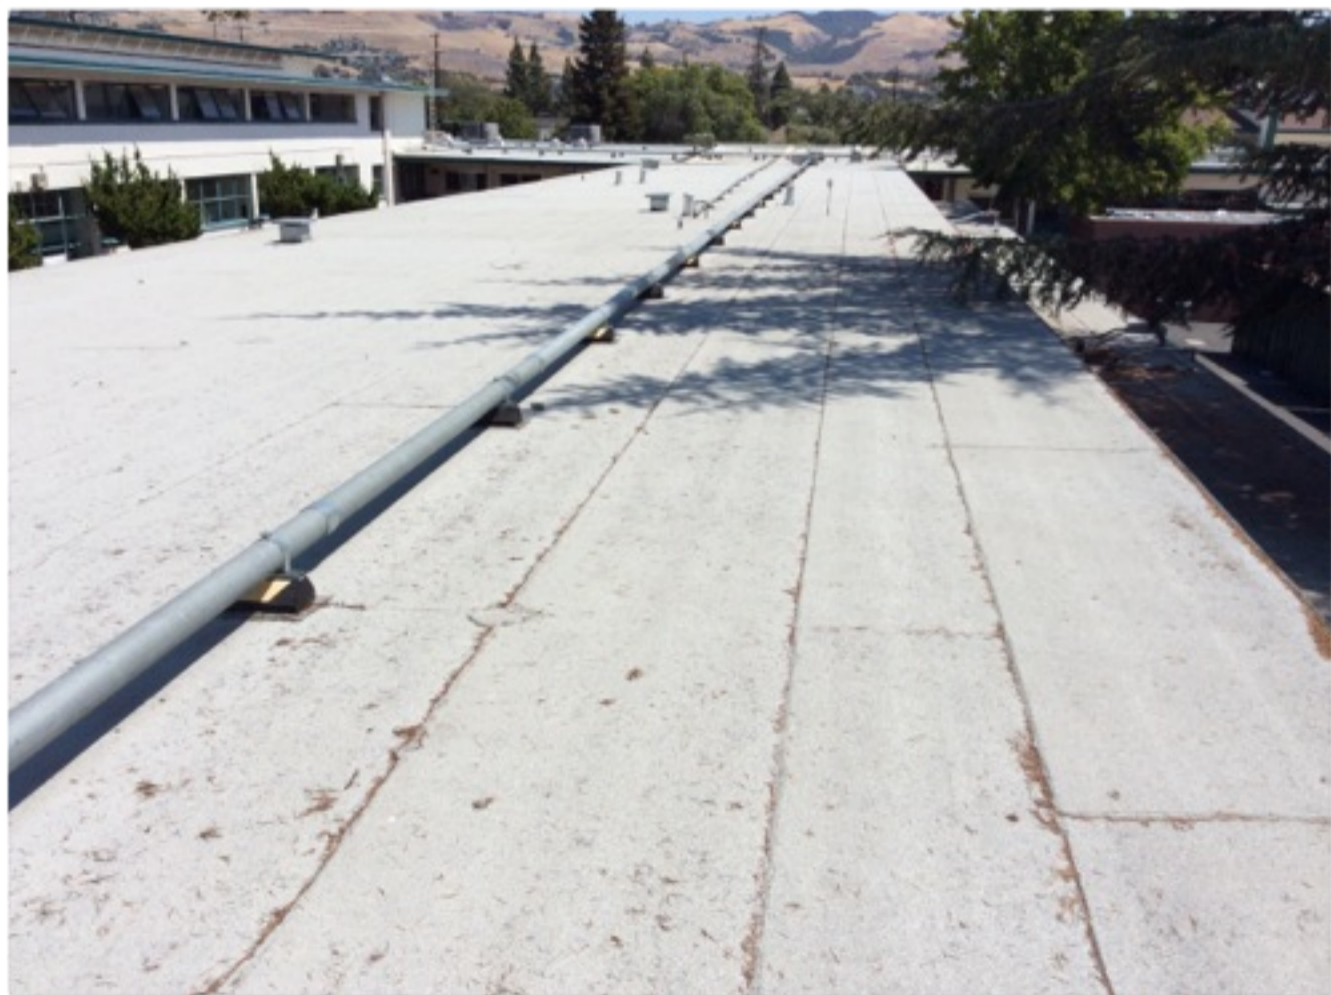
An overview photo from the roof level.

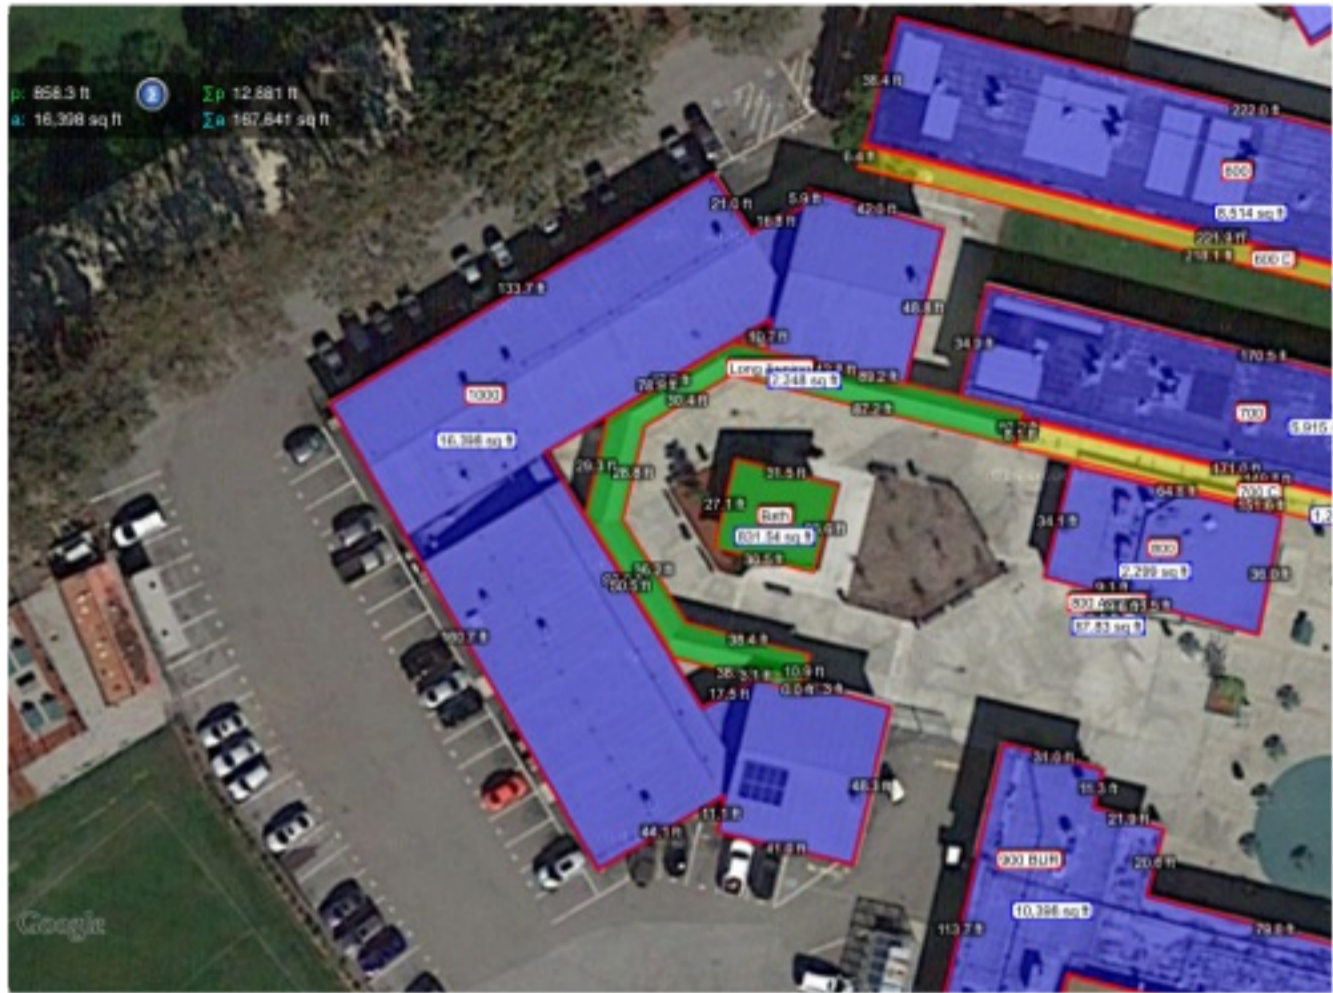
An aerial view of the building.

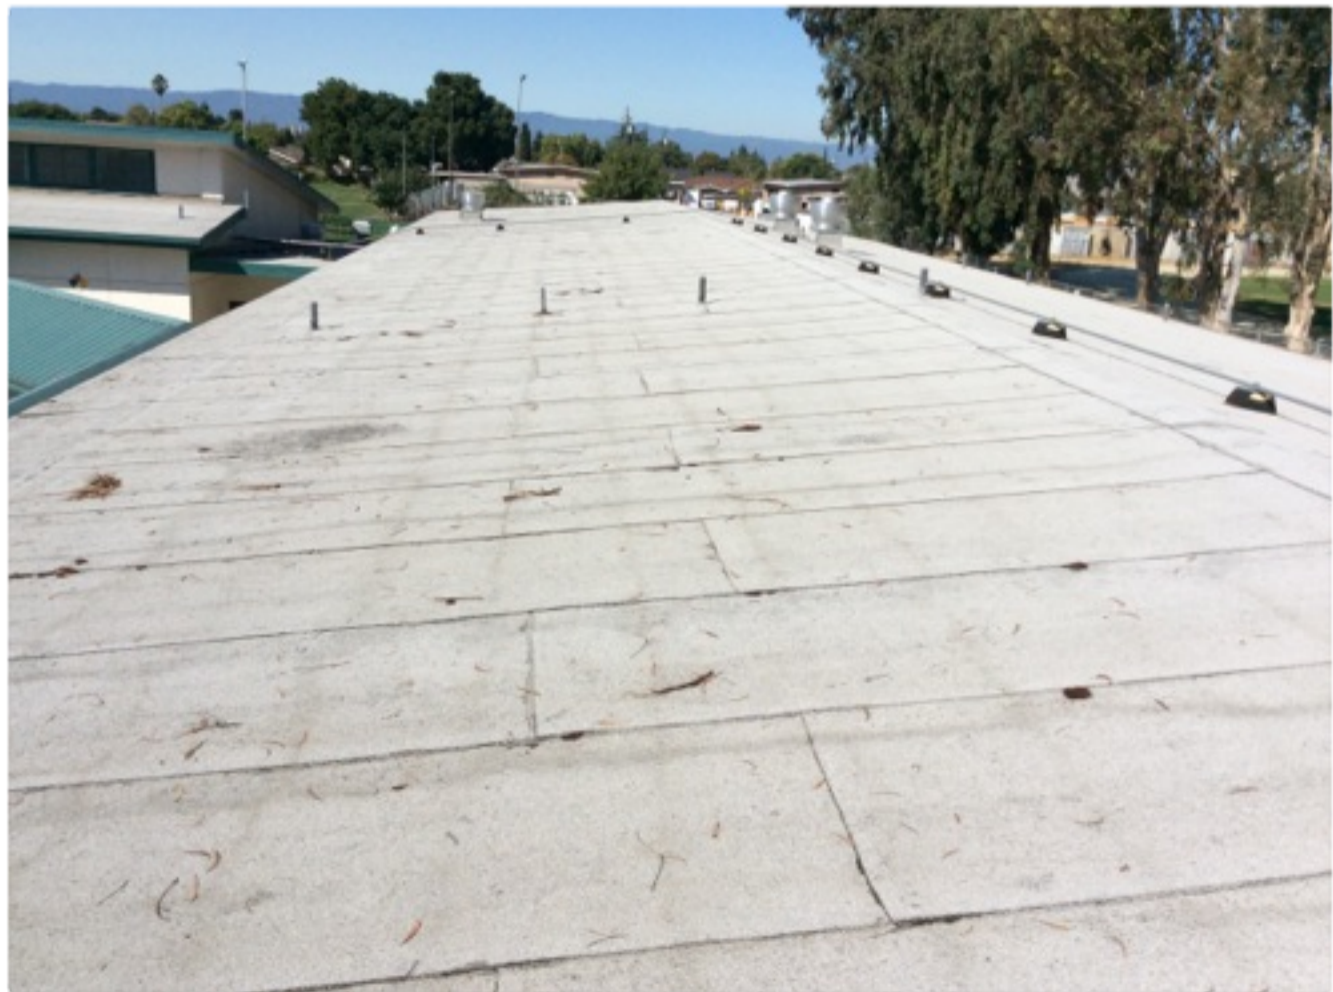
An overview photo from the roof level.

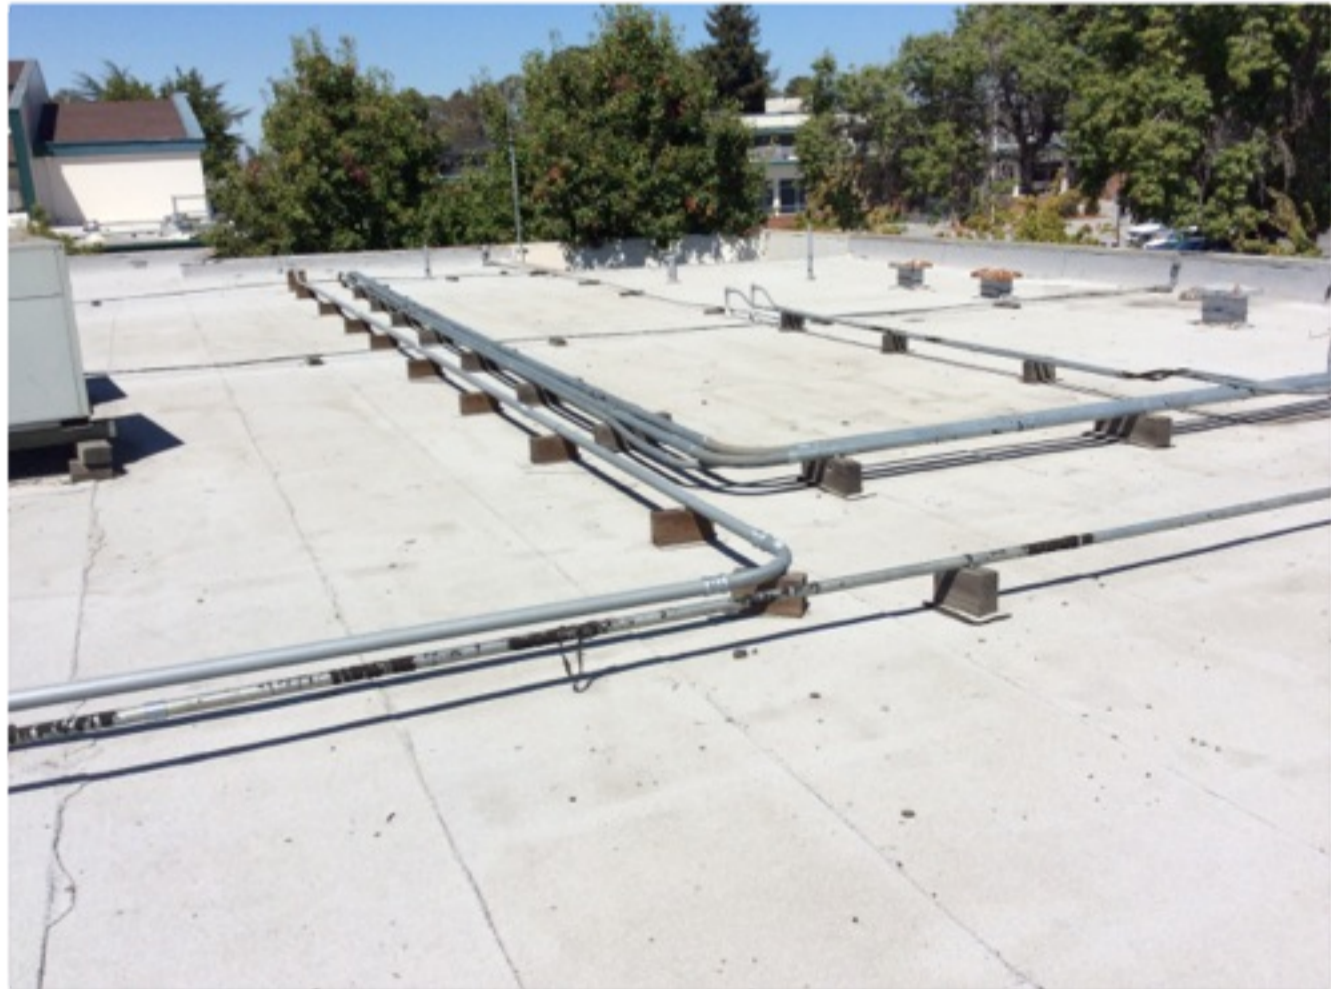
An overview photo from the roof level.

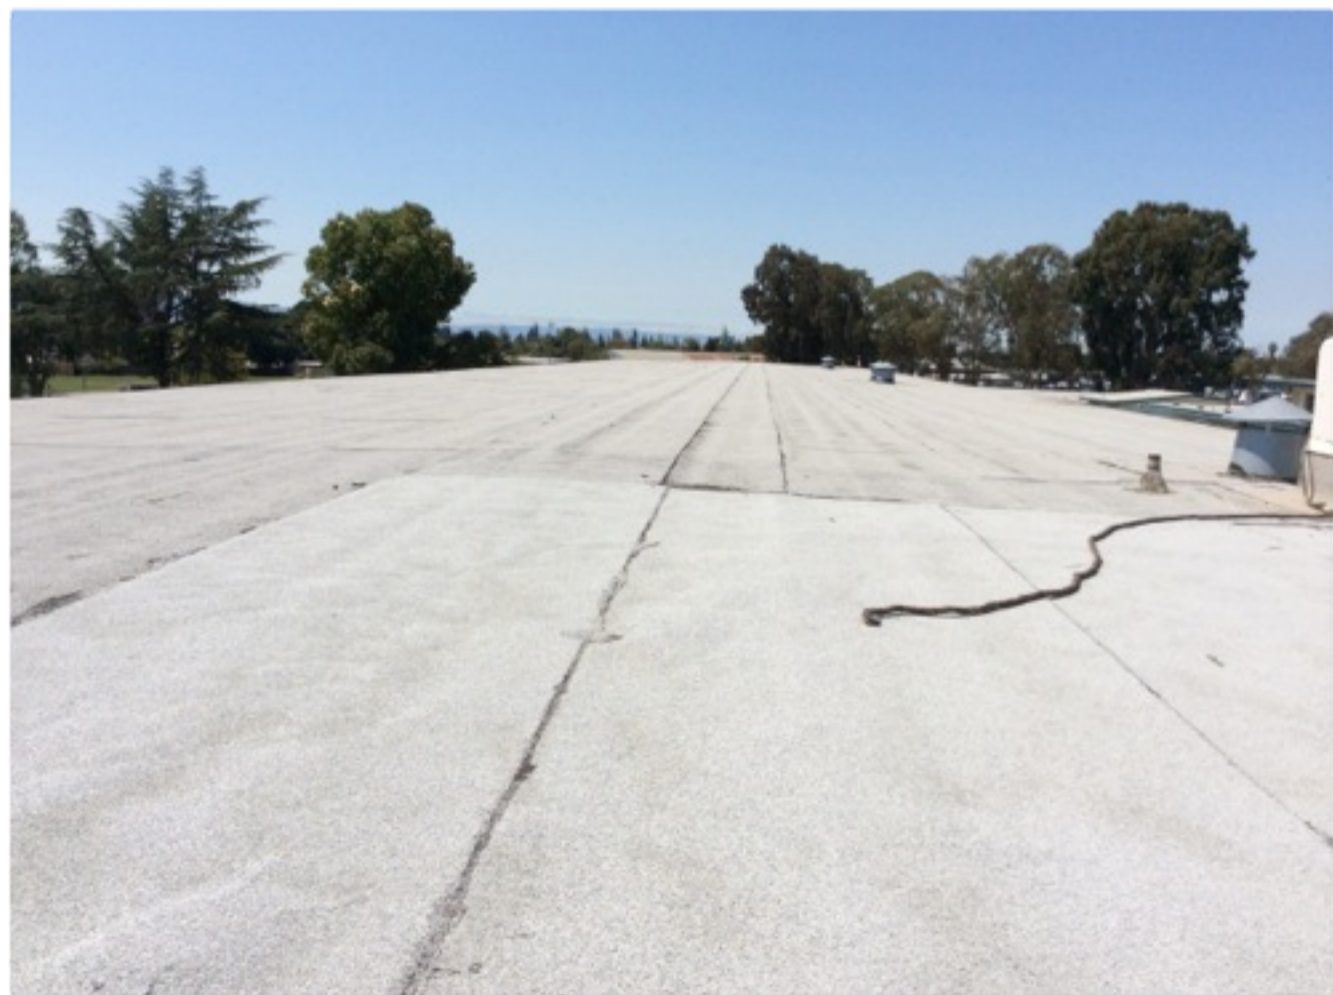
An overview photo from the roof level.

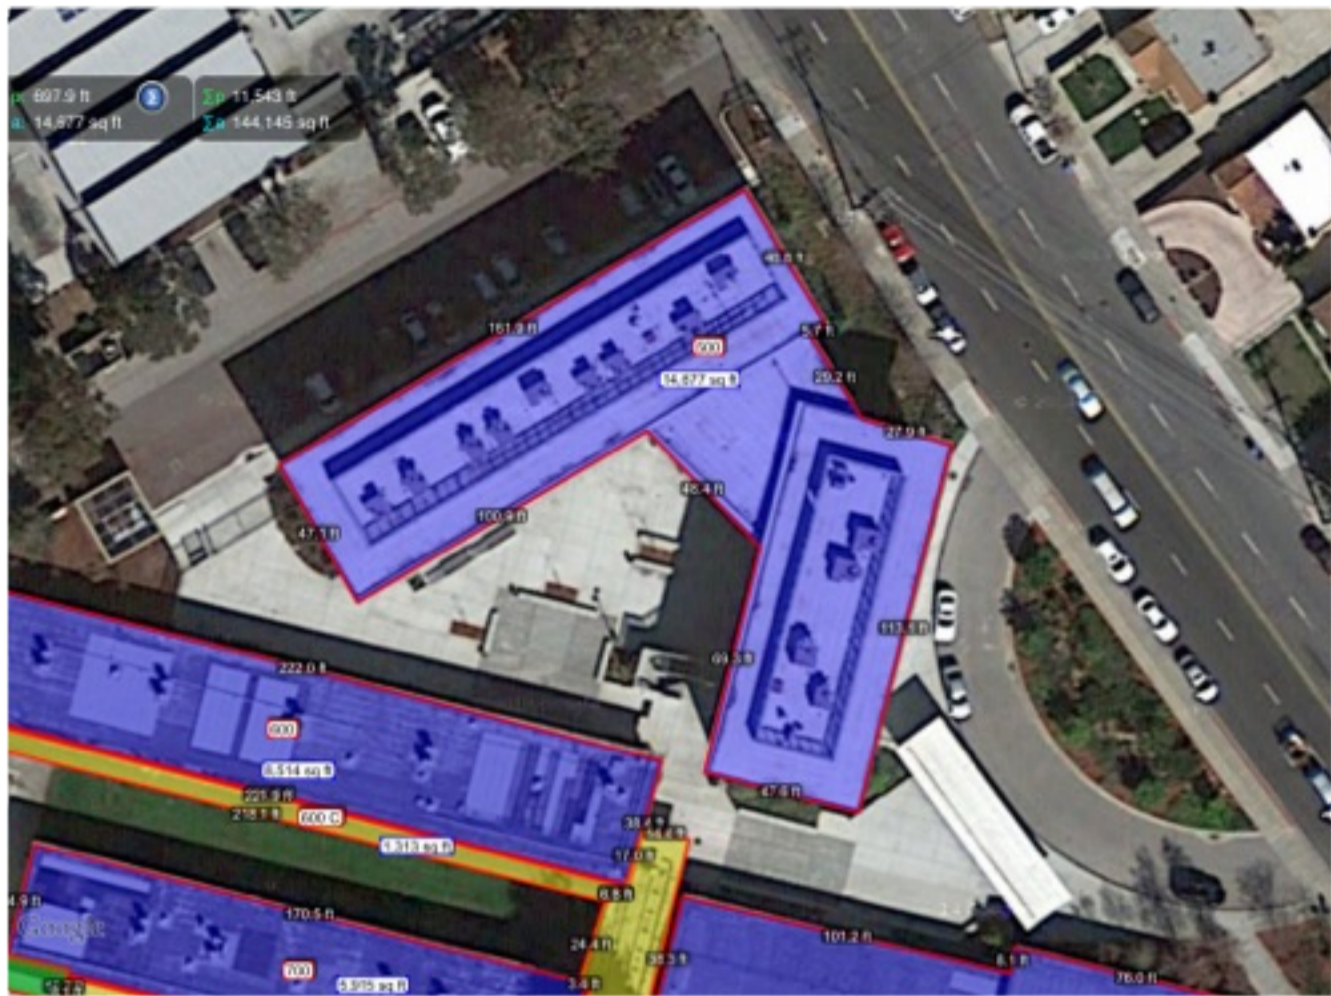
An aerial view of the building.

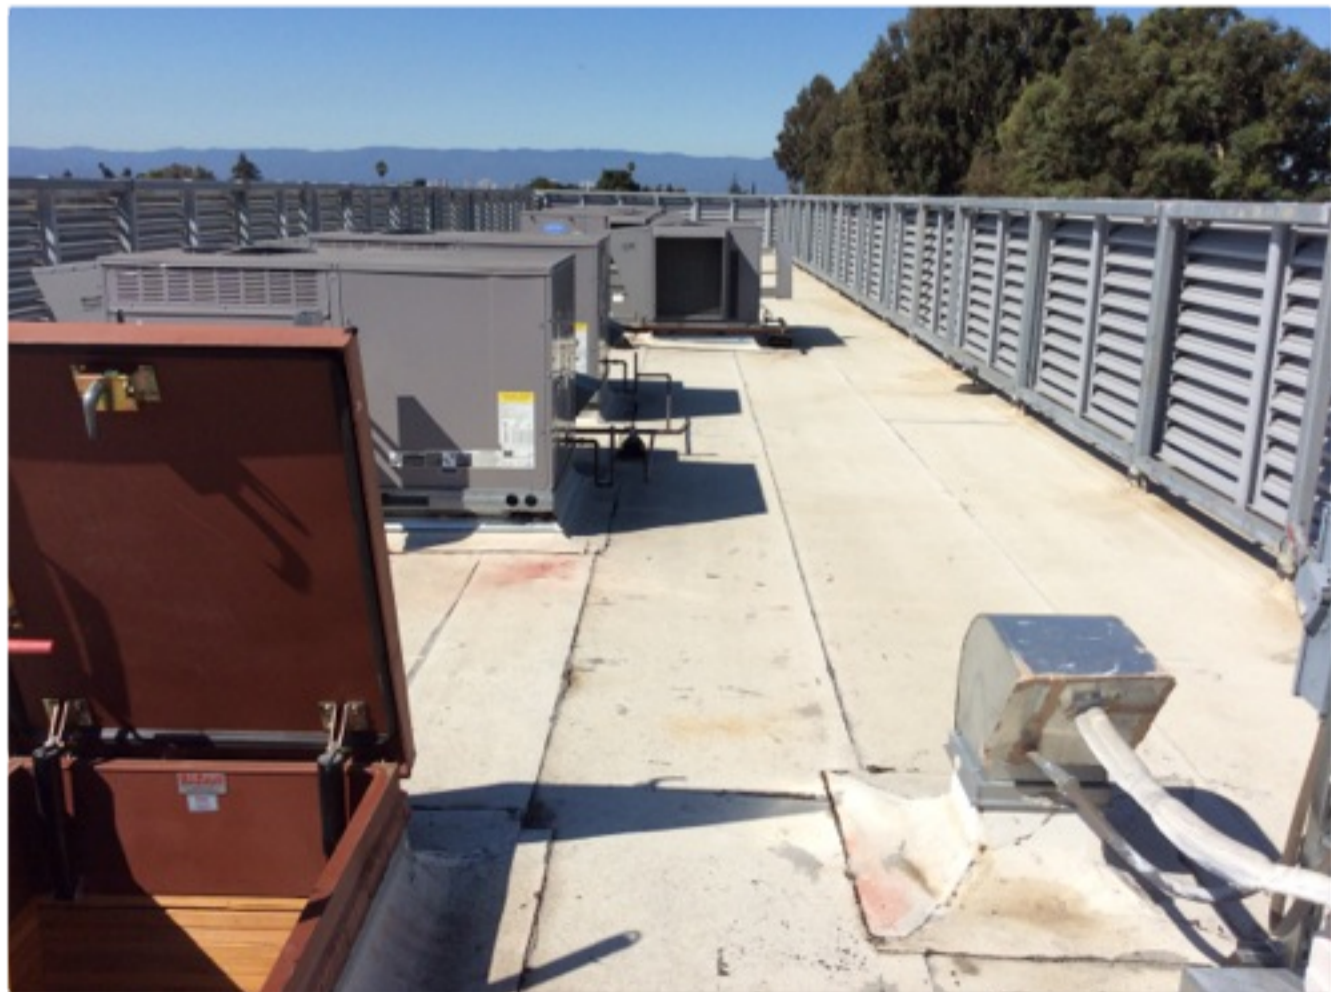
An overview photo from the roof level.

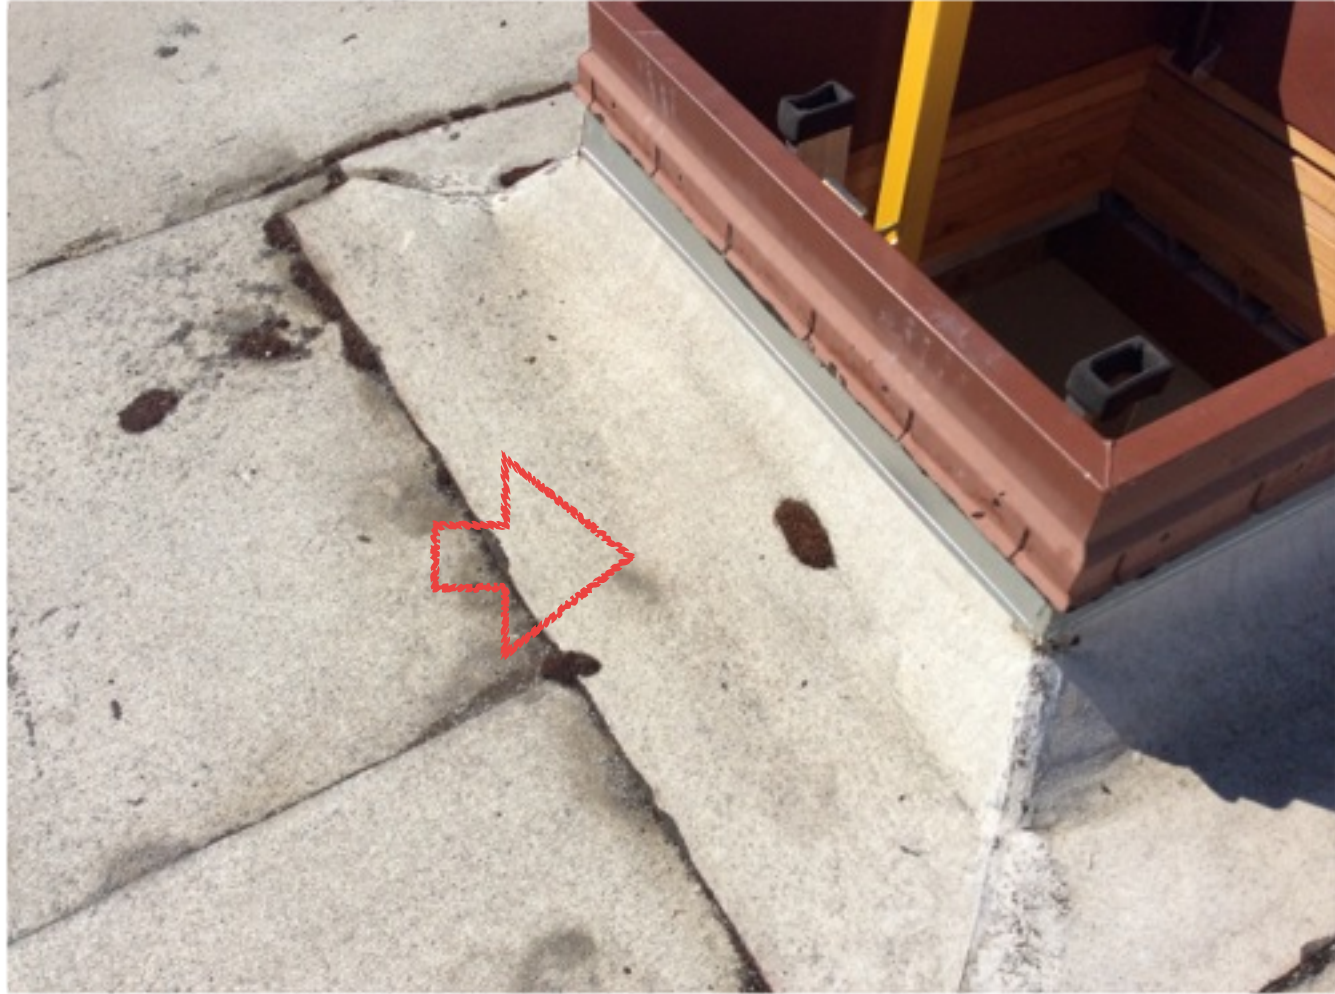
ADDITIONAL NOTES
 THIS IS A NEW ROOF AND SHOULD LAST FIFTEEN YEARS. HOWEVER IT IS LEAKING AND HAS SOME BLISTERS THAT NEED TO BE REPAIRED - HOPEFULLY UNDER WARRANTY. THE BLISTERS ARE A SIGN OF MOISTURE UNDER THE FELTS. ALSO REPAIR GAPS AT EDGE METAL PONDING LOCATIONS.

The photo below shows a large blister close to the hatch.

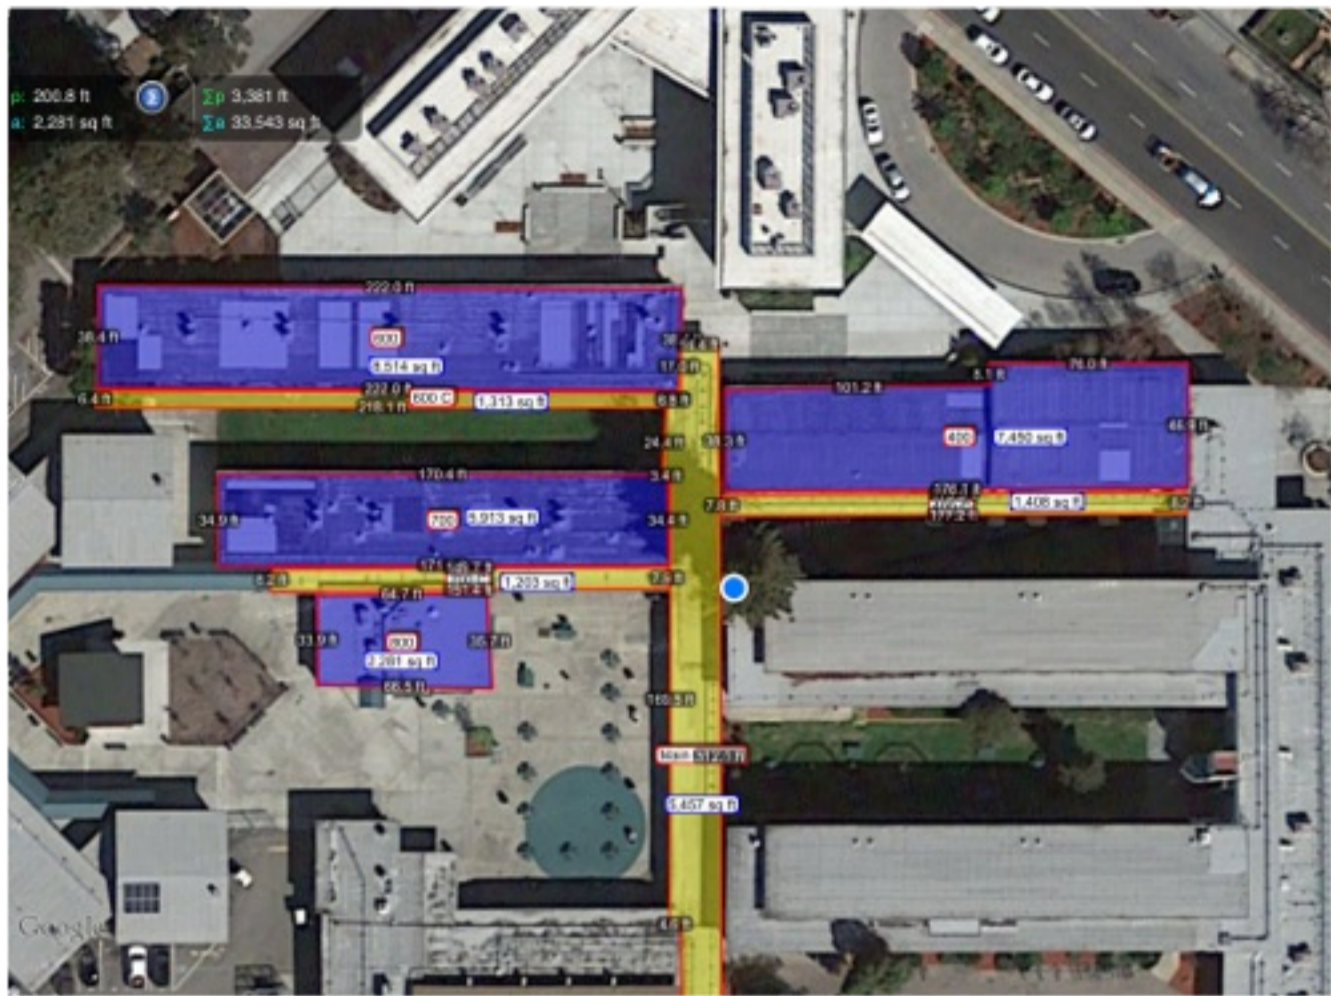
An aerial view of the building.

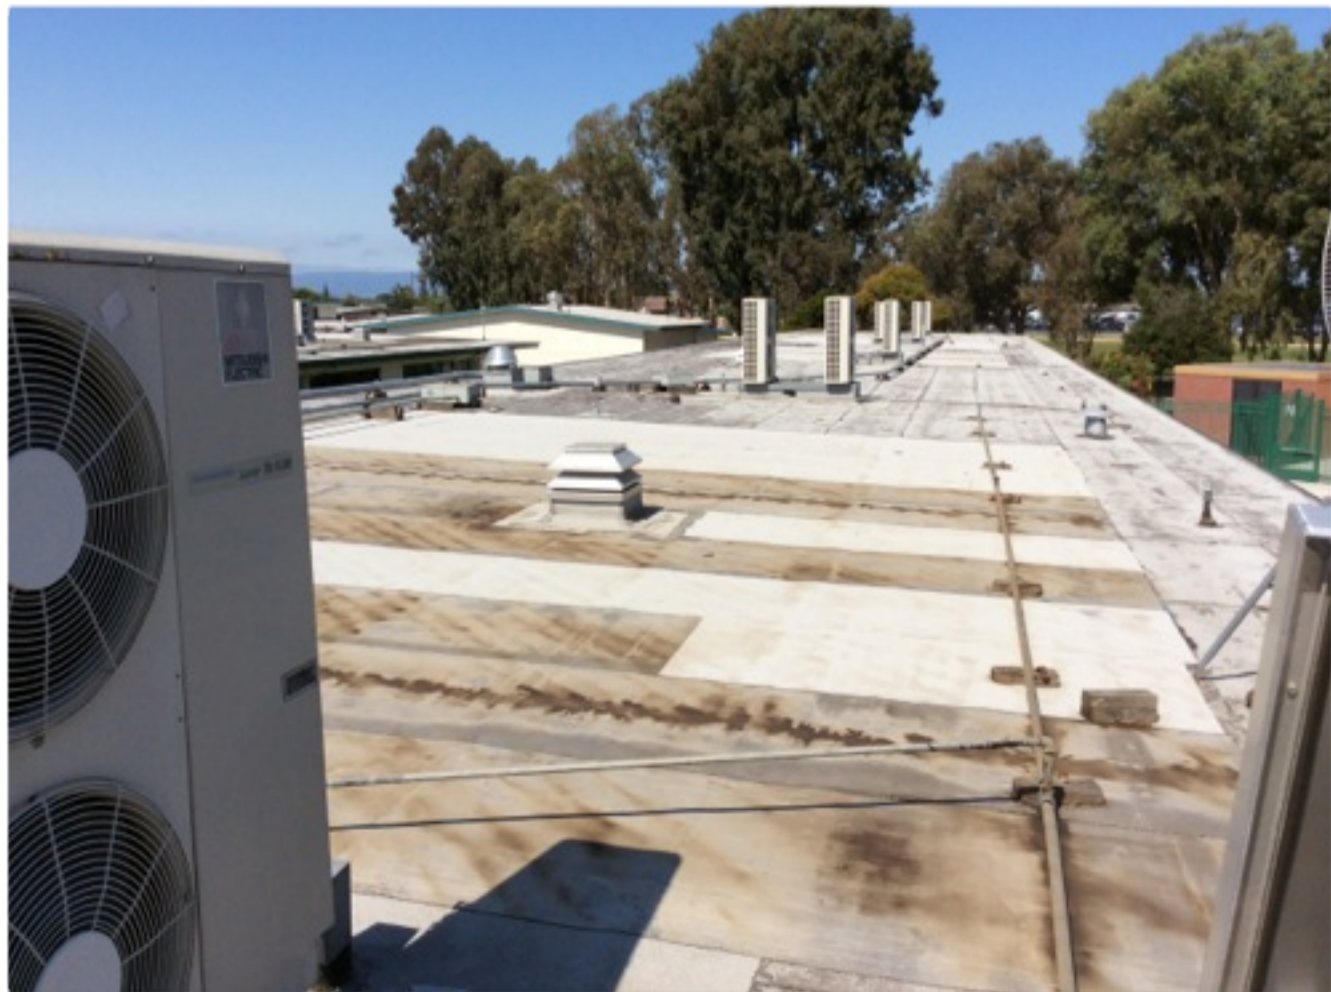
An overview photo from the roof level.

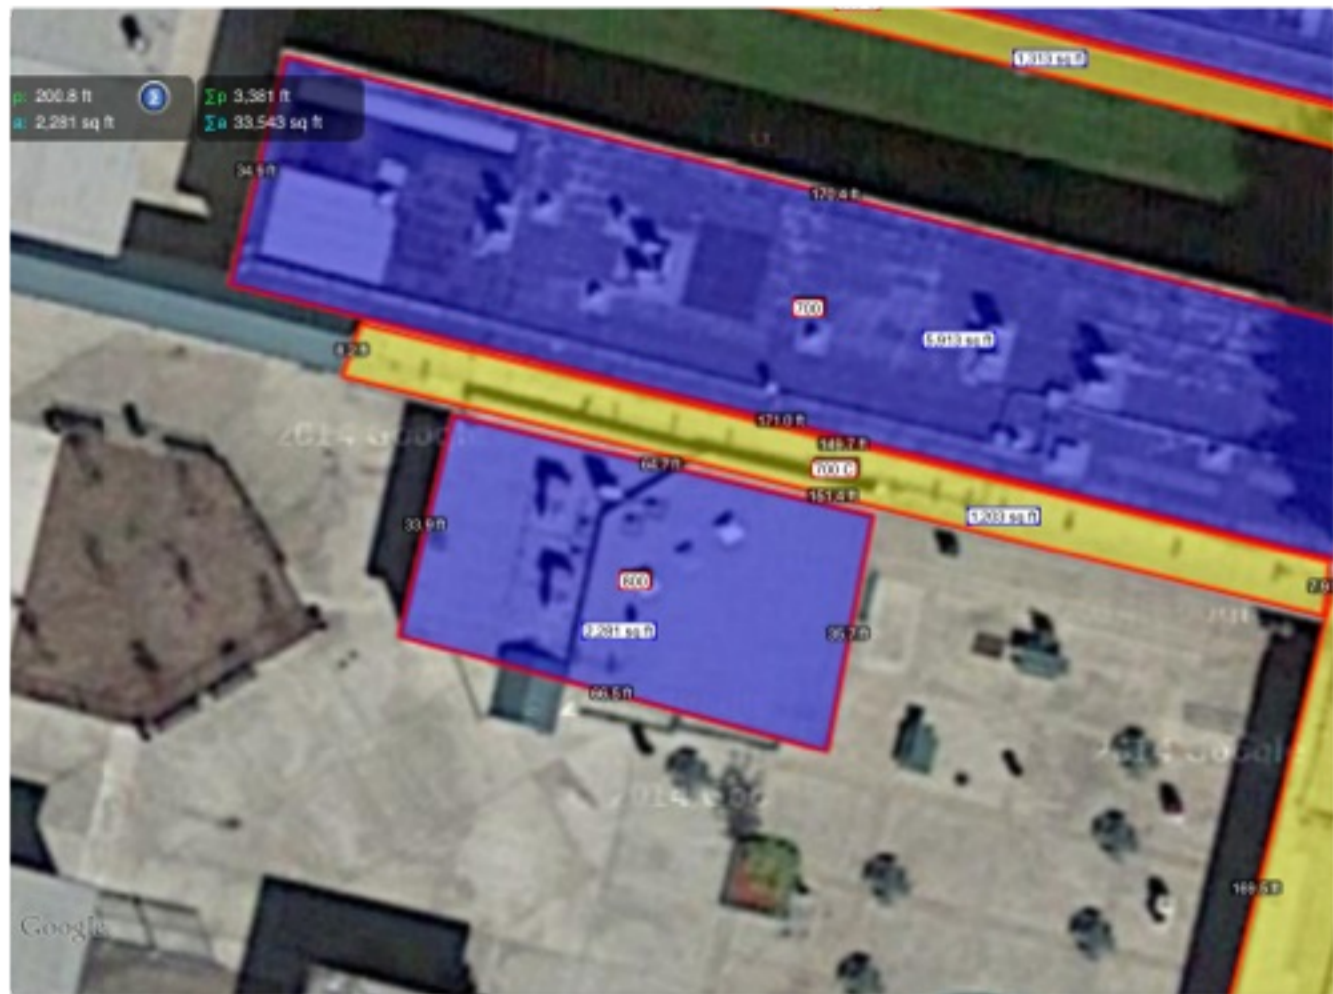
An aerial view of the building.

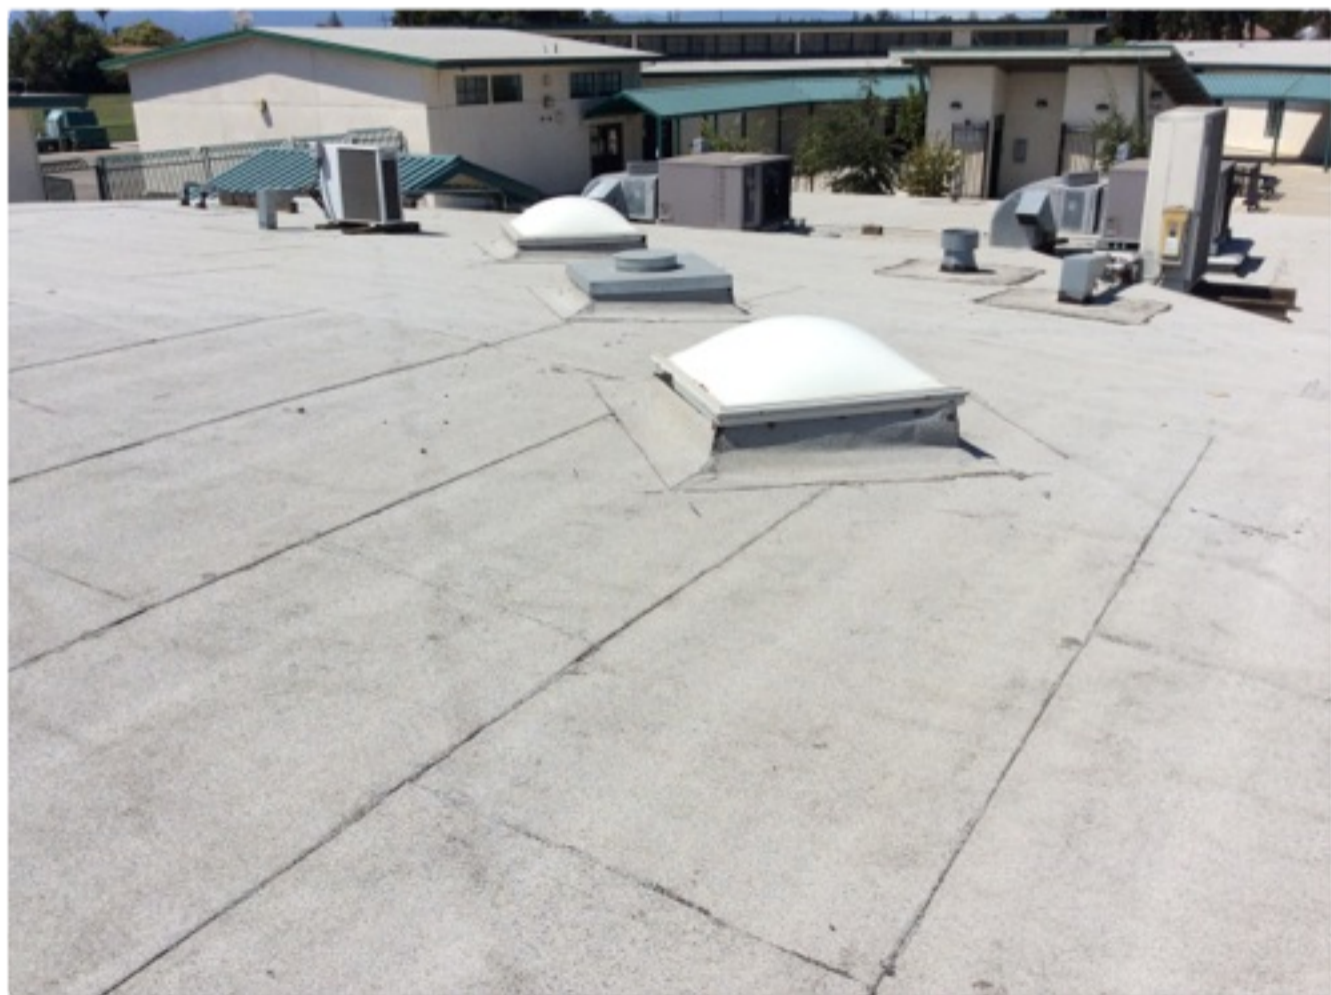
An overview photo from the roof level.

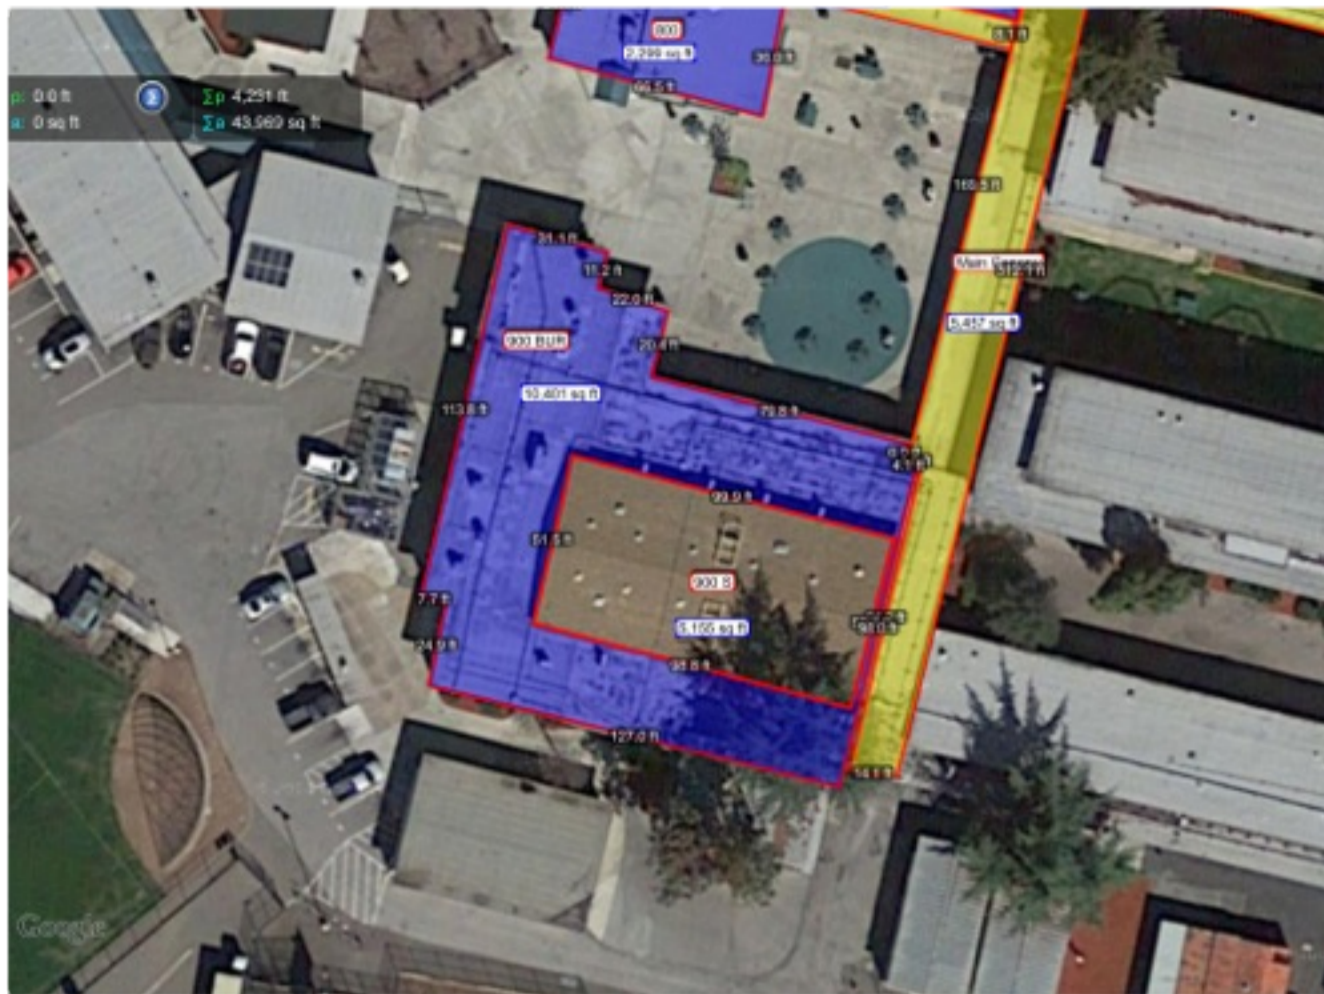
An aerial view of the building.

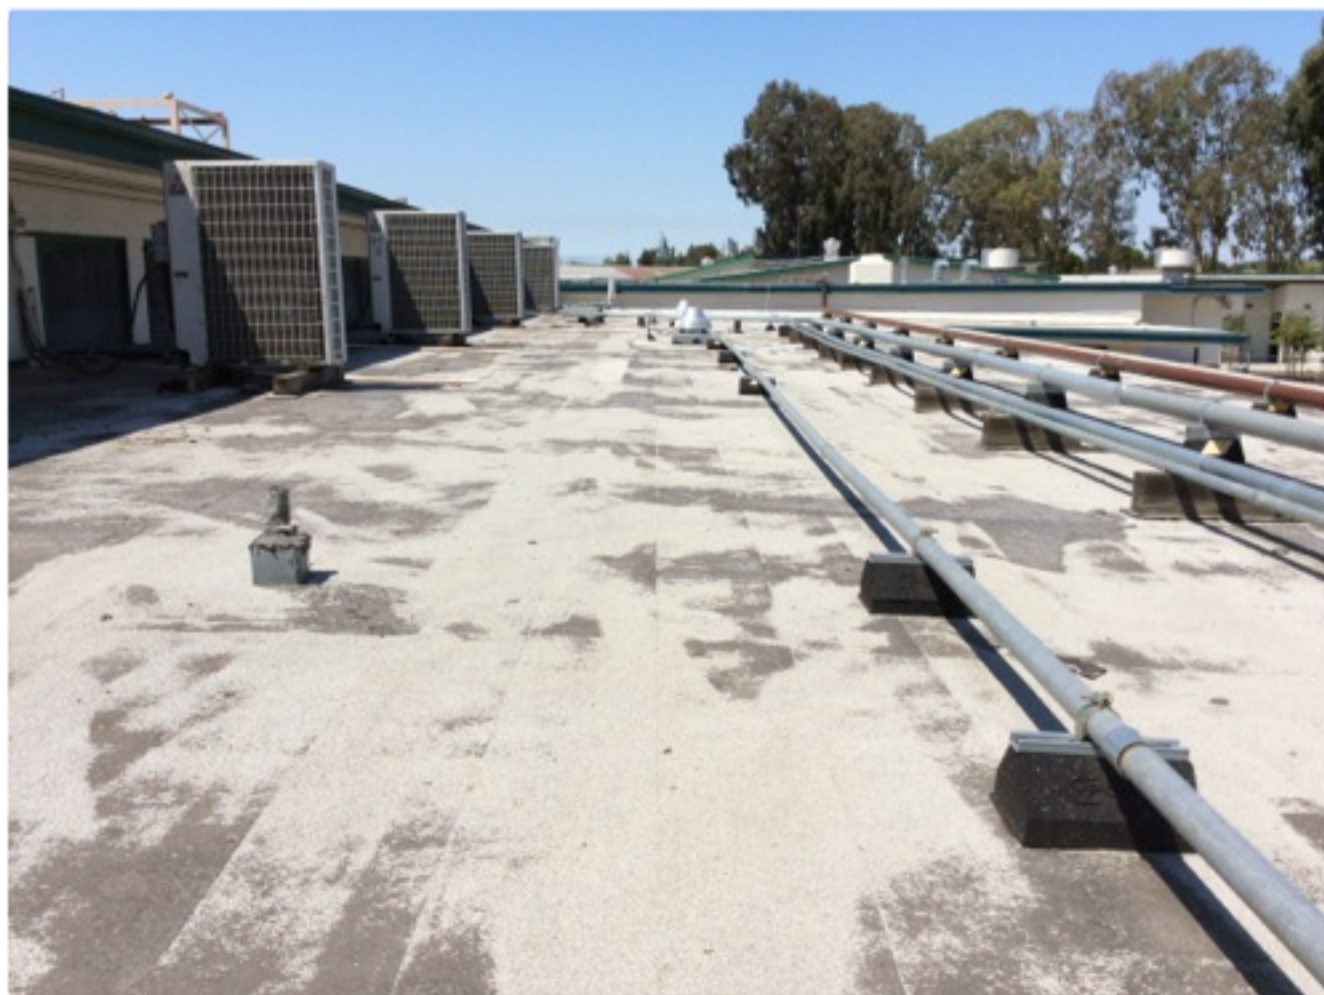
An overview photo from the roof level.

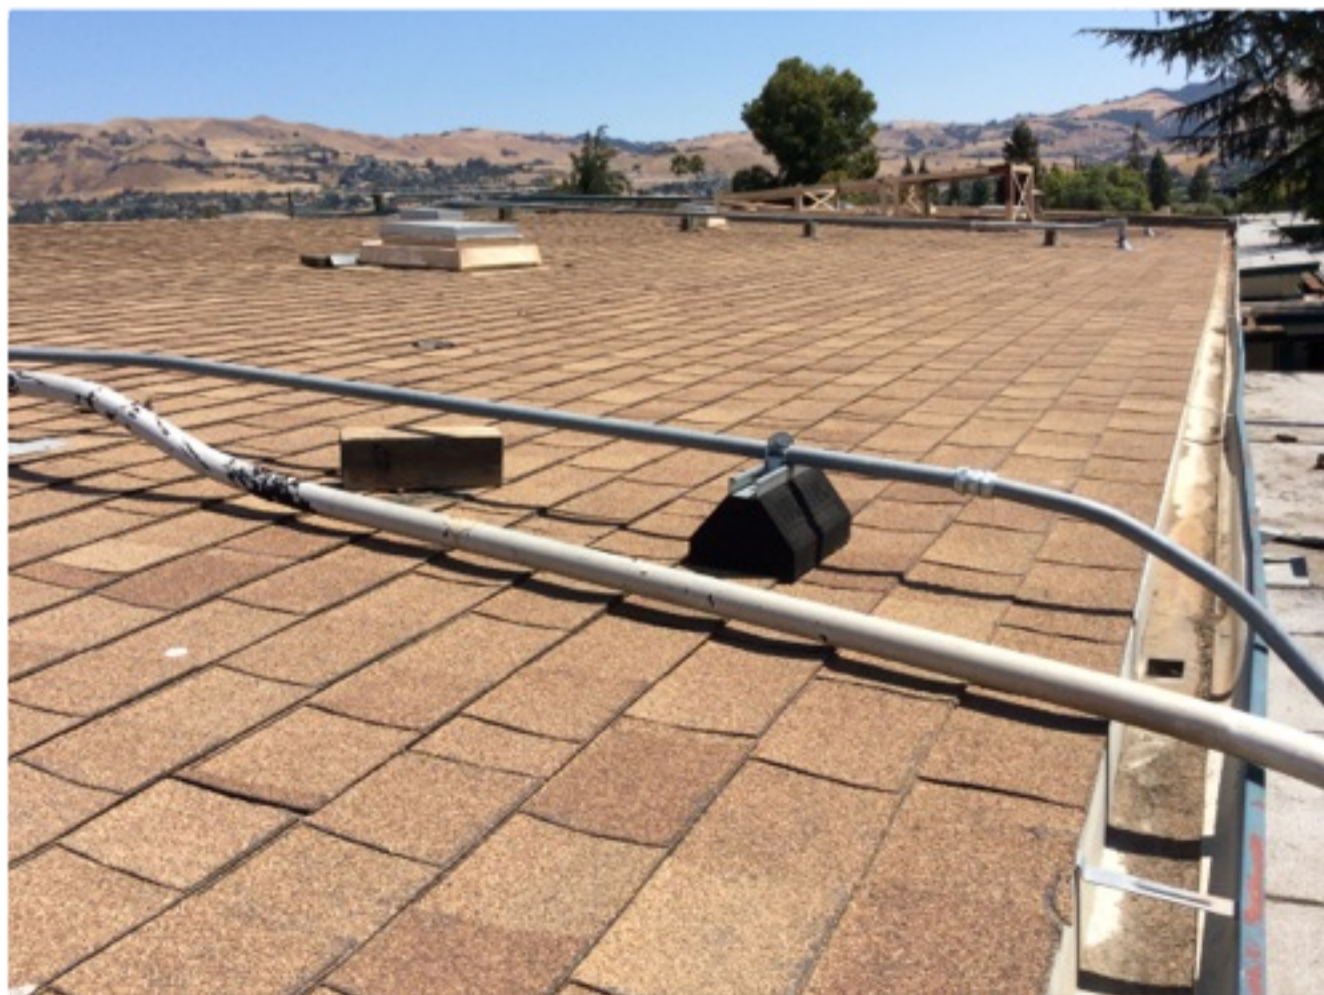
An overview photo from the roof level.

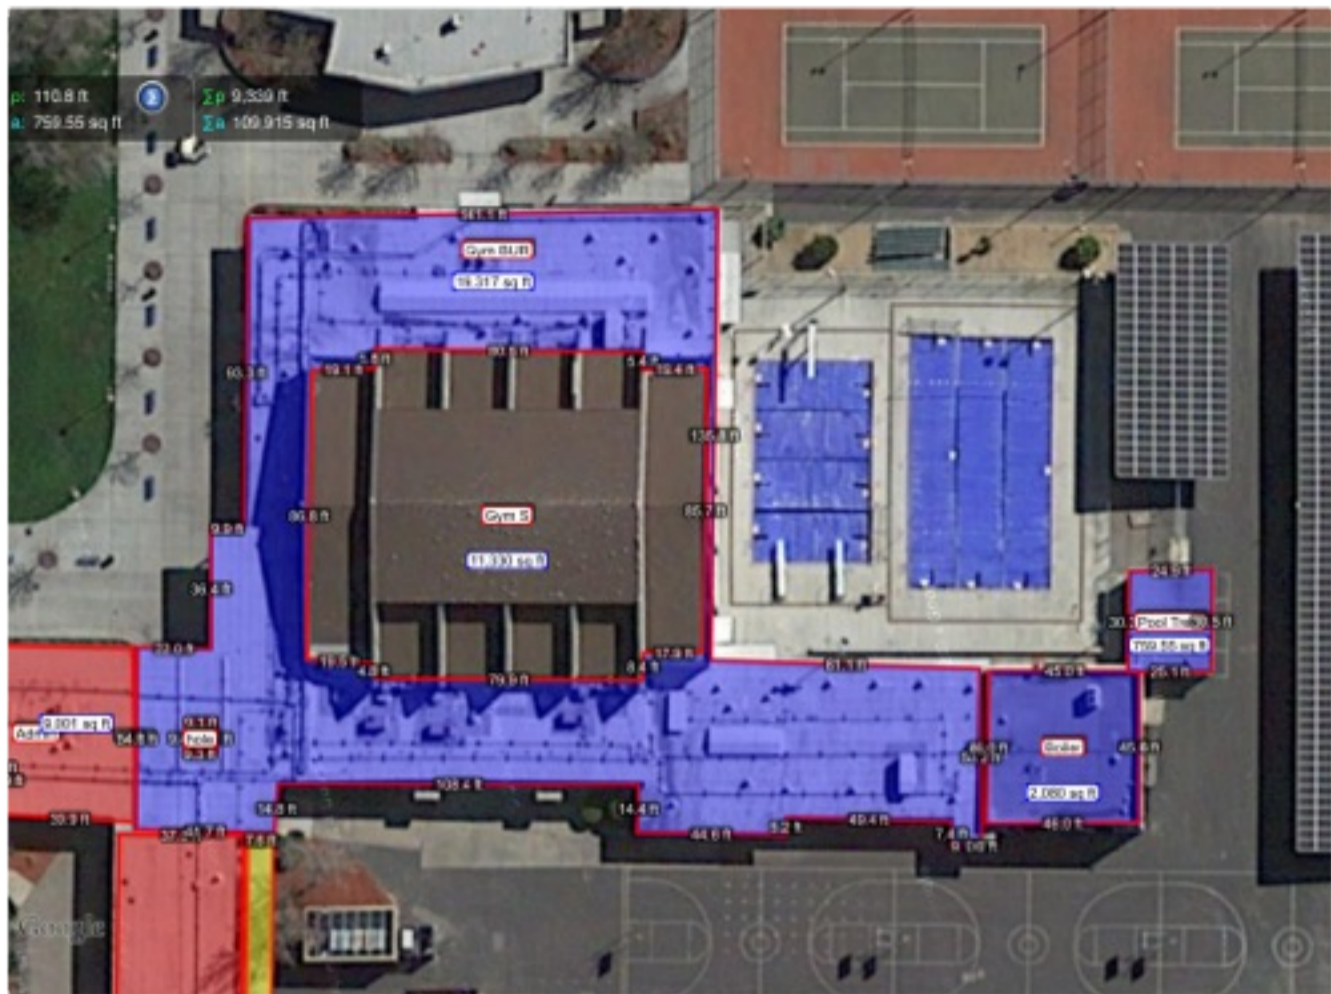
An aerial view of the building.

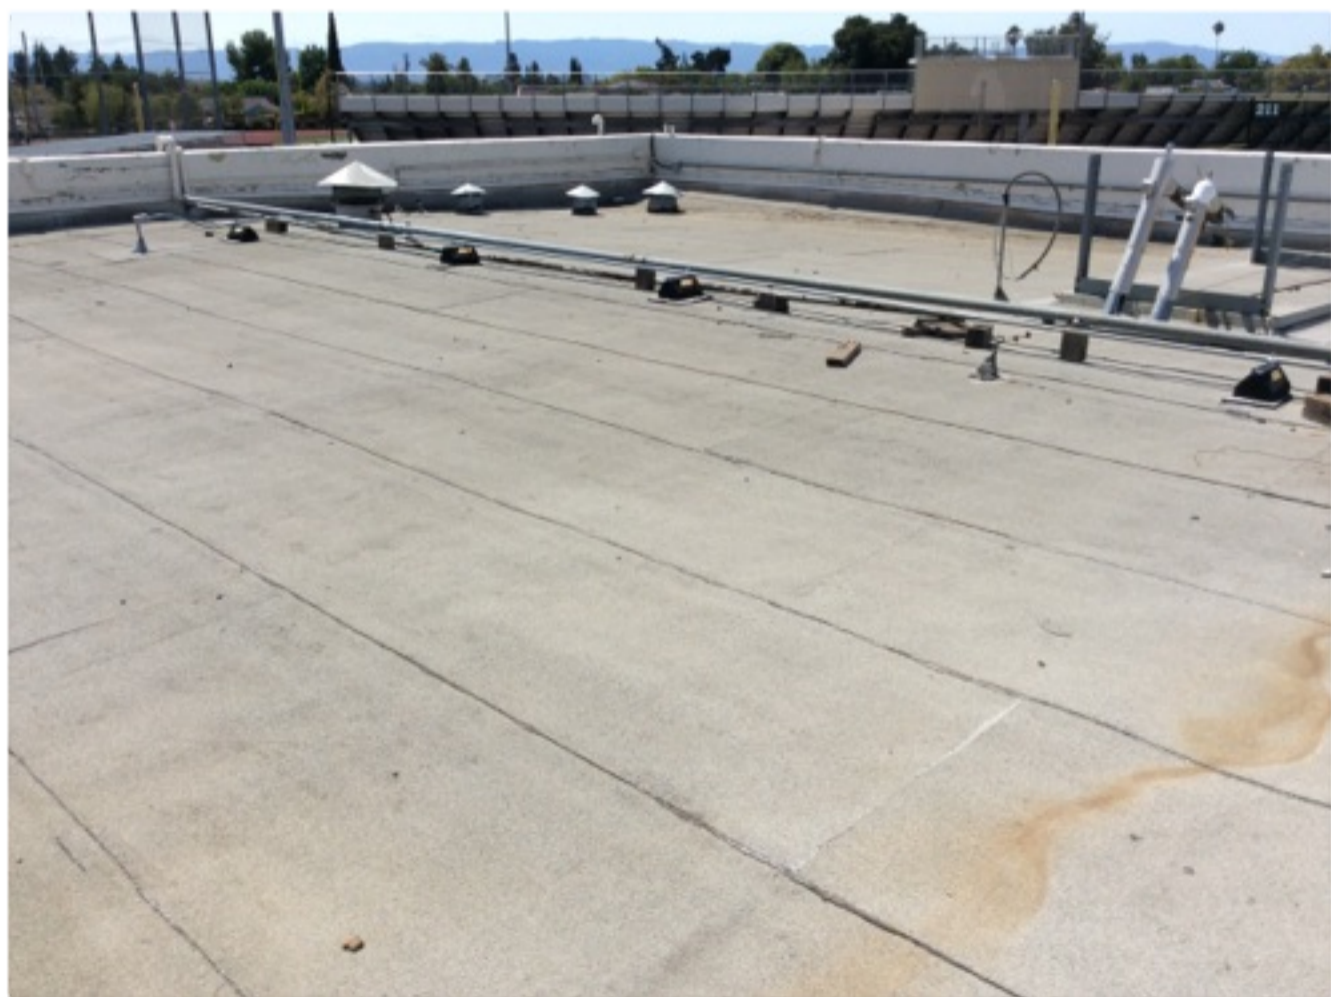
An overview photo from the roof level.
