BUILDING INFORMATION	
FACILITY	James Lick HS
DATE	August 20, 2014
BUILDING	100 and Administration
ROOF SQ FT	16,000

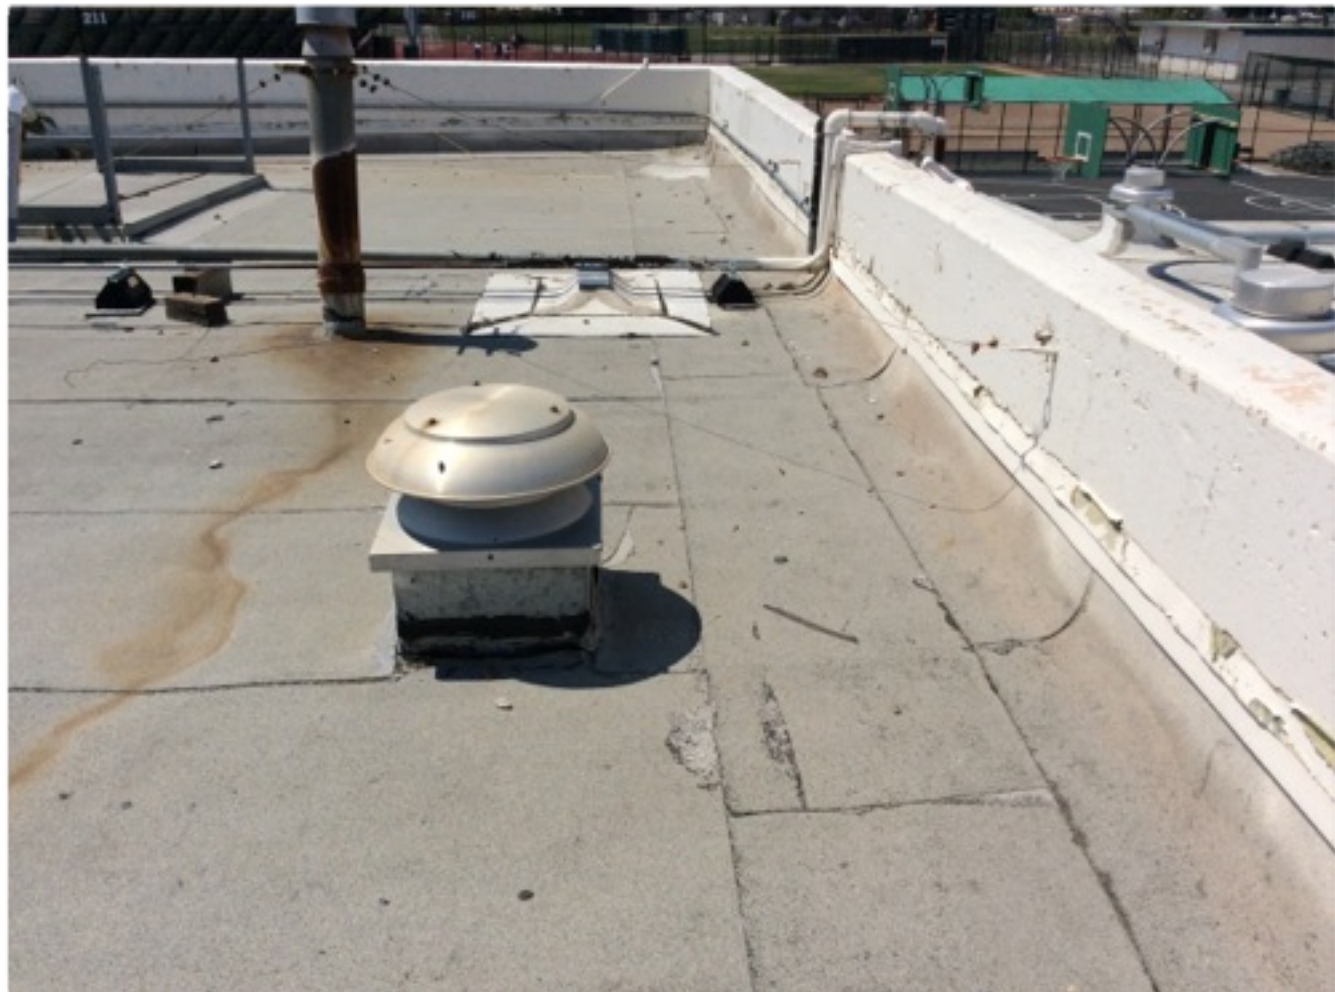
The photo below shows the need for the wall to be sealed and coated.

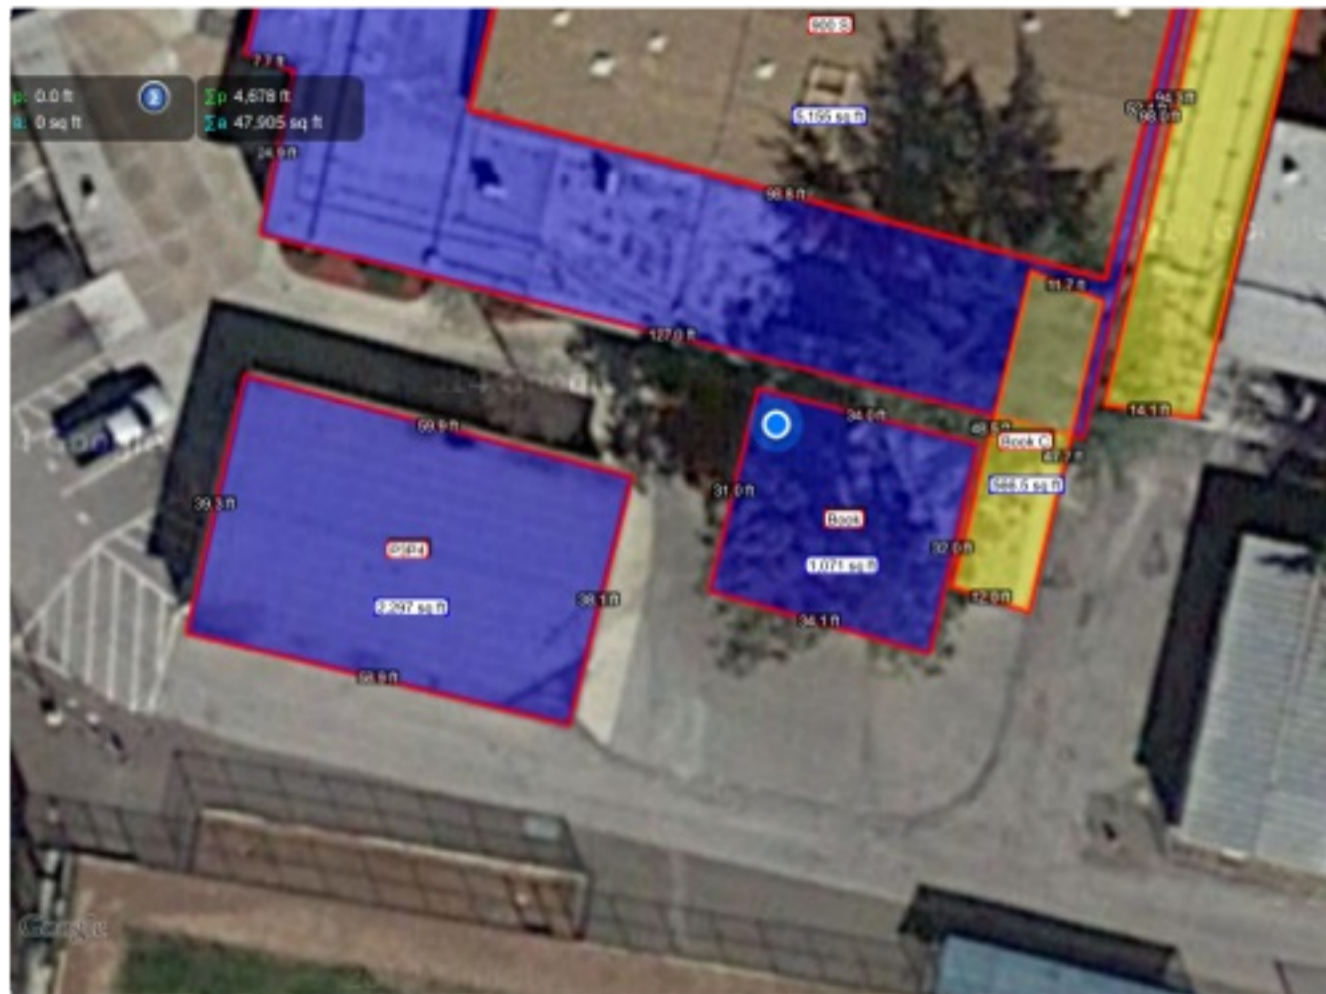
An aerial view of the building.

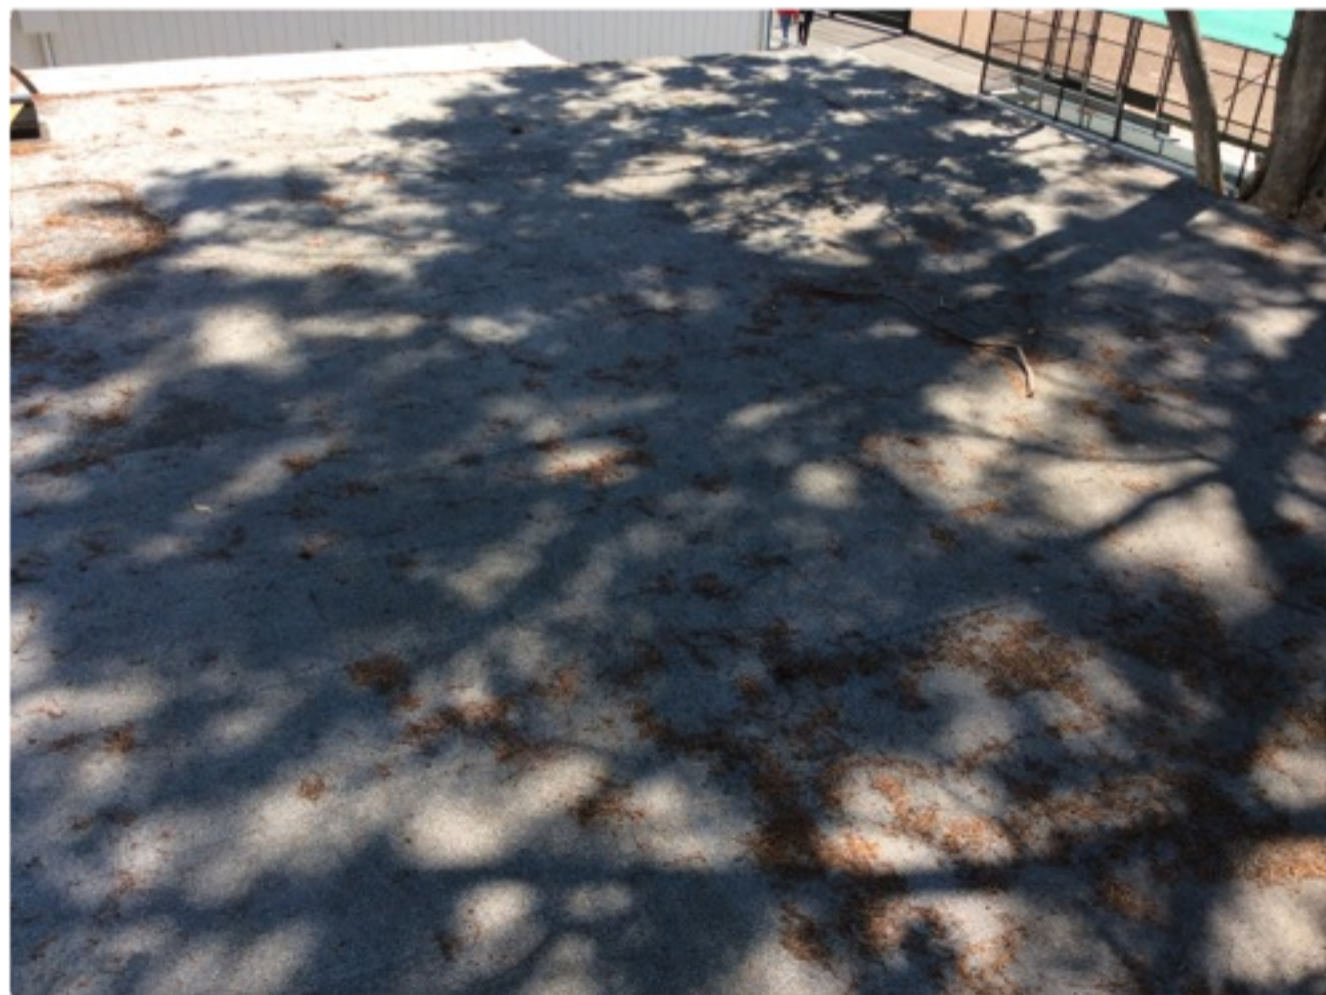
An overview photo from the roof level.

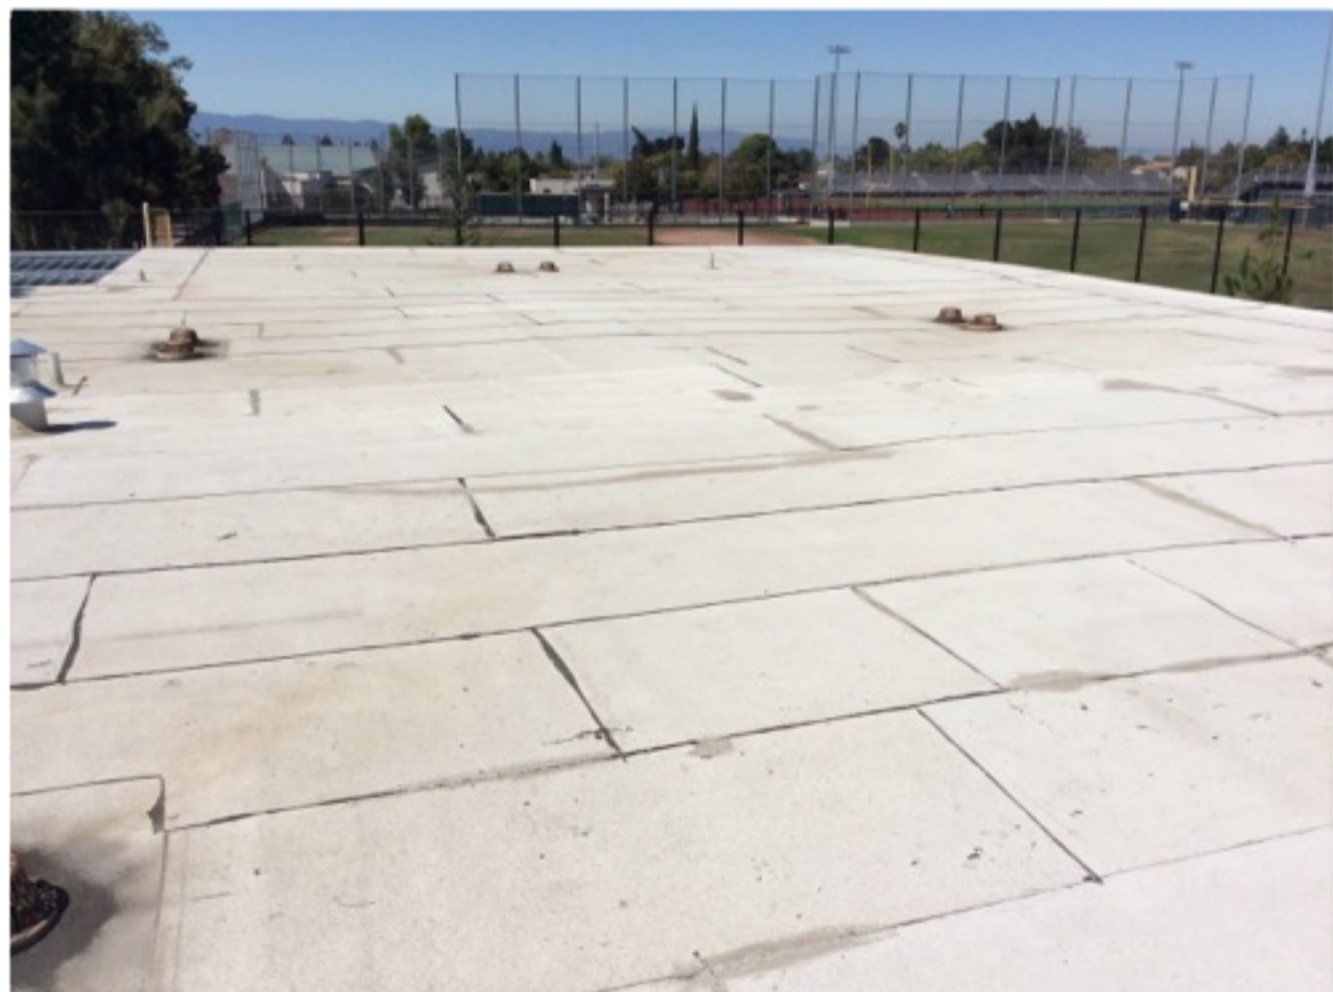
An overview photo from the roof level.

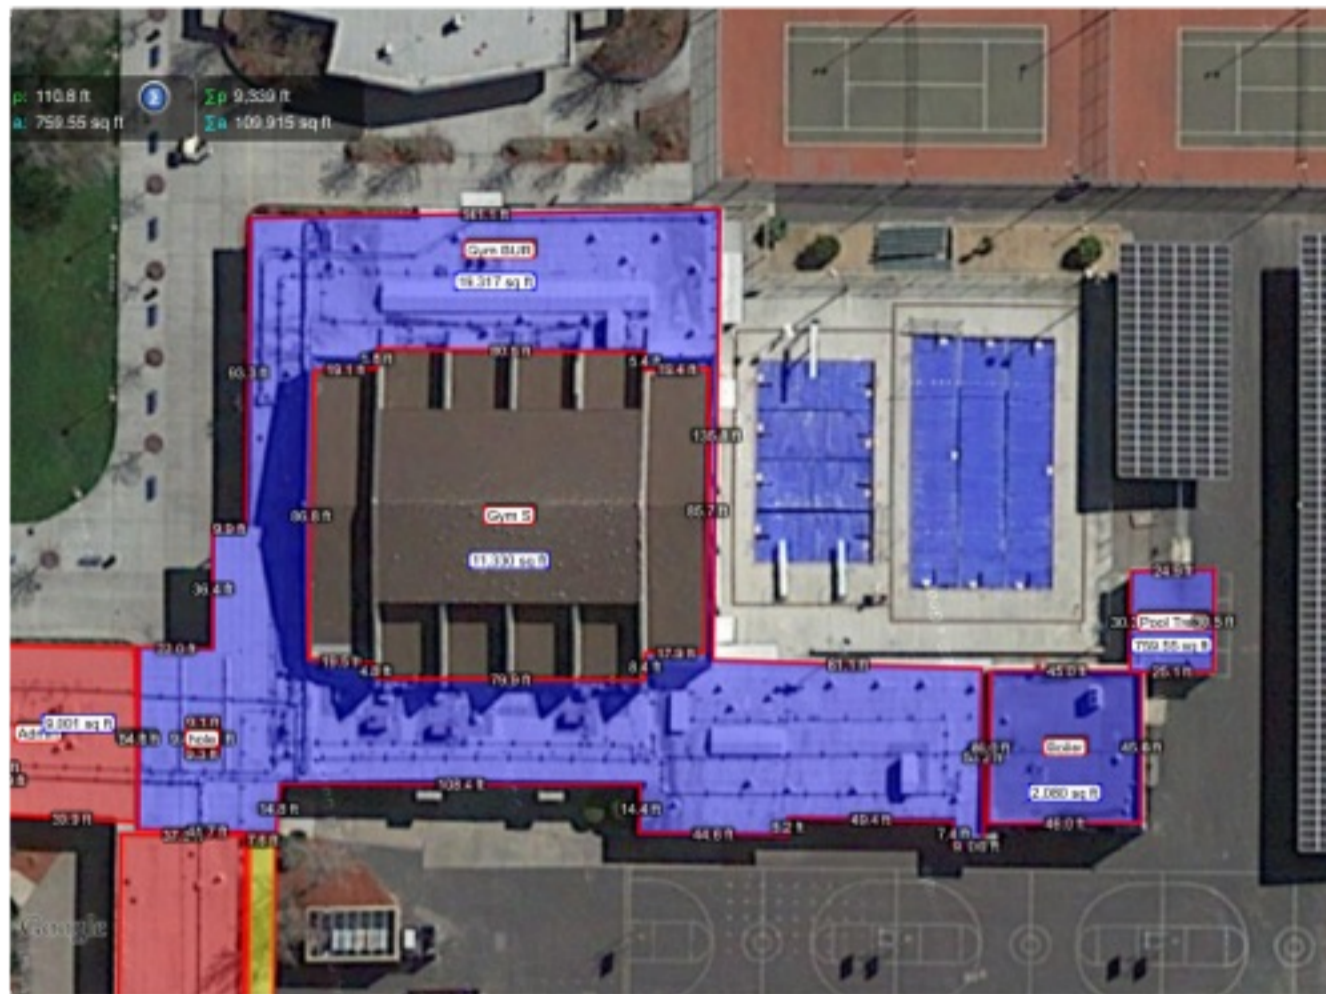
An aerial view of the building.

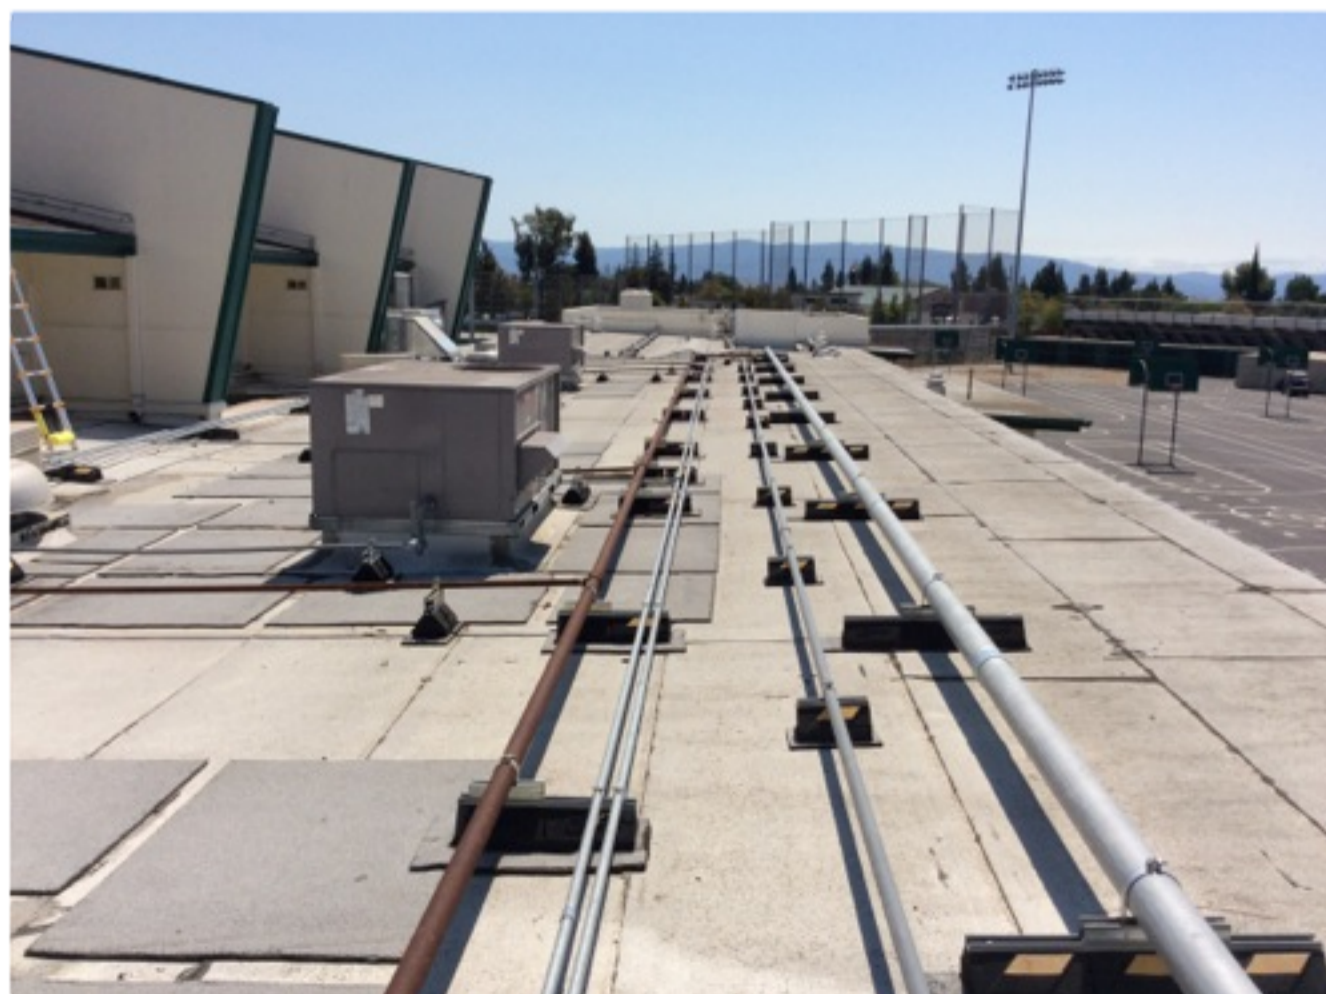
An overview photo from the roof level.

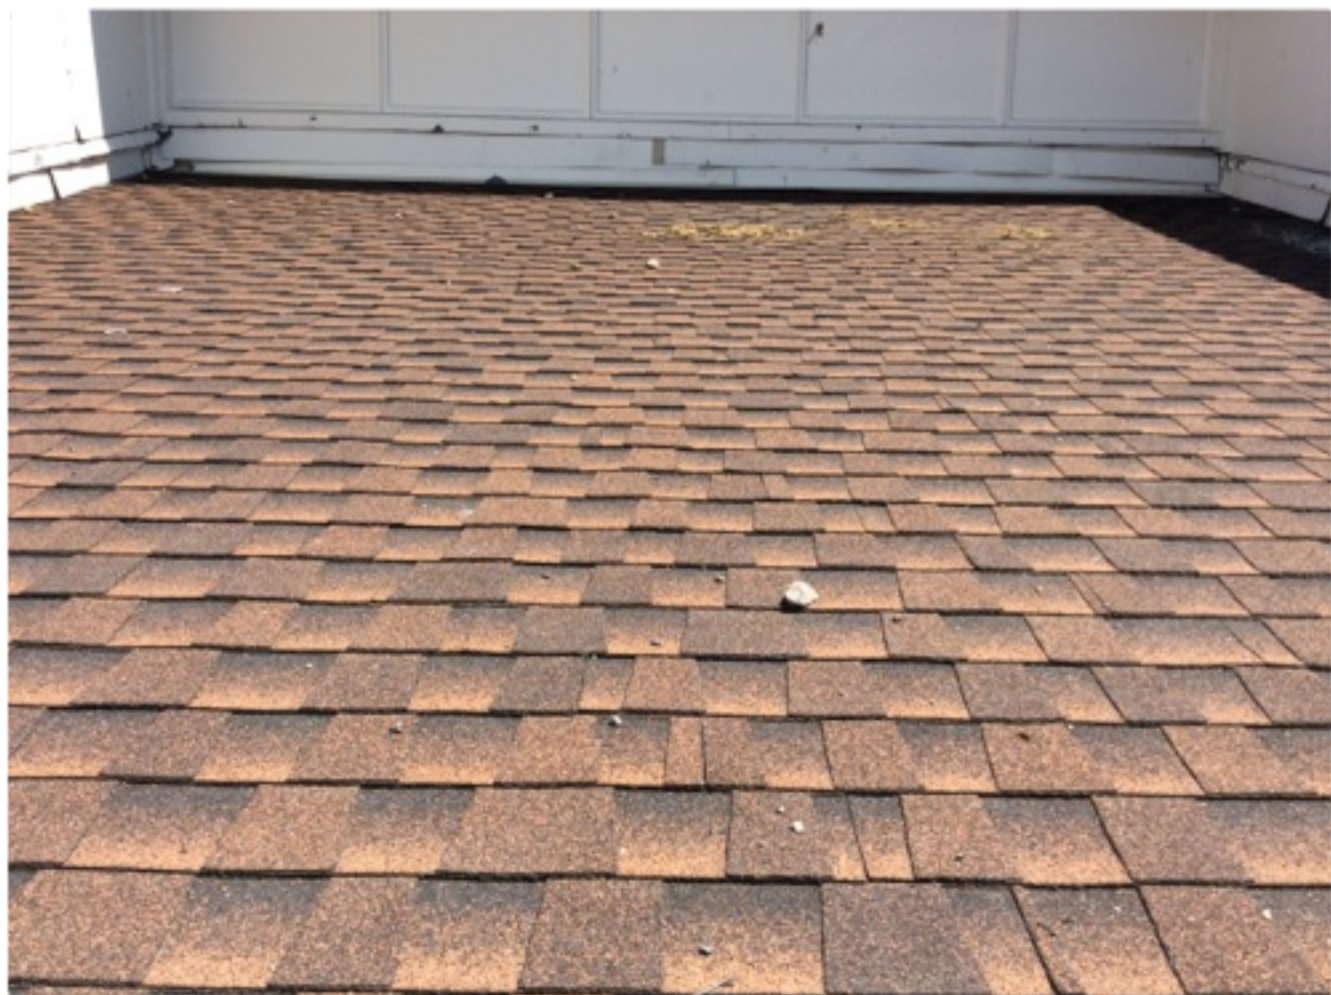
An overview photo from the roof level.

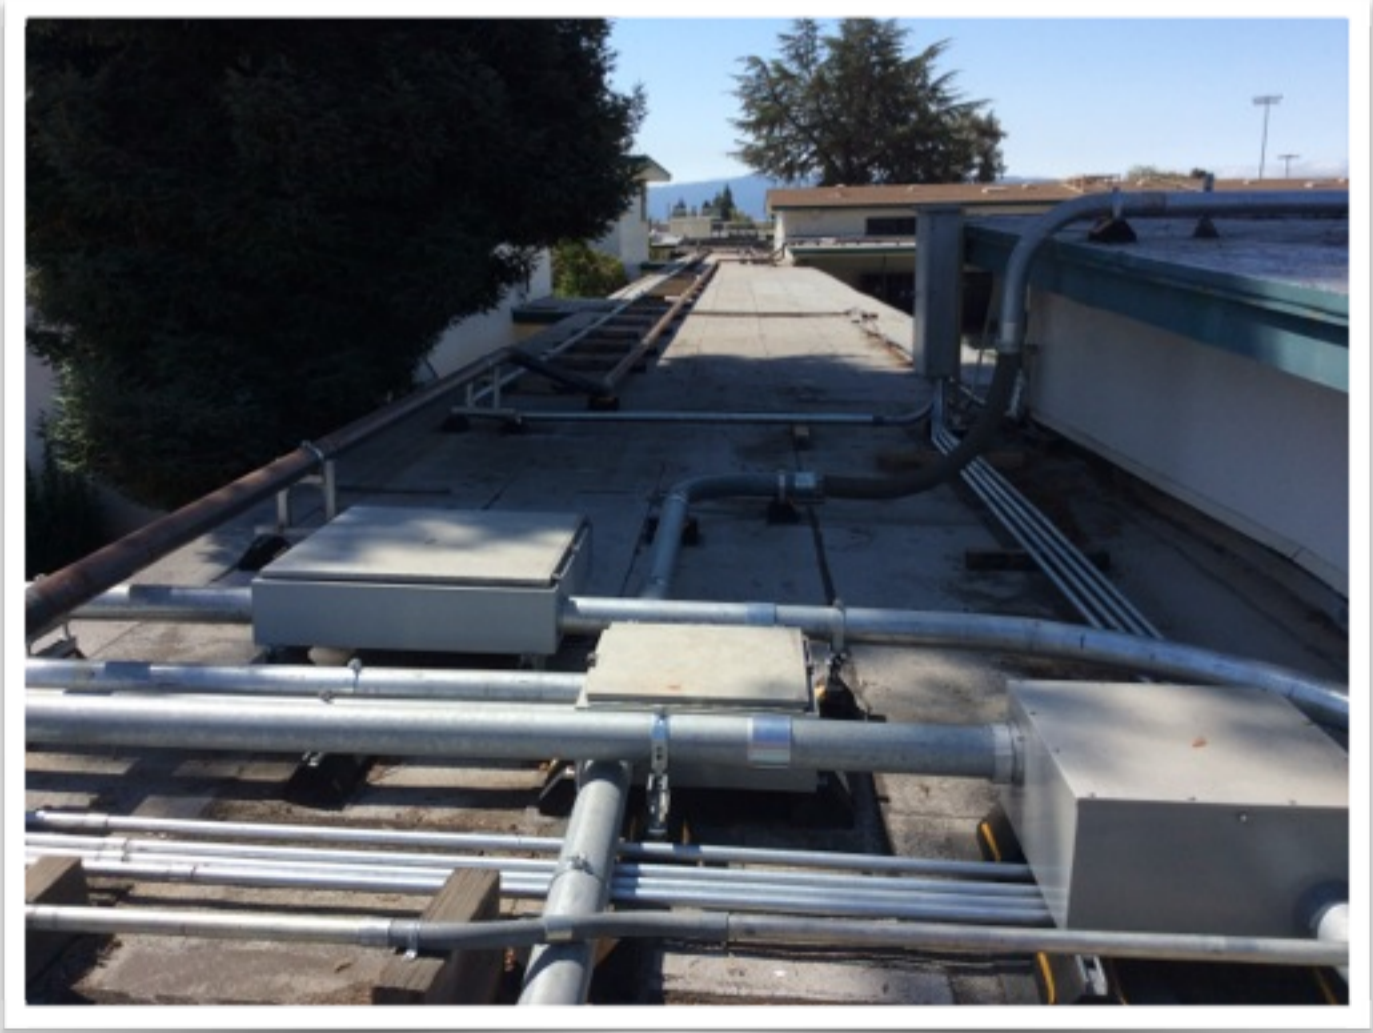
An overview photo from the roof level.

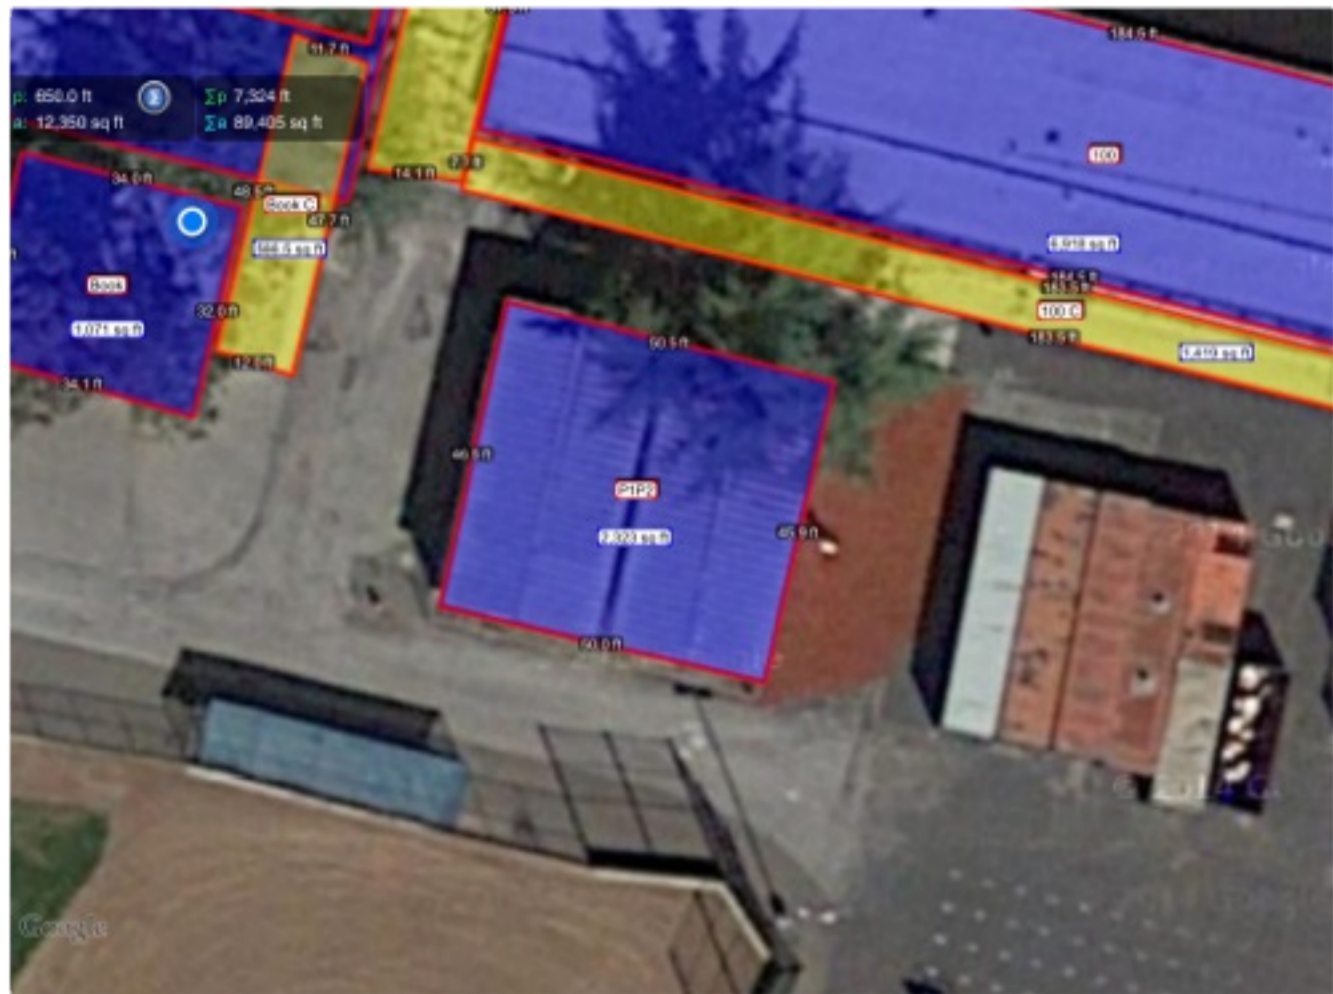
An aerial view of the building.

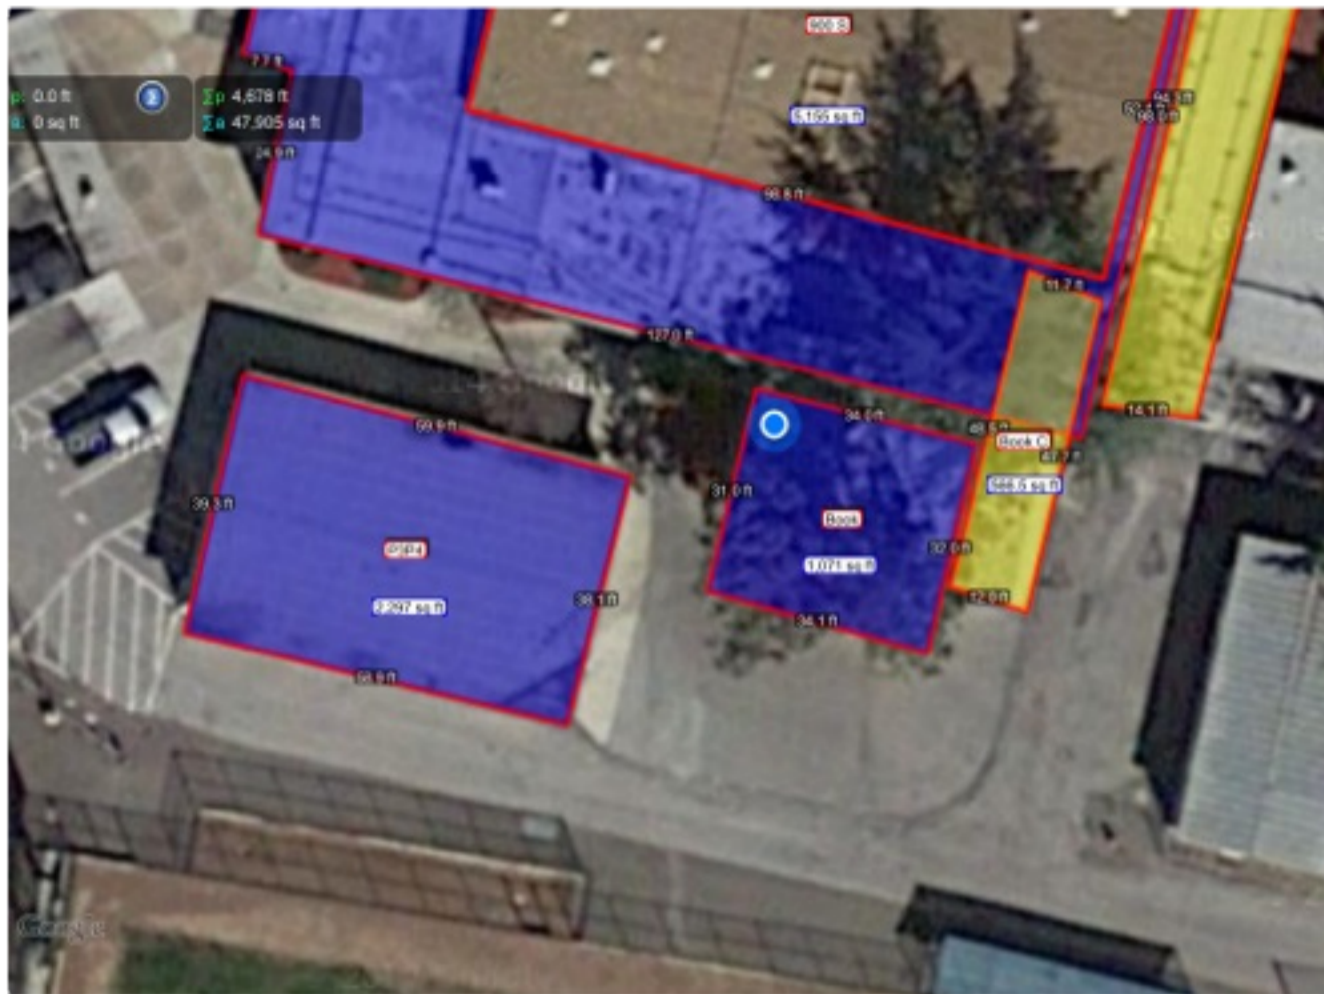
An aerial view of the building.

ADDITIONAL NOTES
 THIS ROOF IS IN POOR CONDITION YET IN BETTER SHAPE THAN THE MULTIPURPOSE BUR SYSTEM. THAT BEING SAID IT IS STILL RECOMMENDED TO REPLACE THE ROOF.

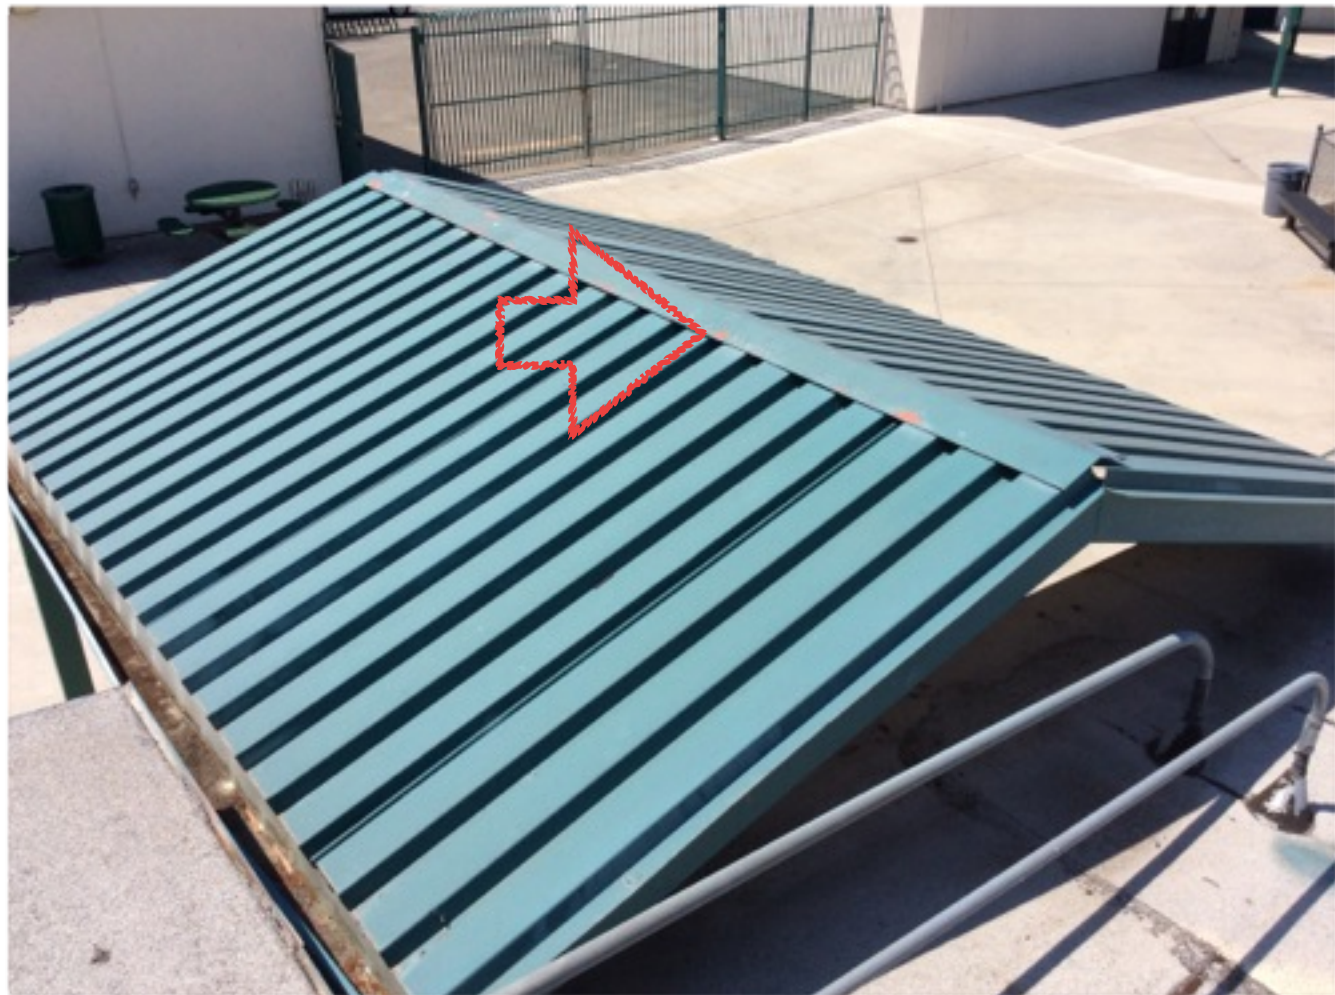
The photo below shows the beginning signs of rust.

If managed and recoated within the next few years, these roofs should last for decades.
